WOOD DESTROYING PESTS AND ORGANISMS INSPECTION REPORT

BUILDING NO. 29404	STREET, CITY, STATE, ZIP Alpine Drive, Cold Springs CA 95335	Date of Inspection 8/12/2024	No. of Pages 6
 		P.O. Box 3731 Sonora, CA 95370 Tel: (209) 536-4615 www.bestpestsierra.com Email: bestpestsierra@gmail.com	
Firm Registration No. PR 8652	Report No. 27321	Escrow No.	
Ordered By: Berkshire Hathaway 133 Old Wards Ferry Rd Ste E Sonora, CA 95370 Attn: Rachel Brannon	Property Owner/Party of Interest	Report Sent To: Manuel Palazuelos 29404 Alpine Drive Cold Springs, CA 95335	
COMPLETE REPORT <input checked="" type="checkbox"/>	LIMITED REPORT <input type="checkbox"/>	SUPPLEMENTAL REPORT <input type="checkbox"/>	REINSPECTION REPORT <input type="checkbox"/>
General Description: ONE STORY SINGLE FAMILY RESIDENCE FURNISHED		Inspection Tag Posted: SUBSTRUCTURE AREA	
		Other Tags Posted: None	
An inspection has been made to the structure(s) shown on the diagram in accordance with the Structural Pest Control Act. Detached porches, detached steps, detached decks and any other structures not on the diagram were not inspected.

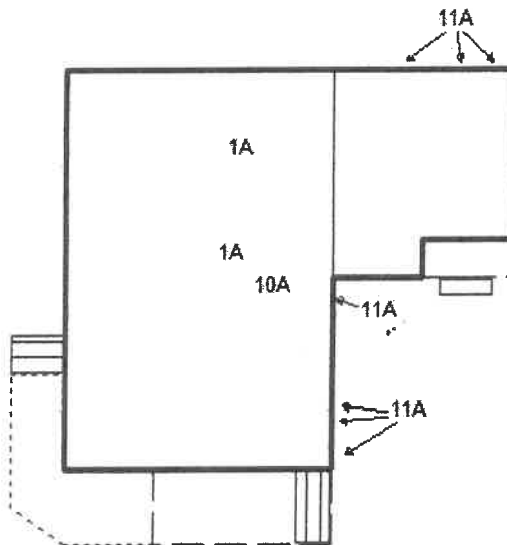
Diagram not to scale. Items in approximate location.

ITEM 1A Cardboard covers were noted around some piers in the subarea.

ITEM 10A The toilet was found to be loose in the bathroom.

ITEM 11A Fungus damage/wood rot was noted at the T1-11 siding under/around the window, minor rot at the right side corner and at the rear right lower siding.

RECOMMENDATION Remove the cardboard covers from the piers and dispose of them.

RECOMMENDATION Re tighten the toilet as necessary. A supplemental report will be given if it is found that the bolts/flange need to be replaced.

RECOMMENDATION Remove the damaged siding around the window for further inspection. If no further damage is exposed, replace with new material with z bar. Repair the damaged siding in the corner and trim off the damaged siding at the bottom of the rear right siding. Paint match new/repared material as necessary.
