# WOOD DESTROYING PESTS AND ORGANISMS INSPECTION REPORT

Building No. 4614	Street Taft Ave	City Richmond	ZIP 94804	Date of Inspection 05/03/2024	Number of Pages 5
----------------------	--------------------	------------------	--------------	----------------------------------	----------------------

4614	Taft Ave	Richmond	CA	94804
Address of Property Inspected		City	State	ZIP
05/03/2024	27462			
Date of Inspection	Corresponding Report No.		Escrow No.

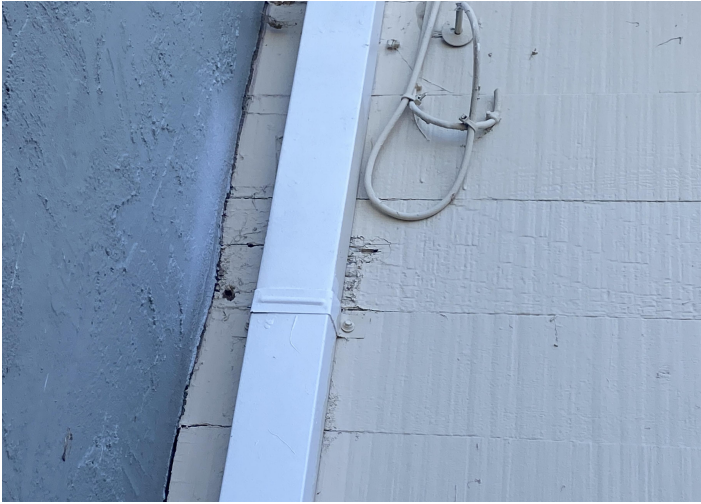
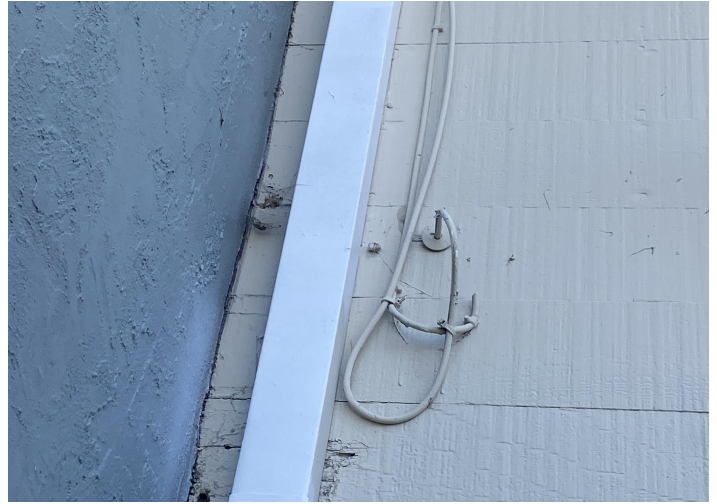
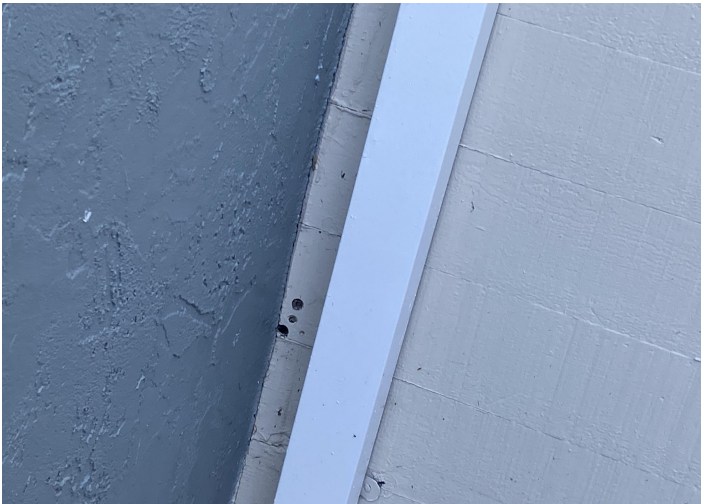
3A

**FINDING:** Fungus has damaged the siding at exterior.

**RECOMMENDATION:** Remove the damaged siding for further inspection. If no further damage is exposed, replace with new material. If additional damage is found, a supplemental report will be issued.

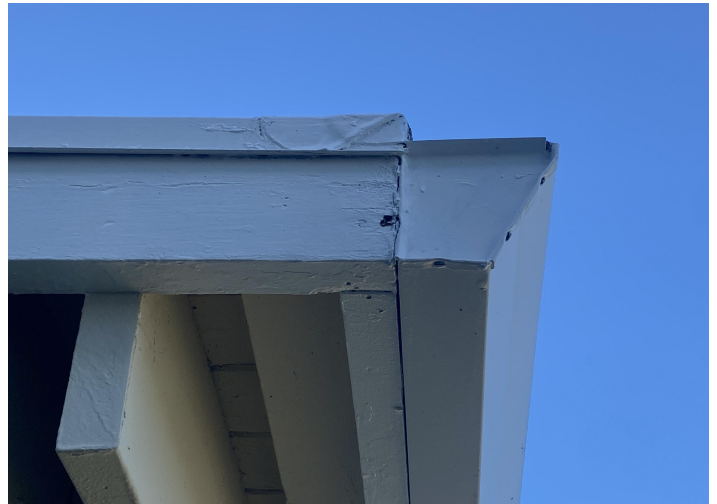
3B

**FINDING:** Fungus has damaged the barge rafter at the exterior.

**RECOMMENDATION:** Remove enough roof covering (if applicable) to allow for the removal of the damaged barge for further inspection. If no further damage is exposed, replace with new material. If additional damage is found, a supplemental report will be issued.

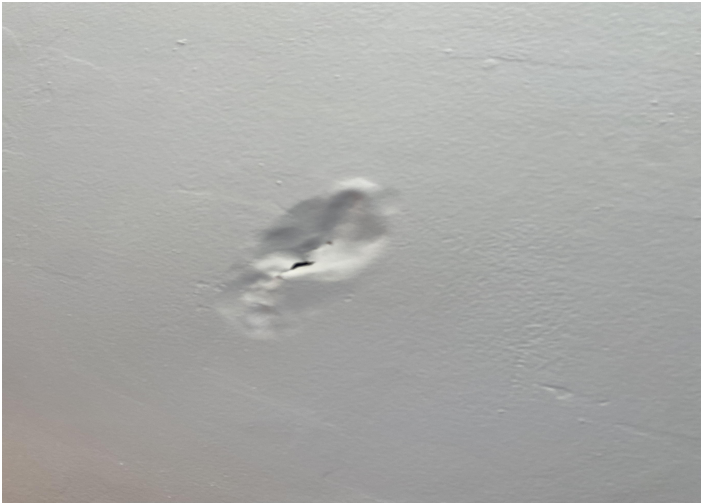
4A

**FINDING:** Water stains/water damage were/was noted at the ceiling in the kitchen ceiling witch is under hall bath upstairs

**RECOMMENDATION:** Remove the stained section of the sheetrock for further inspection. If no further damage is exposed, install new sheetrock, tape and texture. Owner is to paint as desired. The owner should employ a licensed roofing contractor to inspect and/or repair the roof.

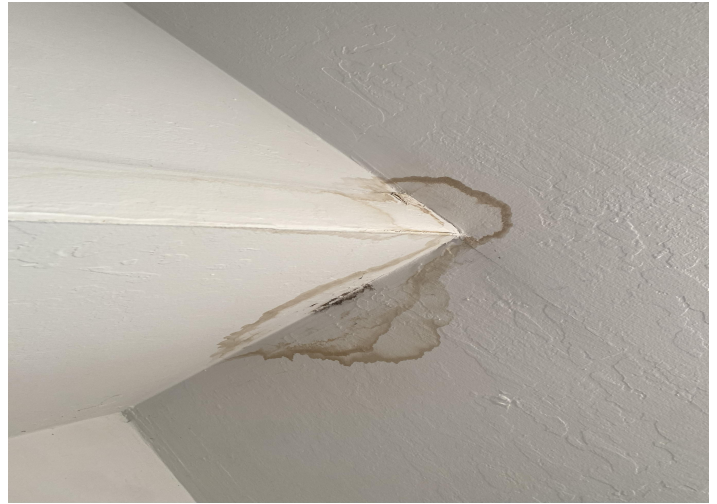
4B

**FINDING:** Water stains/water damage were/was noted at the ceiling in the bedroom closet indicating a possible roof leak.

**RECOMMENDATION:** Remove the stained section of the sheetrock for further inspection. If no further damage is exposed, install new sheetrock, tape and texture. Owner is to paint as desired. The owner should employ a licensed roofing contractor to inspect and/or repair the roof.

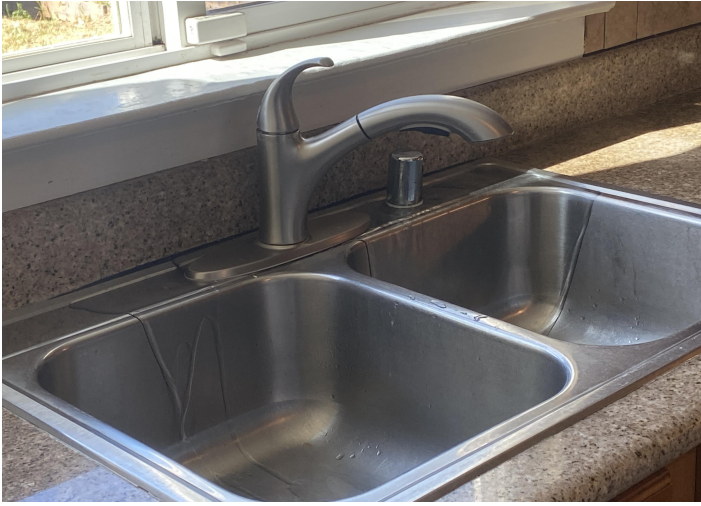
4D

**FINDING:** A plumbing leak was noted at the dish washer drain in the kitchen .

**RECOMMENDATION:** Repair the leak.

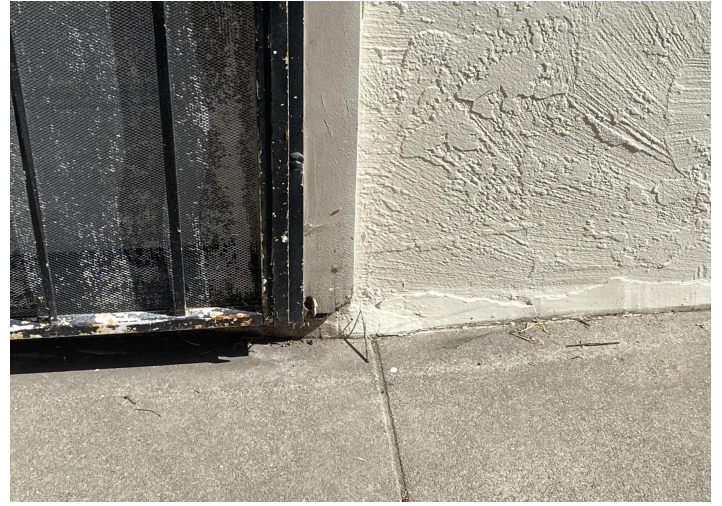
3C

**FINDING:** Fungus has damaged the back door jam and framing

**RECOMMENDATION:** Remove the damaged door jam and framing for further inspection. If no further issues are found, replace wood as necessary. If additional damage is found, a supplemental report will be issued.
