WOOD DESTROYING PESTS AND ORGANISMS INSPECTION REPORT

Building No.	Street	City	ZIP		Inspection	Number of Pages	
1207	San Ramone Way	Ojai	93023	01/2:	5/2023	3	
Ordered by: c/o Anne Williamson Keller Williams 109 N. Blanche Stree Ojai CA 93023	OJ	AI TERMIT 11584 (805) 6 bugs@ojaiten	N. VENTURA AVENU OJAI CA 93023 646-6504 (800) 400-650 mite.com Fax (805) 645 r and/or Party of Interest:	TROL, INC JE 04 46-3539	C. Report Registr Escrow	# : 23032 ration # : PR6289	
COMPLETE REPO	RT 🔀 LIMITED R	EPORT 🗌	SUPPLEMENT	AL REPORT	REINSF	PECTION REPORT	
GENERAL DESC	RIPTION:				Inspection Tag	Posted:	
One-story residence, furnished and occupied, composition roof, on a concrete slab with attached garage.							
					Other Tags Po		
Ojai Termite- 12/2/2020 An inspection has been made of the structure(s) shown on the diagram in accordance with the Structural Pest Control Act. Detached porches,							
detached steps, detached decks and any other structures not on the diagram were not inspected.

1207	San Ramone Way	Ojai	CA	93023	
Address of Property	Inspected	City	State	ZIP	
01/25/2023	2	23032			
Date of Inspection	Corres	ponding Report No.	E	scrow No.

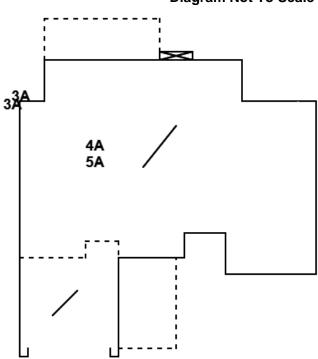
Diagram Not To Scale

Fungi (dry-rot) noted in fascia. Section 1.

Water stains noted in framing. May be from past or present leaks. OJAI TERMITE AND PEST CONTROL assumes no responsibility for roofing as this is beyond the scope of our license. Section 2.

Portions of the attic is not accessible for a complete and thorough inspection due to insulation/construction. It does not appear practical to make this area accessible without tearing out or defacing wood members. Section unknown.

Remove and replace and/or reinforce structural damaged wood members, also chemically treat if necessary. Cost includes primer only. If during the process of our work any more damage is found in inaccessible areas that cannot be detected at time of inspection then all work will stop until new quotations and recommendations are approved. OJAI TERMITE & PEST CONTROL will do its best to match the existing lumber. Ojai Termite & Pest Control will not be responsible for any damage that may occur to the roof during the process of our work. Please contact a licensed roofer with any questions or concerns.

Refer to other trade.
