WOOD DESTROYING PESTS AND ORGANISMS INSPECTION REPORT

Building No. 2147	Street Hood Dr.	City Thousand Oaks	ZIP 91362	Date of Inspection 03/26/2024	Number of Pages 4
----------------------	--------------------	-----------------------	--------------	----------------------------------	----------------------

Report # : 22158

CORRECTED REPORT

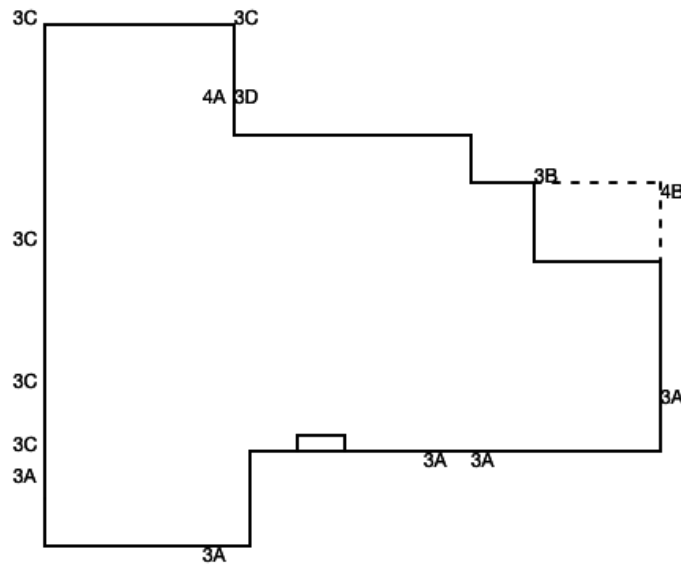
Diagram Not To Scale

FINDING - Fungus/Dryrot damage to the wood member(s) of the structure including: Shiplap and rafter tails, as indicated on the diagram.

FINDING - Fungus/Dryrot damage to the wood member(s) of the structure including: Patio post trim, as indicated on the diagram.

FINDING - Fungus/Dryrot damage to the wood member(s) of the structure including: Fascia boards, as indicated on the diagram.

FINDING - Fungus/Dryrot damage to the wood member(s) of the structure including: Exterior door jamb, as indicated on the diagram.

FINDING - Moisture damage noted at floor near door, as indicated on the diagram.

FINDING - Chipped paint noted at rear patio eaves and framing, as indicated on the diagram.

RECOMMENDATION - Remove, replace, reinforce/repair damaged lumber. Treat adjacent lumber with a State registered wood preservative solution (Disodium Octaborate Tetrahydrate). Primer, ready for paint by others.

RECOMMENDATION - Remove & replace all damaged lumber as deemed necessary. Treat adjacent lumber with a State registered wood preservative solution (Disodium Octaborate Tetrahydrate). Primer, ready for paint by others.

RECOMMENDATION - Interested party should engage the services of an appropriate tradesperson to inspect and correct as they deem necessary.
