# WOOD DESTROYING PESTS AND ORGANISMS INSPECTION REPORT

Building No.	Street	City	Zip	Date of Inspection	Number of Pages
5522	Bloch St	San Diego	92122-4012	04/23/2025	1 of 6

General Description: One and Two Story, Single Family Residence, Composition Roof, Stucco Siding, Attached Two Car Garage Covered in Drywall, Slab Foundation	Inspection Tag Posted: ATTIC
Other Tags Posted:

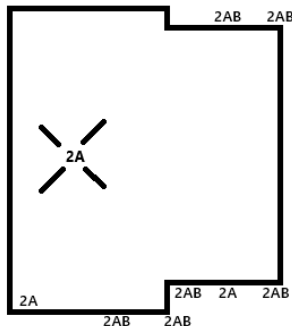
Key: 1 = Subterranean Termites    2 = Drywood Termites    3 = Fungus/Dryrot    4 = Other Findings    5 = Unknown Further Inspection

Finding:	2A	Evidence of Drywood Termite infestation was noted at the garage framing, attic, fascia, window trim, garage door jamb, and rafter tail as indicated on the diagram.
Recommendation:		Vacate the premises and seal the structure with tarpaulins for fumigation with Sulfuryl Fluoride a state approved fumigant for the control of Drywood Termites. An Occupant Fumigation Notice must be signed prior to the commencement of any work completed. Cover and or mask accessible Drywood Termite Pellets. Drywood termite Fumigations are warranted for a period of four years from the date of fumigation.
Price:	\$1,980.00	
Finding:	2B	Evidence of Drywood Termite damage was noted at the fascia, window trim, garage door jamb, and rafter tail as indicated on the diagram.
Recommendation:		Repair Drywood Termite damaged wood members as needed. If damage extends into an inaccessible area, a supplemental report will be generated with an additional cost estimate. Paint is included in this estimate, however exact match is not guaranteed. Termite repairs are warranted for a period of one year from the date of completion.
