# Integrity inspections

## Home Inspection Report

**28006 Pontevedra Dr.**

Inspected on Tue, Jan 26 2021 at 9:27 AM

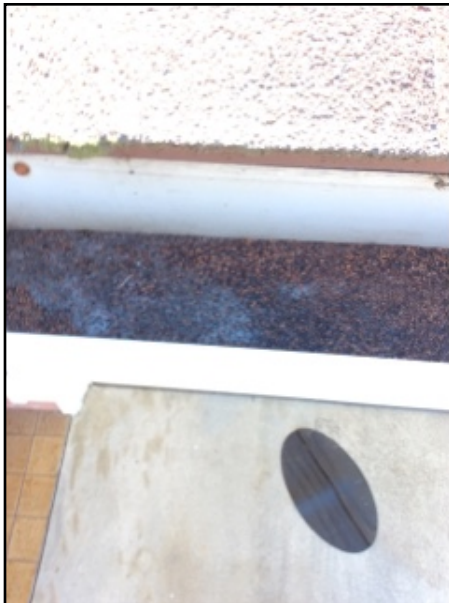
Figure 12-1

Comment 12:  
Suggest cleaning rain gutters.

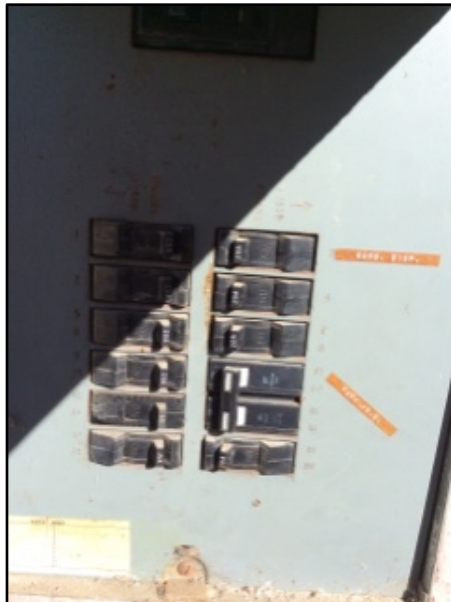
Figure 17-1

Comment 17:  
Panel not labeled completely.

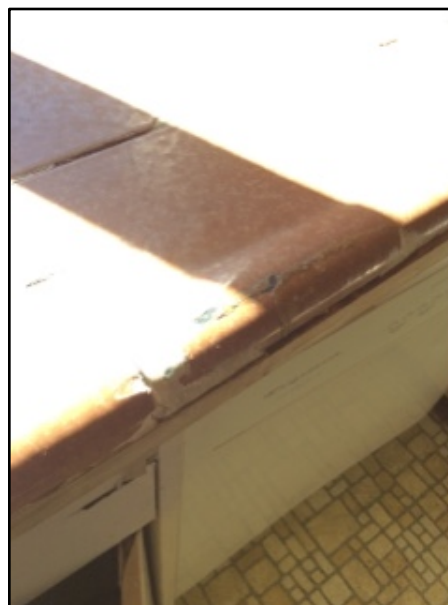
Figure 40-2

33) Cracked/worn/damaged tiles.

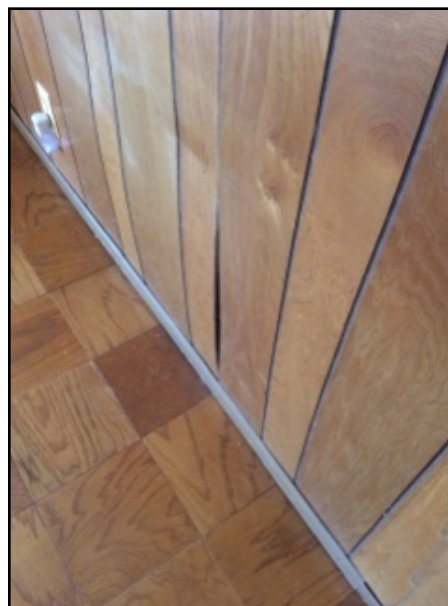
Figure 51-2

43) Paneling coming away from wall.

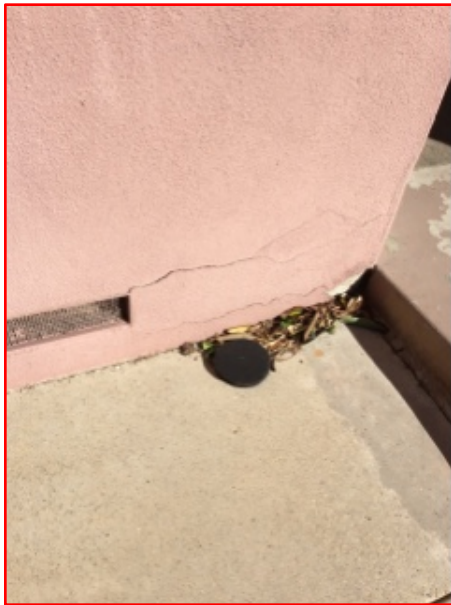
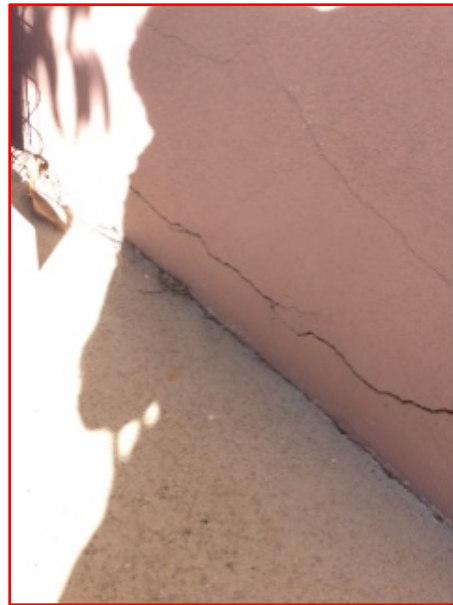
Comment 2:  
Cracks on exterior walls.

2) Cracks on exterior walls.

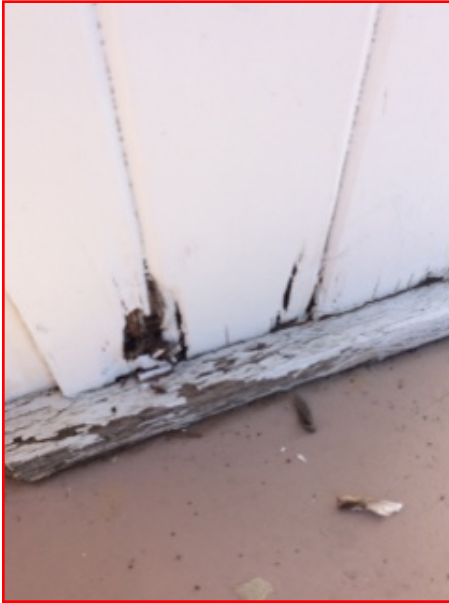
Figure 3-1

Moisture damage to exterior wood at patio .

3) Moisture damage to exterior wood at patio .

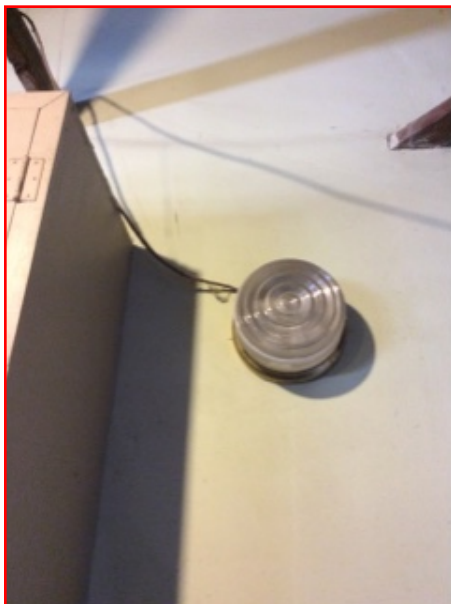
Figure 6-1

Comment 6:  
Light not working. Improper wiring off light

5) Light not working. Improper wiring off light

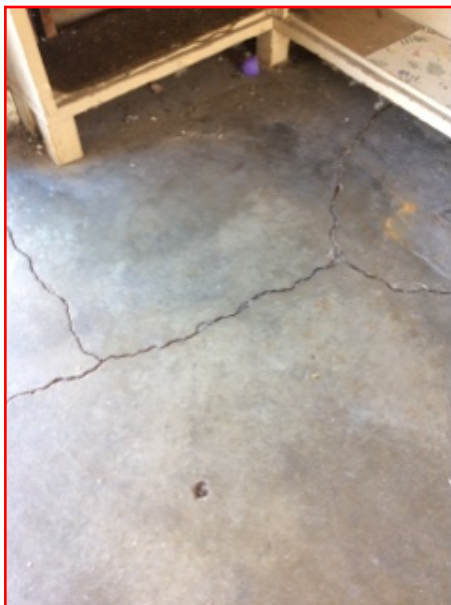
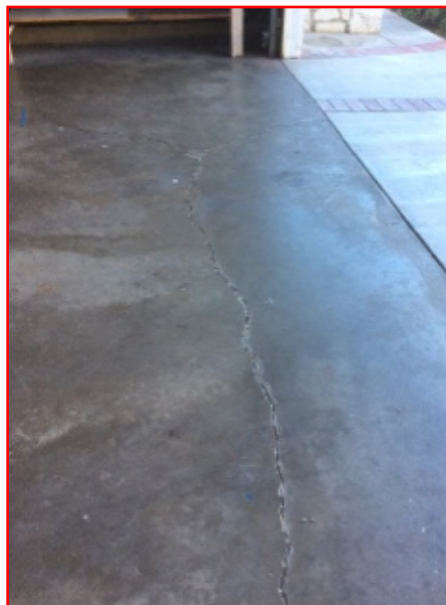
Comment 8:  
Cracks on garage floor if concerned suggest further evaluation.

6) Cracks on garage floor if concerned suggest further evaluation.

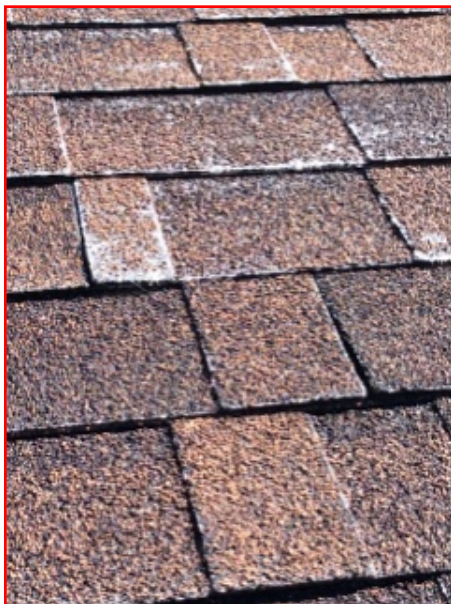
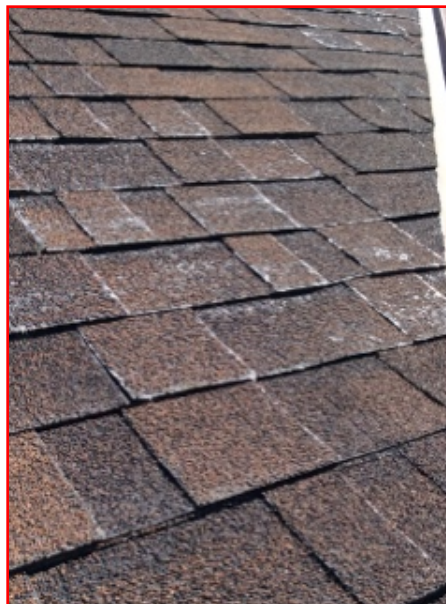
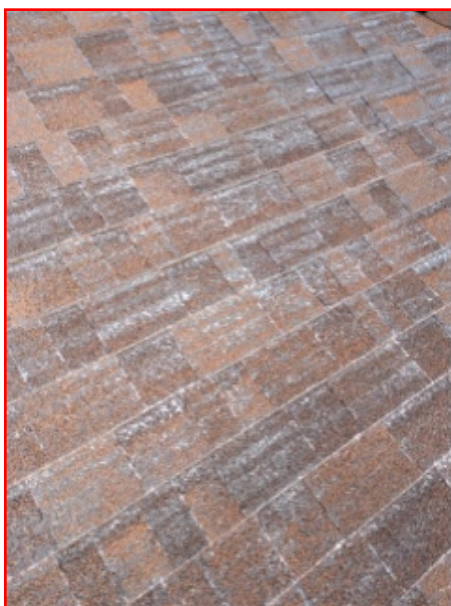
Comment 9:  
Shingles starting to wear. If concerned suggest further evaluation

7) Shingles starting to wear. If concerned suggest further evaluation

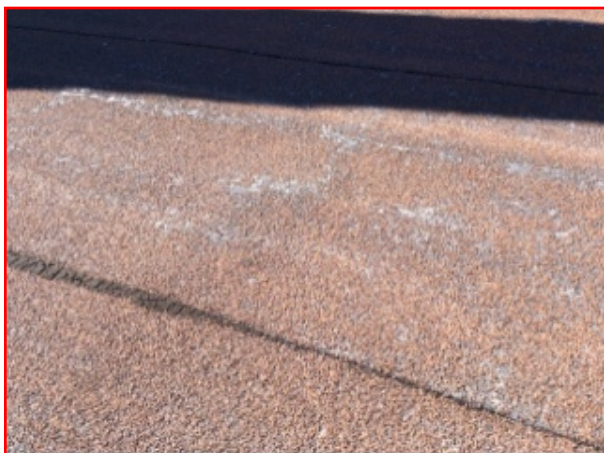
Figure 10-1

Comment 10:  
Roll roofing starting to wear.

8) Roll roofing starting to wear.

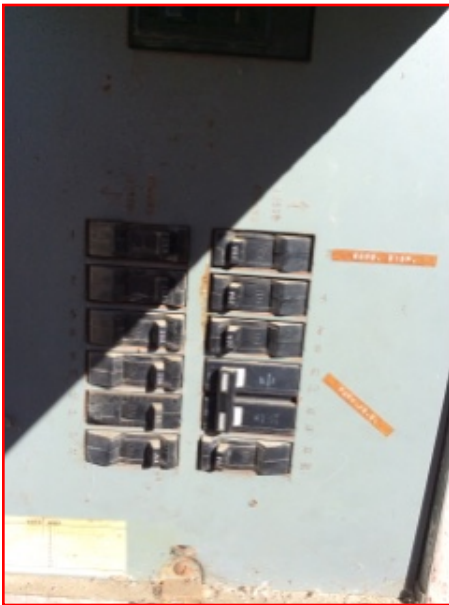
Figure 17-1

15) Panel not labeled completely.

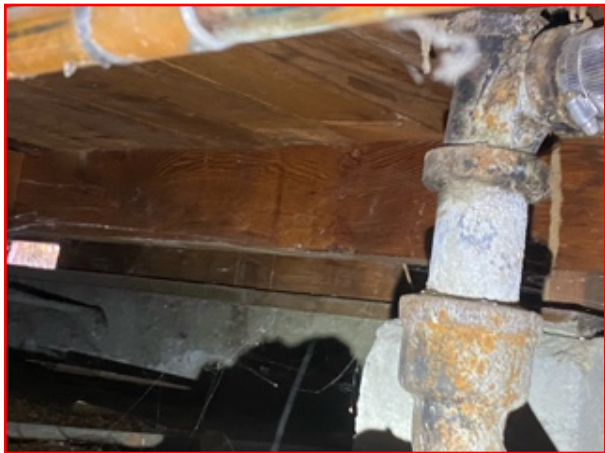
Figure 25-1

21) Some corrosion on piping. Older piping

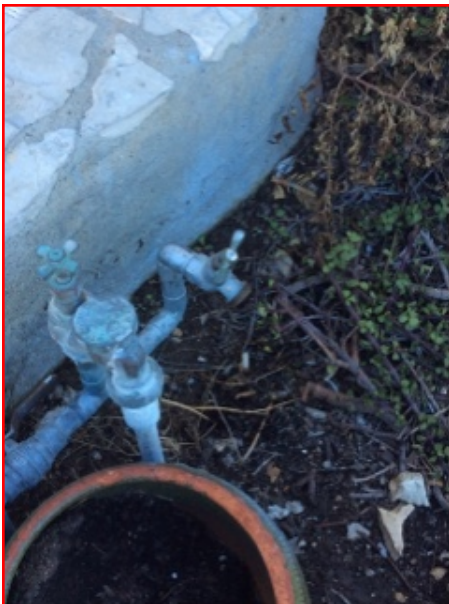
Figure 27-1

23) Constant dripping at exterior front faucet .

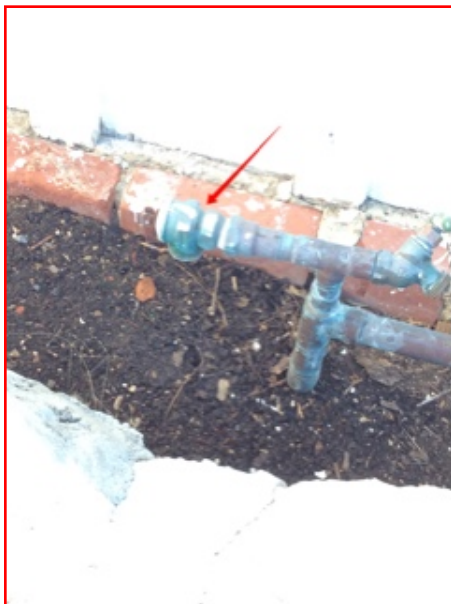
Figure 28-1

24) TPR valve at main line dripping .

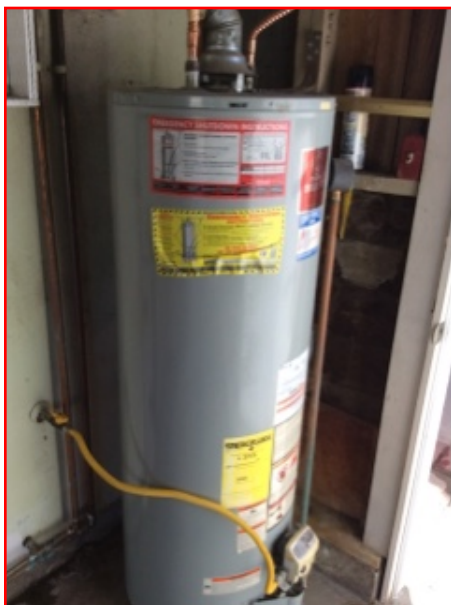
Figure 29-1

25) Water heater needs two straps one on top one third and one on bottom one third. Attached to studs in the wall with 3/4" X 3" lag bolts

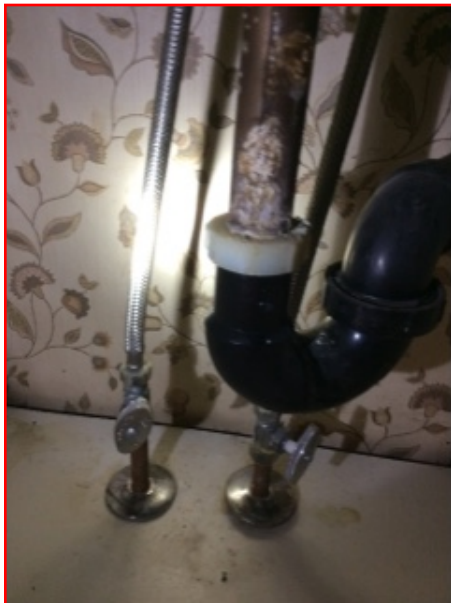
Figure 33-1

27) Rust/Corrosion on pipes.

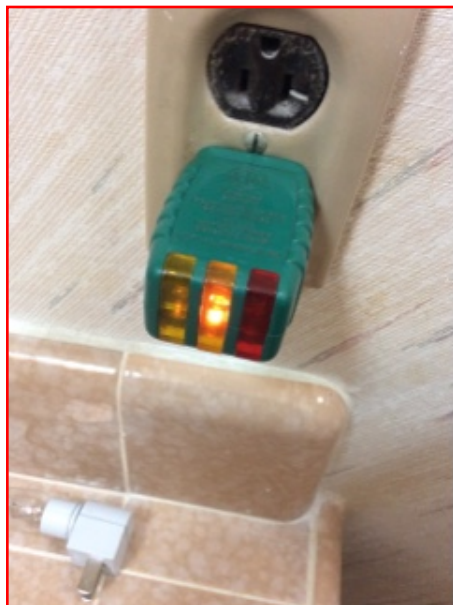
Figure 35-1

29) Has a weak ground suggest further .

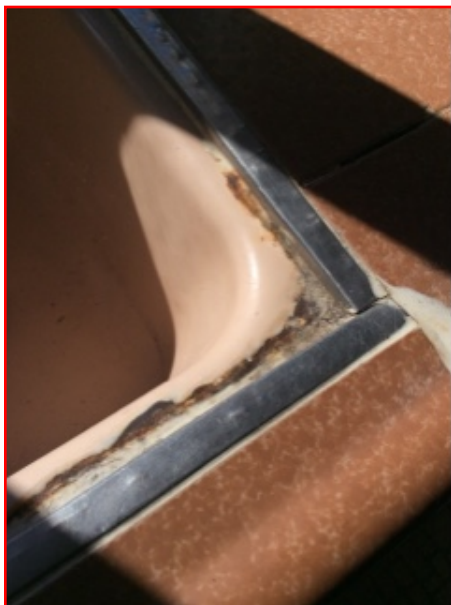
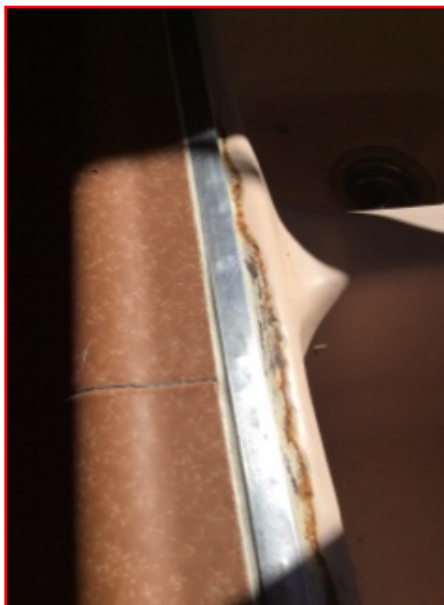
34) Older sink/rusted suggest replacing .

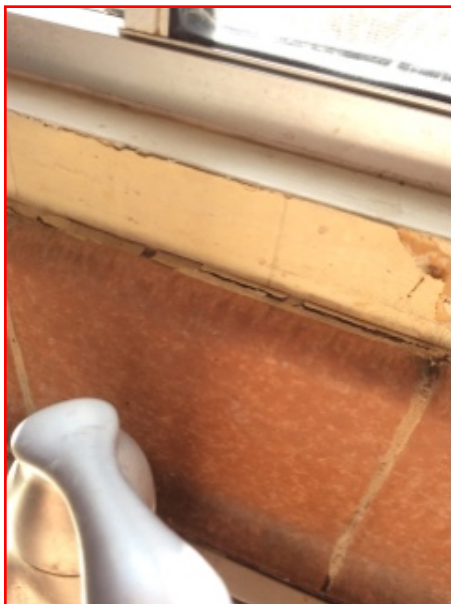
Figure 43-1

35) Need sealing at splash guard .

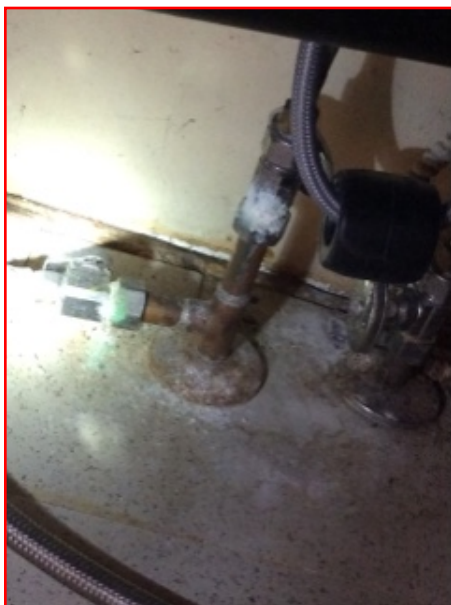
Figure 44-1

36) Oxidation/hard water residue on pipes possibly suggest small pin hole leaks.

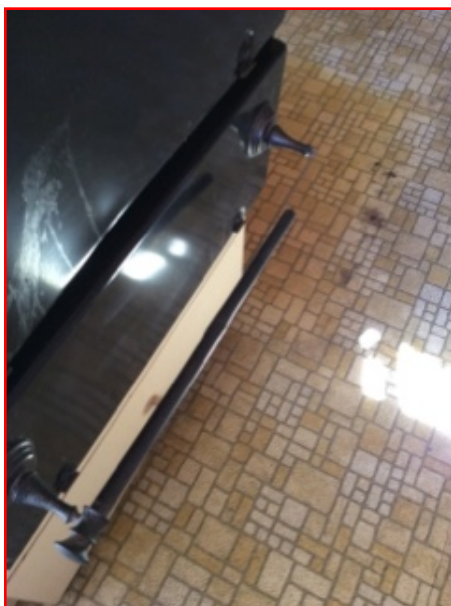
Figure 45-1

37) Broken broiler handle. Oven handle loose

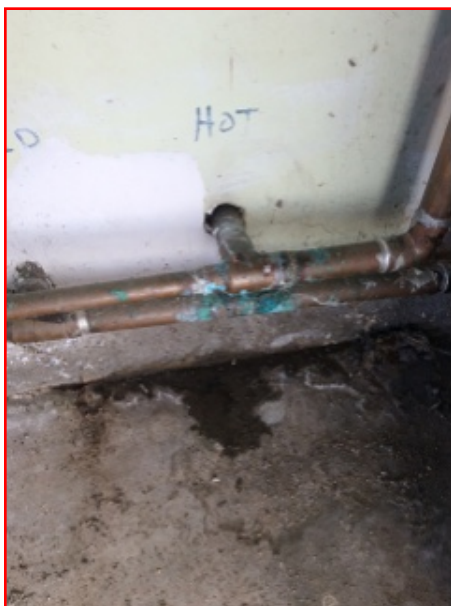
Figure 49-1

41) Oxidation on pipes and appear to be leaking suggest further evaluation .

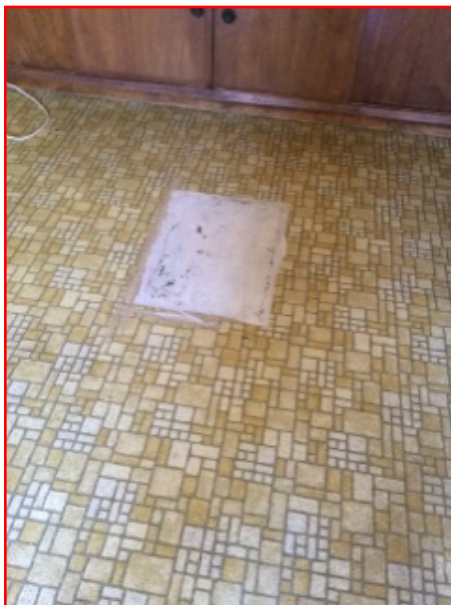
Figure 50-1

42) Repair done on flooring in dining room .

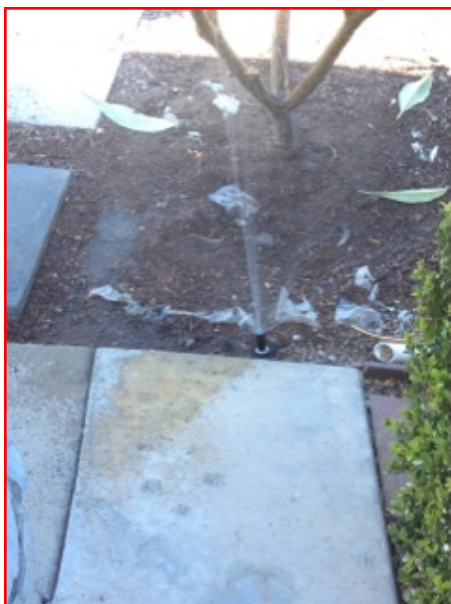
Figure 55-1

47) Damaged sprinkler heads.

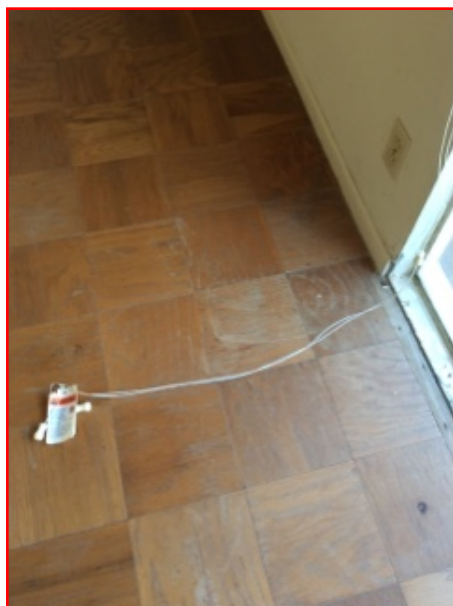
Figure 56-1

48) Flooring worn .

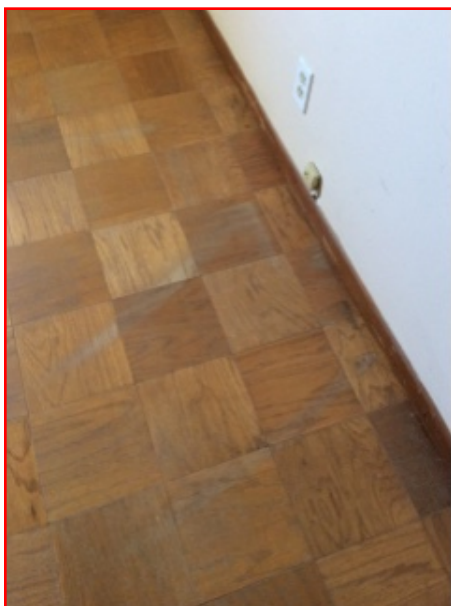
Figure 59-1

50) Flooring worn.

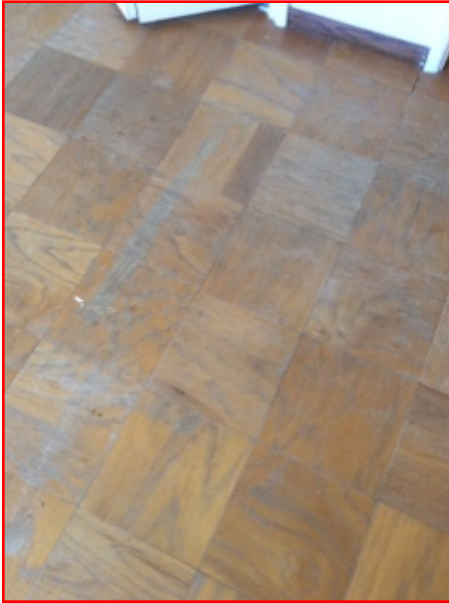
Figure 62-1

52) Flooring worn.

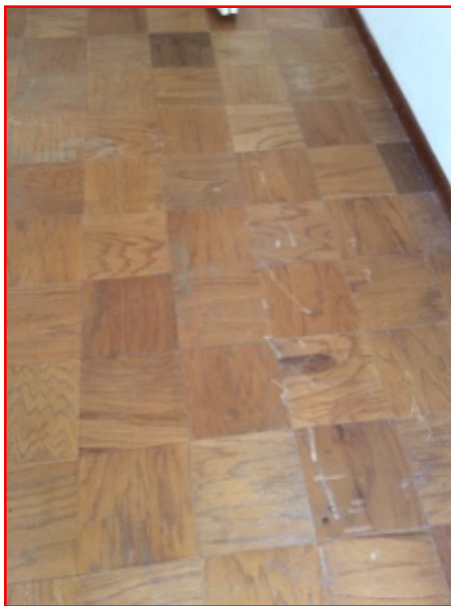
Comment 66:  
Flooring worn.

55) Flooring worn.

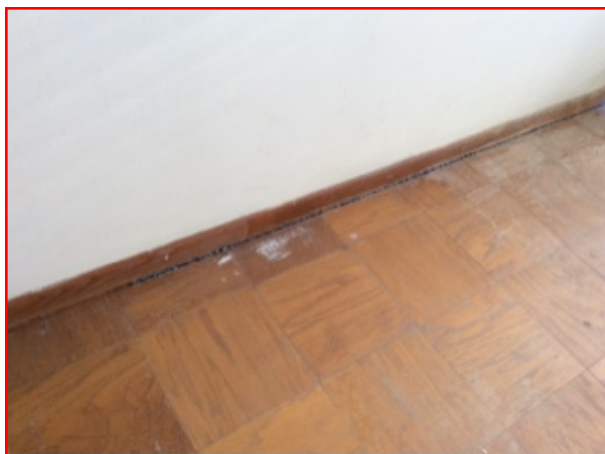
Figure 67-1

56) Possible old separation that was filled in suggest further evaluation .
