March 4, 2025

F.N. 3-25-0110

Subject: Structural Inspection of Single-Family Residence Foundation  
1212 Granvia Altamira, Palos Verdes Estates, CA 90274

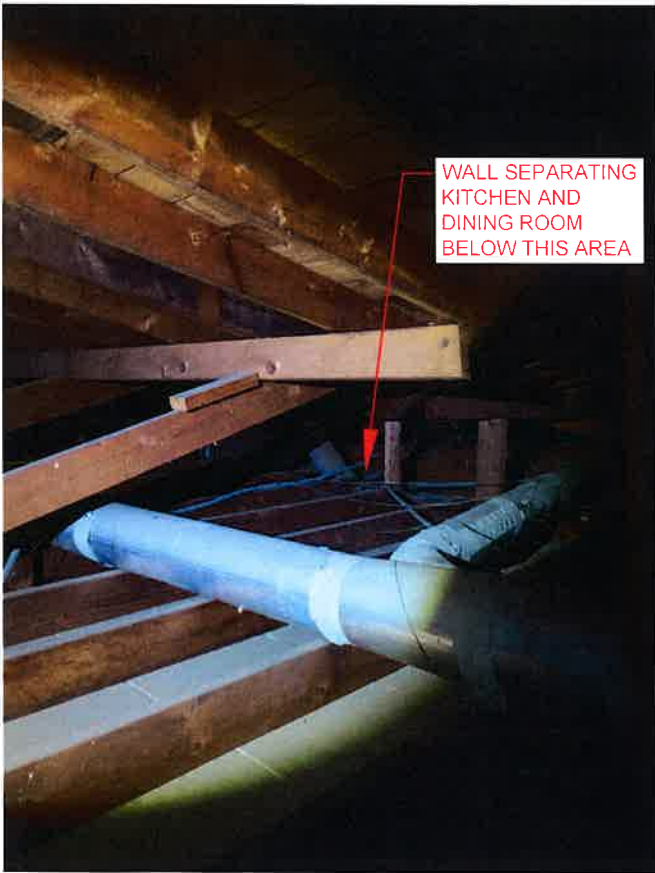
Picture 47

WALL SEPARATING  
KITCHEN AND  
DINING ROOM  
BELOW THIS AREA
