ELITE GROUP

RESIDENTIAL

PROPERTY LOCATION: 700 E 50th St Los Angeles, CA 90011

INSPECTION REPORT

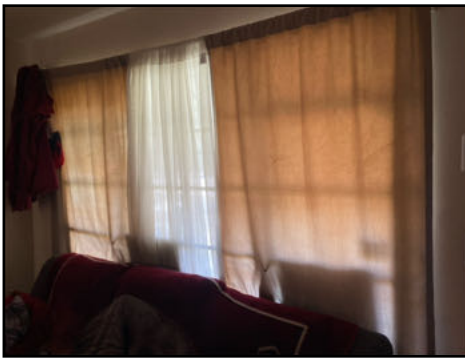
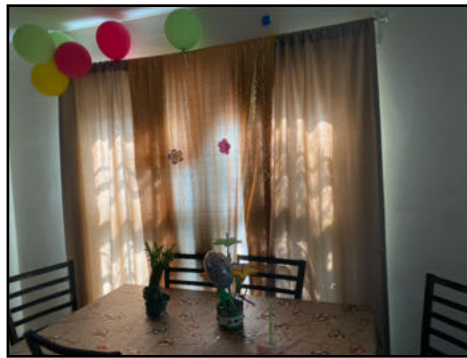
| INTERIOR | | |
|---|---|--|
| Page 10 Item: 4 | Window Conditions | <ul style="list-style-type: none"> Hole in glass- needs to be serviced Deteriorated frame(s)- needs to be serviced |

- Accessible windows were tested and operated at time of inspection
- Visible/accessible windows have worn frames/hardware/sills/tracks - typical for age
- Recommend general window **maintenance**/lubrication and weather tight service
- Small cracks/worn areas/chipped paint observed around sill or frame
- Dirty tracks or hardware - needs to be serviced/cleaned/lubricated
- **Hole in glass- needs to be serviced**
- **Deteriorated frame(s)- needs to be serviced**

Hole in glass- needs to be serviced

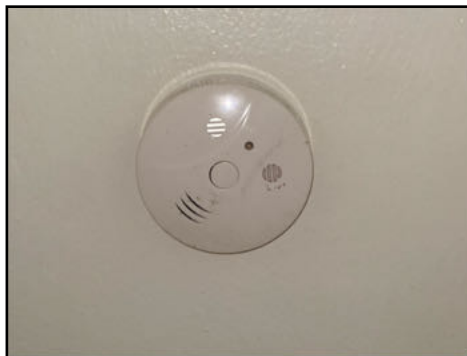
| INTERIOR | | |
|---|---|--|
| Page 12 Item: 11 | Smoke Detectors | <ul style="list-style-type: none"> Missing at hall - needs to be installed (by east bedroom) |

- Smoke and Carbon Monoxide combo unit is present
- Detector out of reach and not tested
- **Missing at hall - needs to be installed (by east bedroom)**

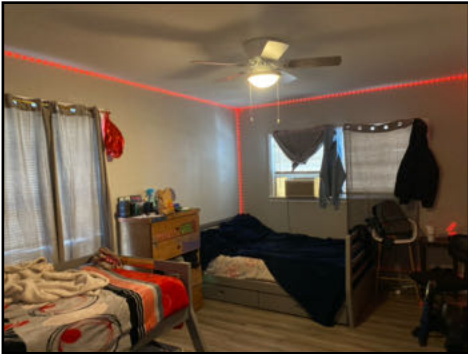
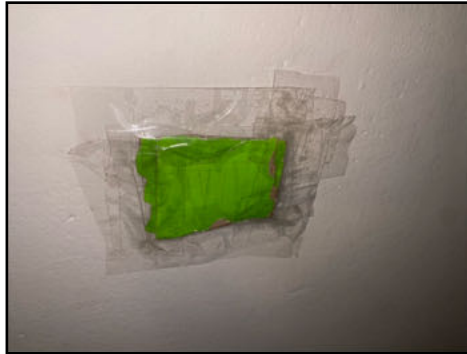
- No major visible defects observed at the time of inspection
- Patched/partial painted areas present - consult seller regarding patched areas

Patched/partial painted areas present - consult seller regarding patched areas

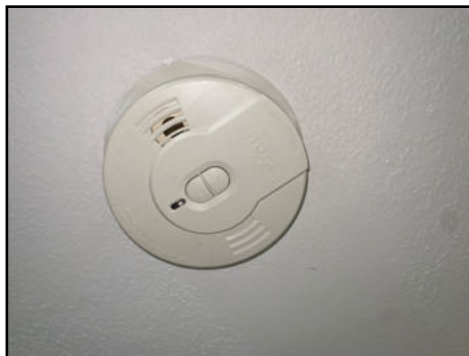
| INTERIOR | | |
|---|---|--|
| Page 16 Item: 12 | Smoke Detectors | <ul style="list-style-type: none"> Missing - needs to be installed |

- Operational at time of inspection via factory installed test button (east)
- **Missing - needs to be installed**

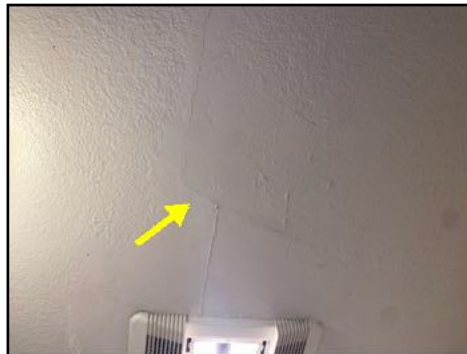
- No major visible defects observed at the time of inspection
- Patched/partial painted areas present - consult seller regarding patched areas

Patched/partial painted areas present - consult seller regarding patched areas

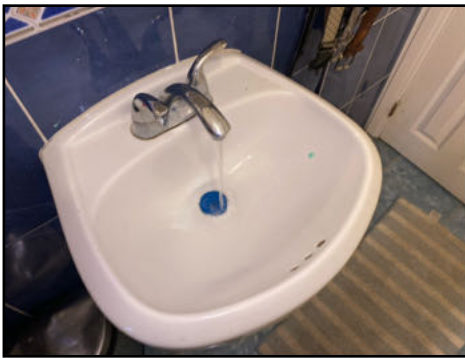
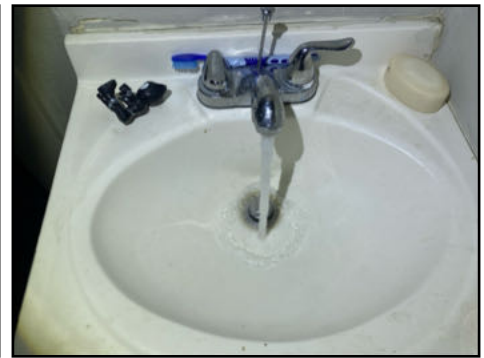
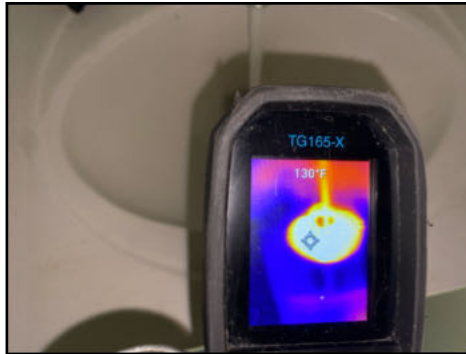
- Fixture operated at the time of the inspection
- Worn fixture/sink - typical for the age
- Corrosion present at fixture(s) - signs of wear - downstairs hall bathroom
- Drain stopper not operating properly - needs to be serviced
- **Hot & cold reversed - needs to be serviced (hall south)**

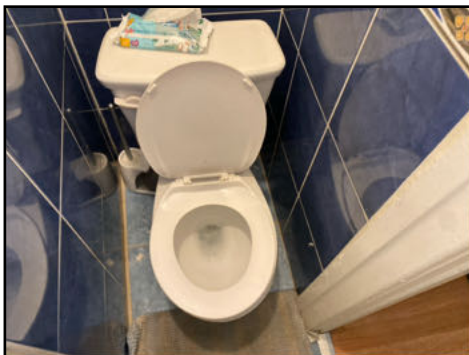
Toilet loose at floor - needs to be serviced (half)

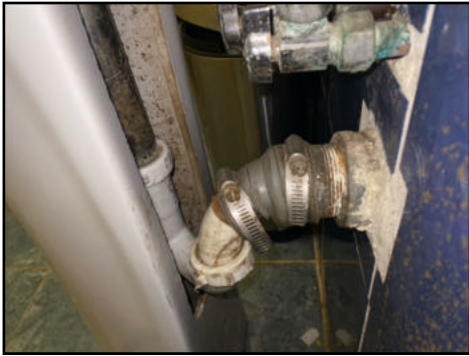
Rubber drain connections present - these are not for long term use - recommend upgrading connections

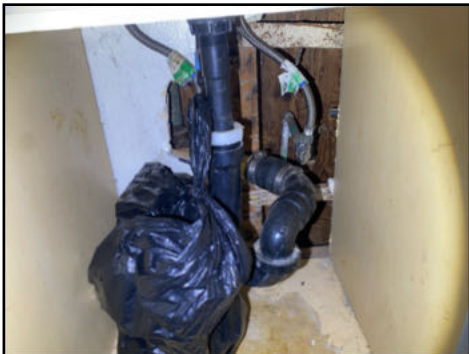
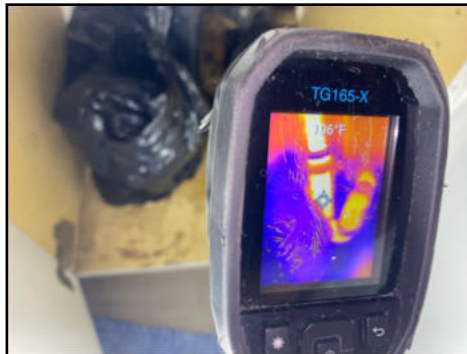
Rubber drain connections present - these are not for long term use - recommend upgrading connections

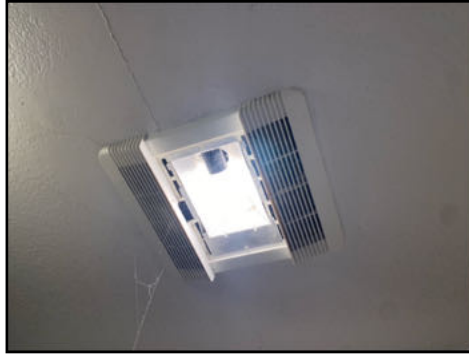
Missing cover

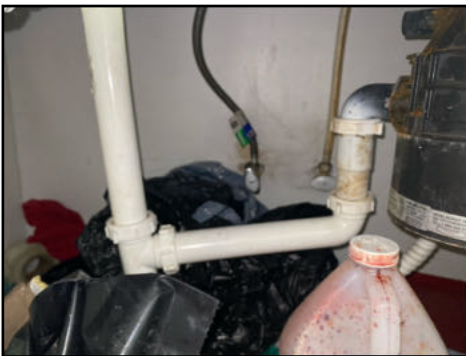
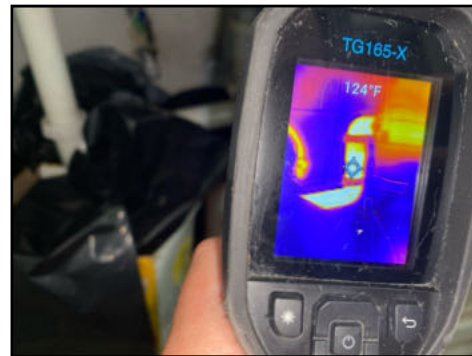
- Operational at time of inspection via normal fixture controls with no major visible defects
- Angle stops/hoses/drain pipes are worn/older - recommend upgrading these areas with new fixtures
- No visible leaks found at the time of the inspection after running water at fixtures
- Corrosion is present at plumbing areas - this is a sign of slow leaking and should be further evaluated by a plumber

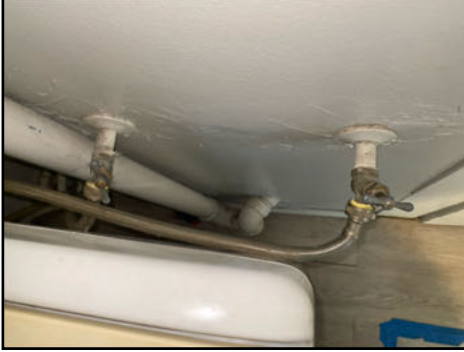
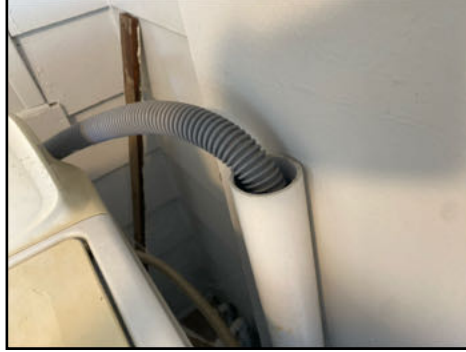
Flex drain present, these are subject to frequent clogging - recommend upgrading

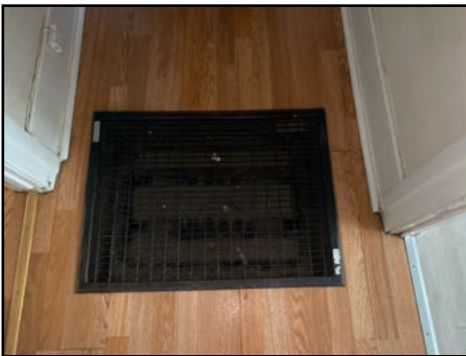
- Dirty/dusty unit - recommend cleaning/servicing unit prior to regular use
- Interior areas of the heater have rust/rust flakes present - needs to be serviced
- *Recommend regular service/maintenance to extend the life of the unit(s)*
- *Inspector does not examine heat exchanger or determine the presence of a cracked heat exchanger - this is not a complete evaluation of the internal areas of the heater - consult an HVAC contractor for further evaluation if you have concerns about the heat exchanger.*
- **Did not operate or respond to thermostat commands - needs to be serviced/further evaluated**
- **Unit is older with signs of deterioration and appears to be nearing end of useful life - recommend consulting with a HVAC contractor to determine remaining life**

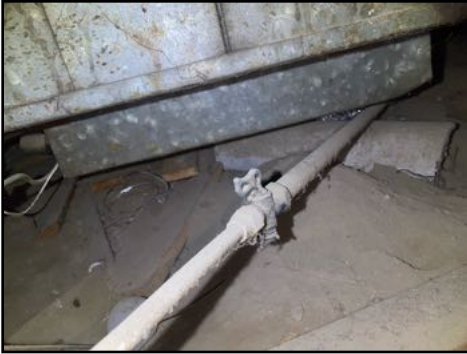
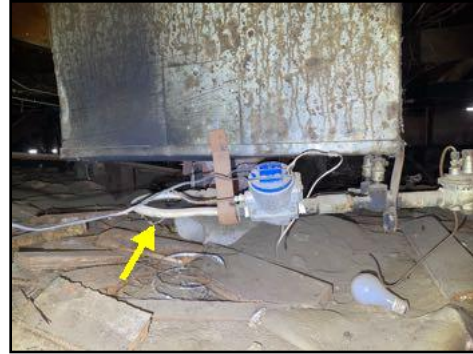
Aluminum gas line is present - immediate upgrade to appropriate flexible gas line is recommended

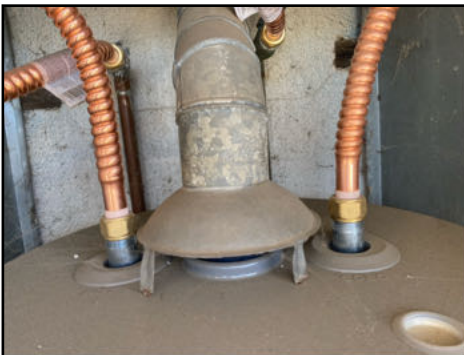
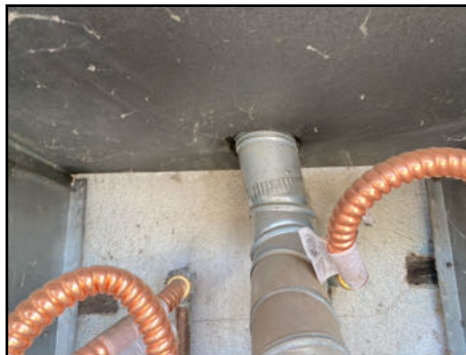
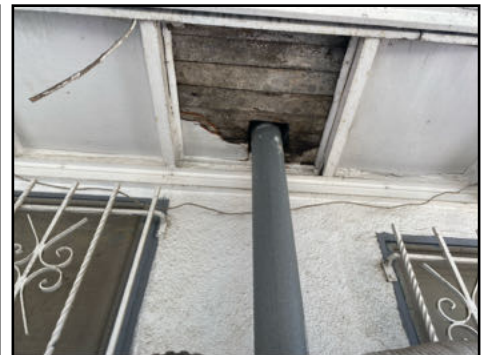
- Vent is worn and older - consider upgrading vent
- Recommend sealing all connections at venting

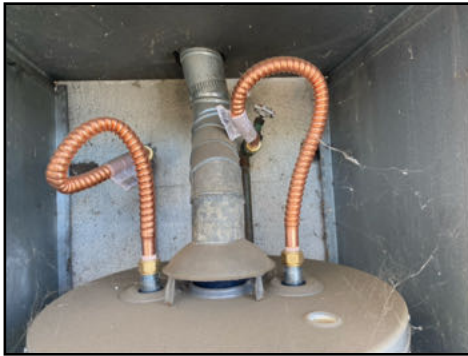
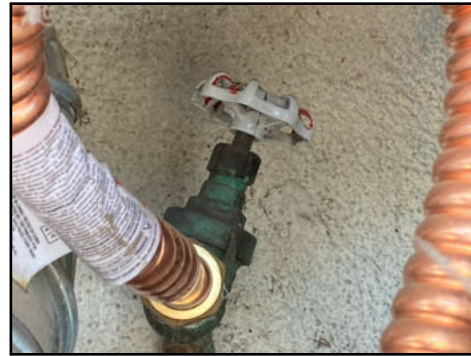
- Worn valve/piping/connections - typical for age - no visible leaks found at the time of the inspection
- Corrosion present - signs of wear - monitor for moisture

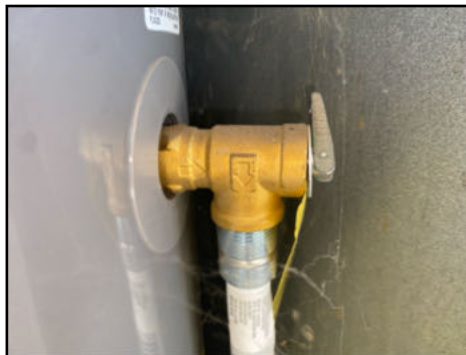
- Worn/older valve present - consider upgrading

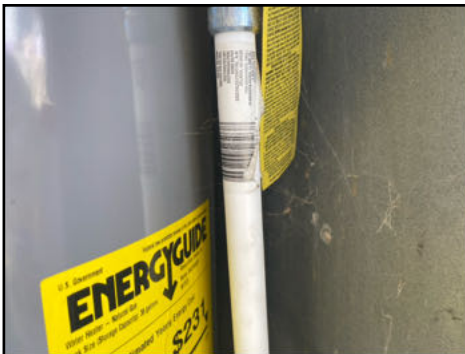
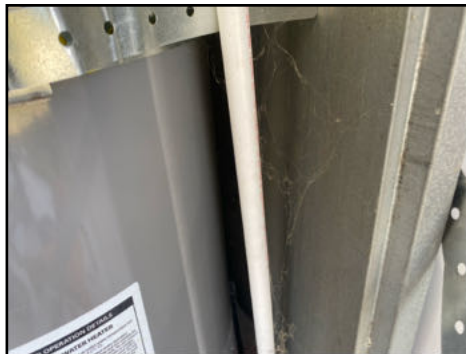
- Worn piping - typical for age
- PVC is an improper material for this overflow line due to it's potential for melting - needs to be serviced/upgraded to an approved material immediately

PVC is an improper material for this overflow line due to it's potential for melting - needs to be serviced/upgraded to an approved material immediately

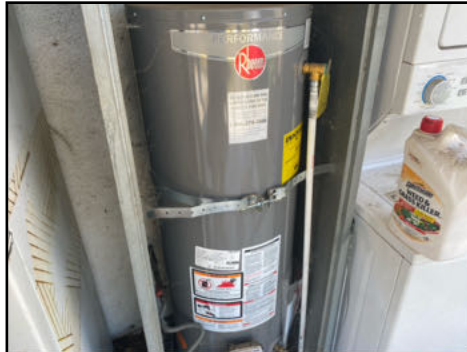
- Standard metal type straps present - normal wear on the day of the inspection - no major visible defects
- **Missing one strap, two are required - needs to be serviced**

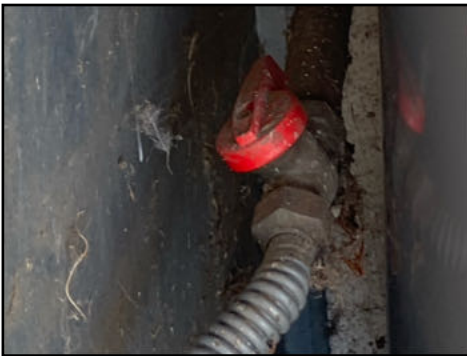
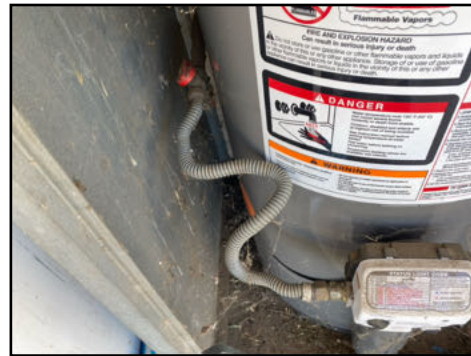
- Worn valve, consider upgrading to newer style valve
- No sediment trap at gas supply - may have not been required at time of original installation, but is recommended

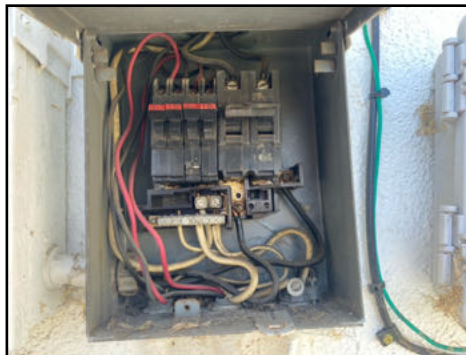
Thermal Image View - Normal temperature readings with no visible signs of overheating at time of inspection

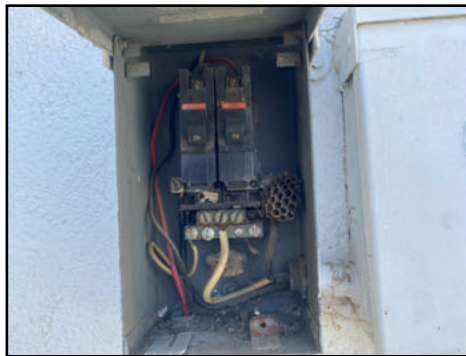
Thermal Image View - Normal temperature readings with no visible signs of overheating at time of inspection

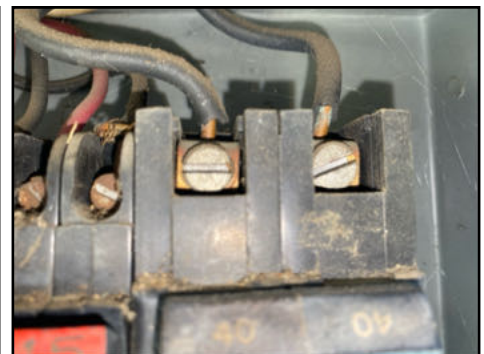
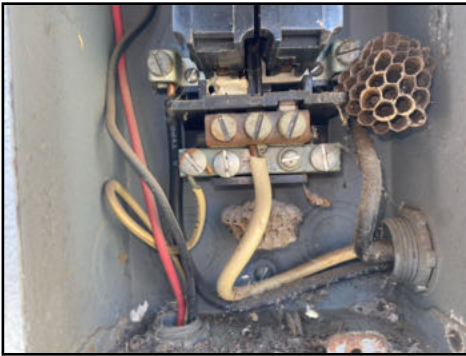
- Wiring type: copper
- Wiring method: non-metallic sheathed cable (romex)
- Unable to determine if this panel is properly grounded - recommend further evaluation by a licensed electrician
- Visible wiring is worn and older - consider upgrading the electrical services

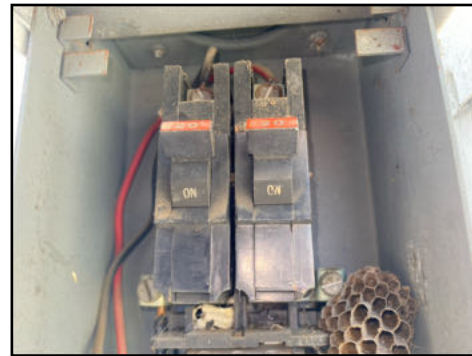
- No visible labeling for breakers on panel cover - needs to be serviced
- Loose/worn breakers - typical for age
- Breakers or panel may require upgrade soon due to age
- Manufacturer of breakers/panel is a brand (Federal Pacific) known for frequent issues - recommend further evaluation by a licensed electrician

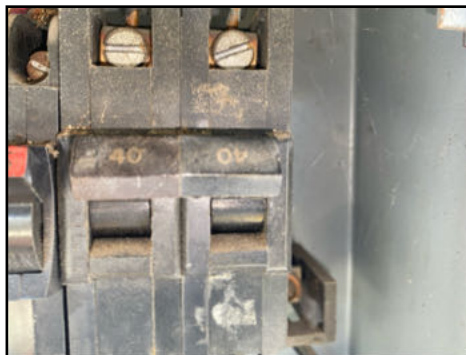
- 40 amp - this is considered to be low capacity by today's standards - recommend upgrading service

40 amp - this is considered to be low capacity by today's standards - recommend upgrading service

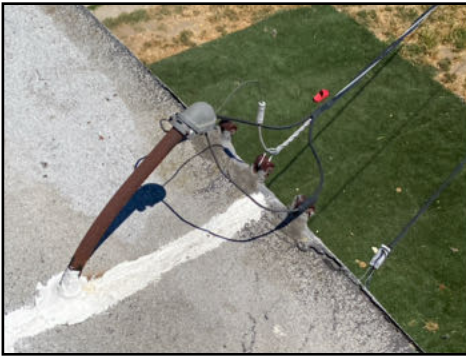
- Overhead - worn/weathered - needs service/maintenance
- Older style wiring connections to the structure - it is recommended that you upgrade these areas

Older style wiring connections to the structure - it is recommended that you upgrade these areas

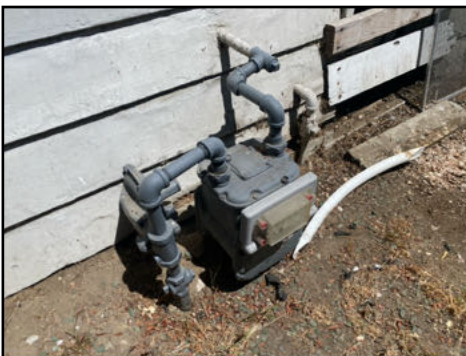
- **No seismic safety valve present - recommend installation for increased safety**

No seismic safety valve present - recommend installation for increased safety

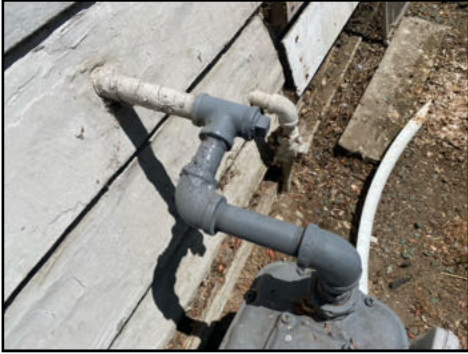
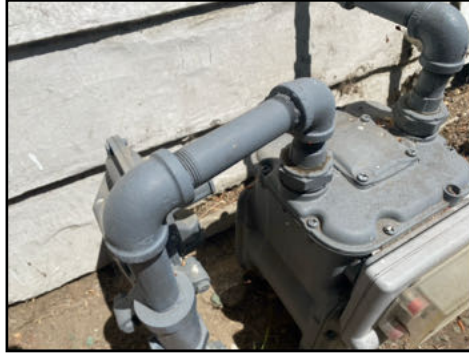
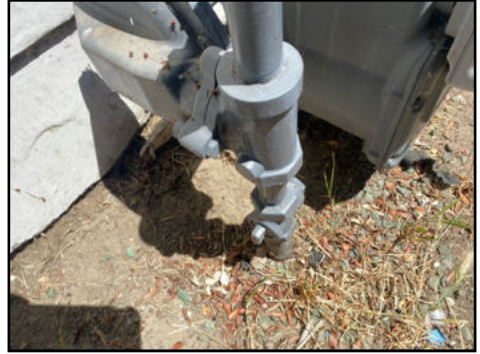
- Worn meter/piping - typical for age and exterior weathering
- Cannot determine if gas piping is properly protected in the ground
- Minor rusting - typical for age - recommend rust treatment
- ***We recommend the gas supplier be contacted to safety check all fuel gas systems/appliances during the contingency period or at least prior to purchase and occupancy. Note: The Inspector cannot determine if a gas leak is present in any area of the home at any time during the inspection. Note: The inspector cannot***

determine if all gas lines are properly protected in the ground.

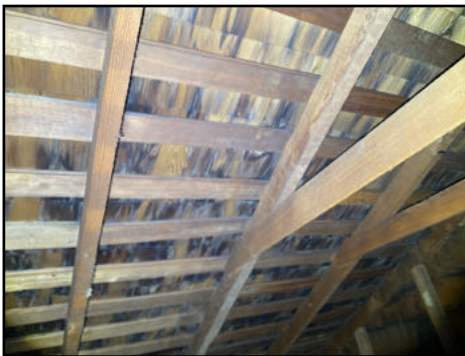
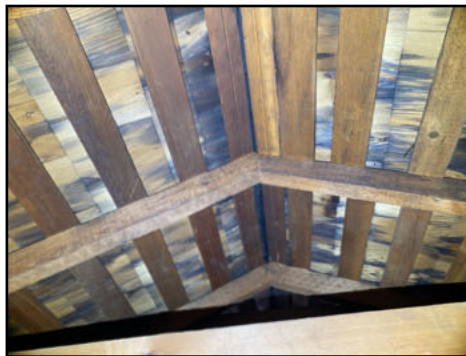
- **Consult termite report for all wood areas in the attic**
- Conventional framing present, normal wear at time of inspection - no major visible defects
- Cracking small at wood members - typical for age
- This structure would benefit from the addition of collar ties, purlin bracing and/or brackets for added support
- **Stains present on wood members of structure - evidence of past moisture entering structure- monitor for future moisture intrusion**
- **No visible roof sheathing at rafters - this is an irregular roofing installation and needs further evaluation by a roofer**

No visible roof sheathing at rafters - this is an irregular roofing installation and needs further evaluation by a roofer

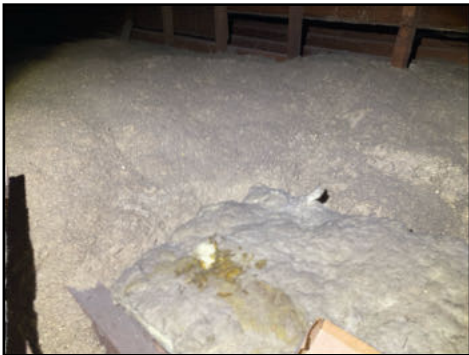
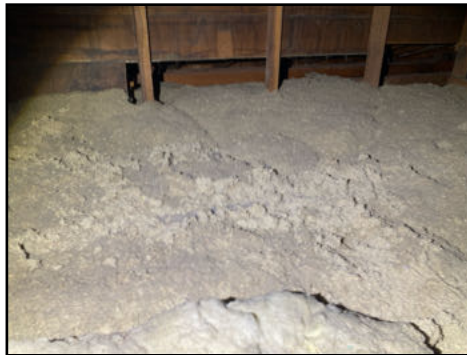
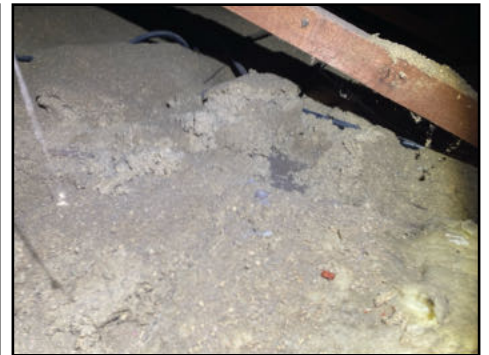
- No visible signs of rodents at this inspection - we recommend pest services seasonally as part of your regular home maintenance
- All visible insulation is worn/older/dirty - typical for the age of the structure
- This structure would benefit from new insulation
- Loose/displaced insulation in areas - recommend repair/replacement as needed for best efficiency
- Insulation was compressed in areas reducing effectiveness - recommend servicing/upgrading
- ***The inspector does not determine R-value of the insulation***

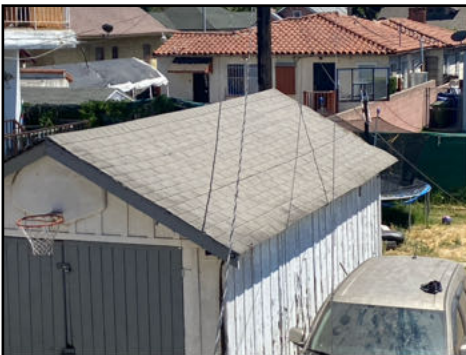
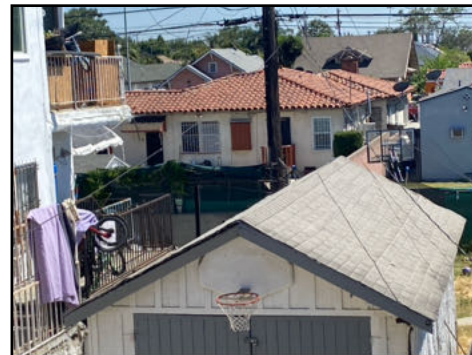
- **Shingles exhibited extensive/abnormal granule loss - needs to be serviced/evaluated by a roofer**
- **Materials appear to be nearing end of useful life - consult with a licensed roofer to determine remaining life**

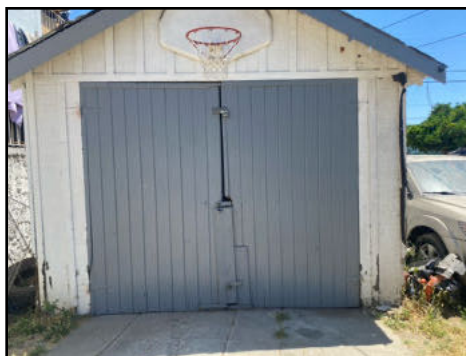
Locked could not test - garage not entered or inspected

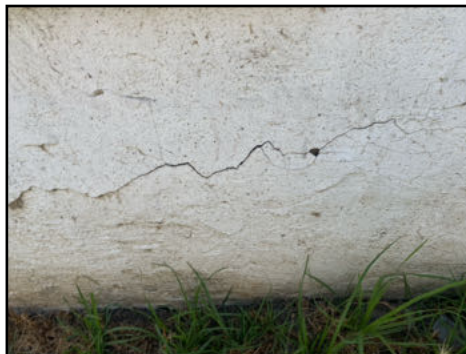
**Blistered due to unknown reason -
needs to be serviced**

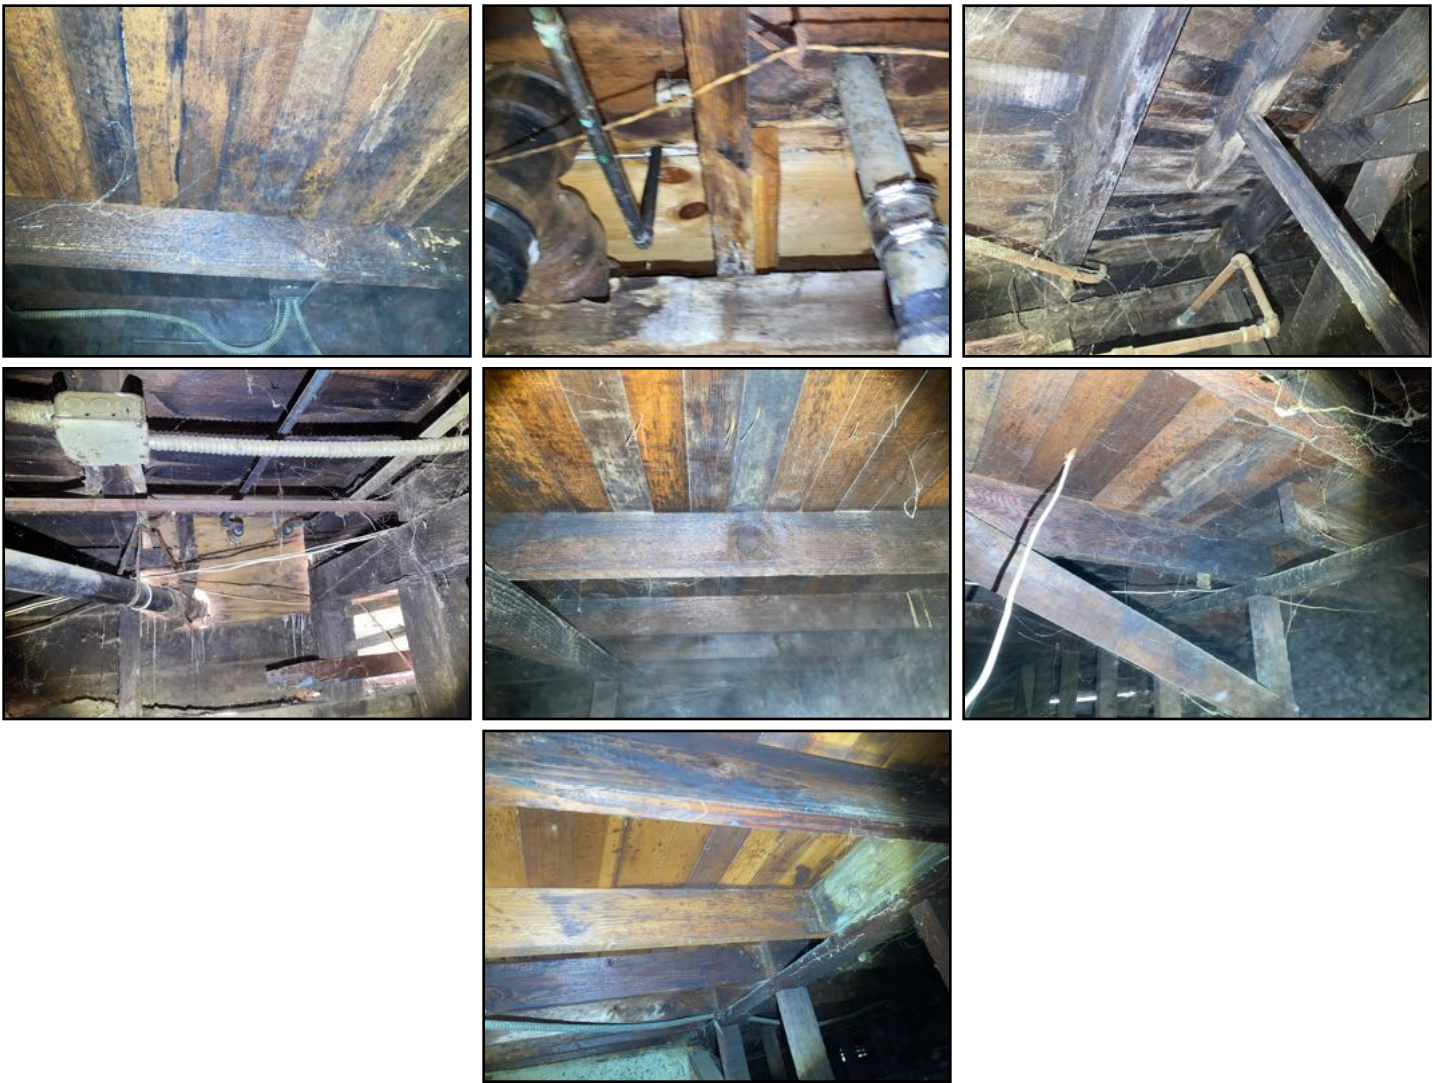
- Wood is worn and stained in areas where visible - typical of a structure this age
- Stained areas present – consult termite report for any wood/moisture issues
- Cracked wood - typical for age
- **Moisture damage in areas - needs to be serviced**

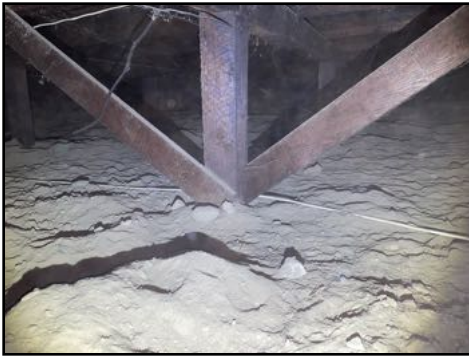
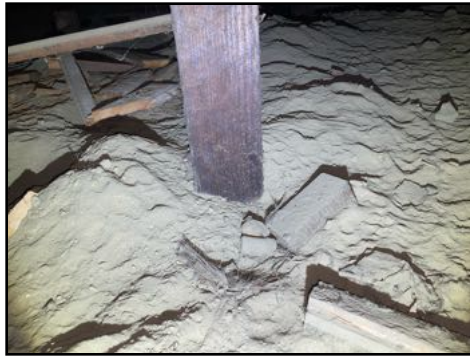
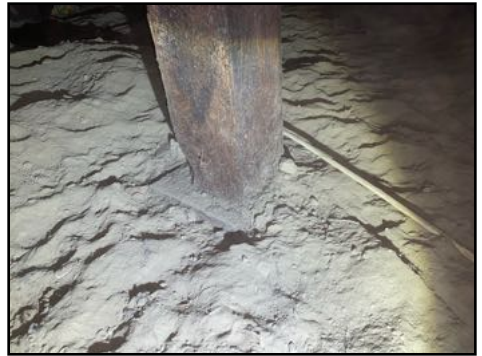
Posts in contact with soil - needs to be serviced - consult the termite report

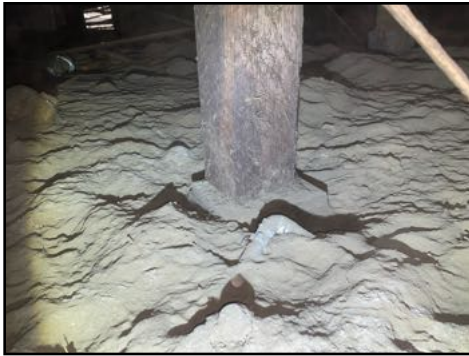
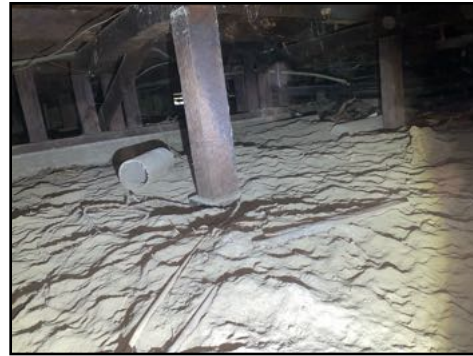
Posts in contact with soil - needs to be serviced - consult the termite report

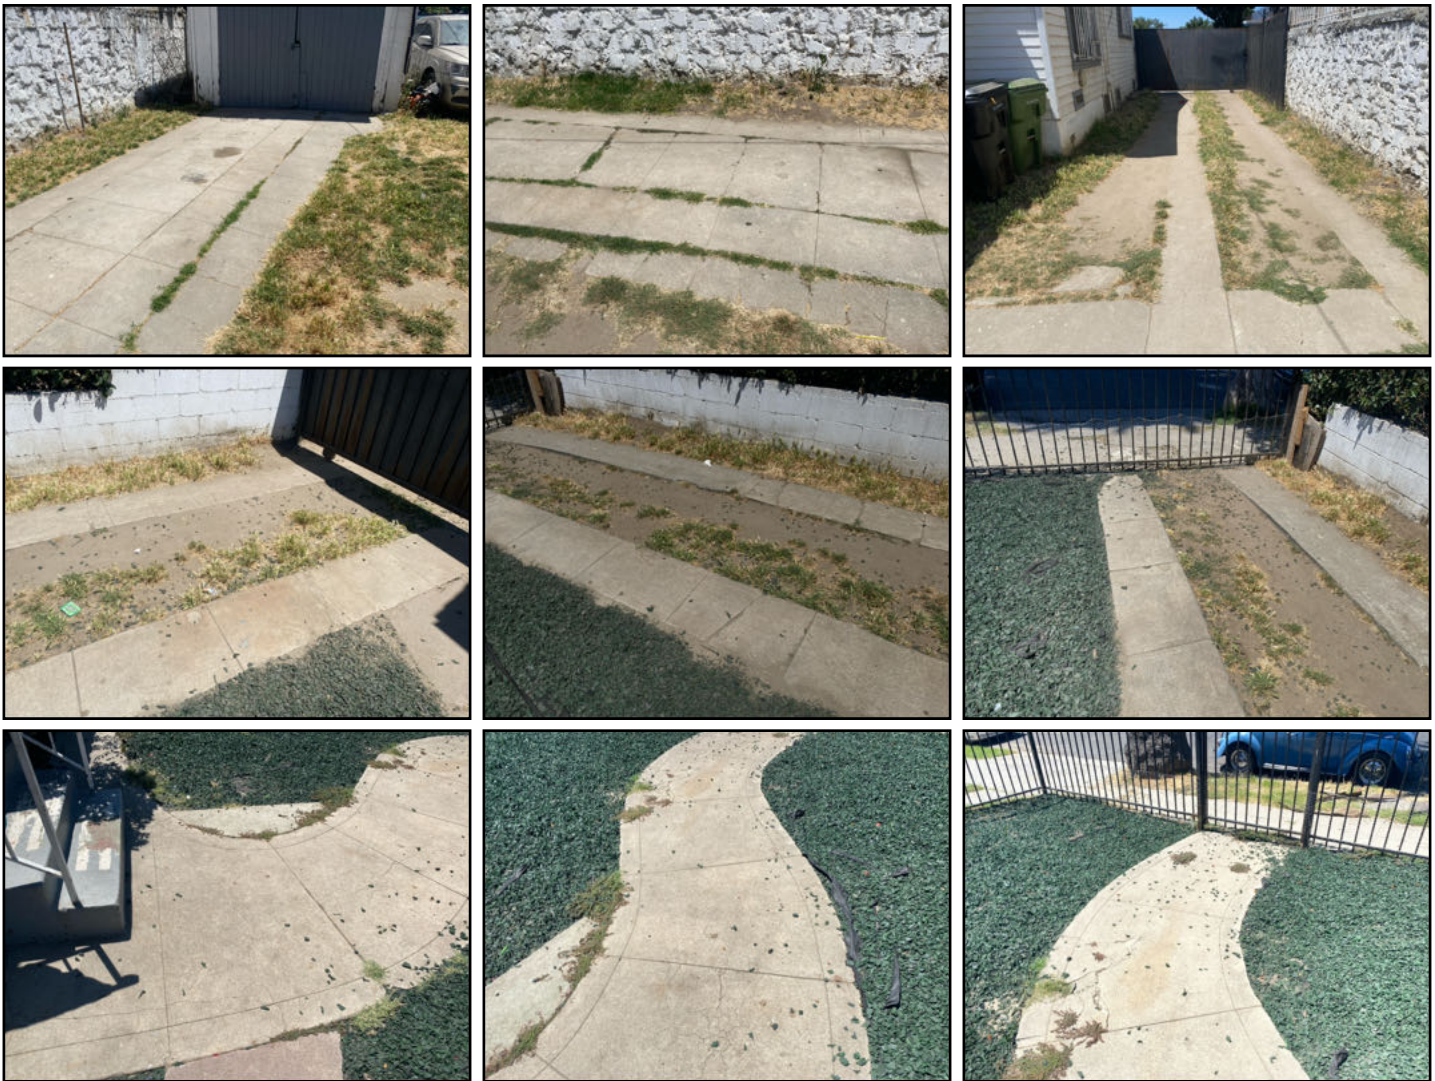
- Worn with common cracks/chips - typical for age of material
- Moderate cracking in areas - recommend maintenance and patching as needed
- Driveway stained in areas
- Walkways stained in areas
- Cracking/chipping small and typical for age
- Small localized water ponding may occur in areas - area drains may be needed, monitor and address as needed

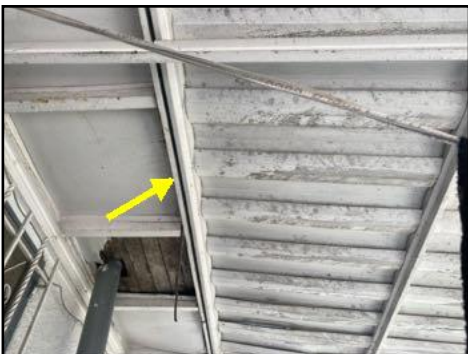
Structure attached to fascia board – irregular installation – recommend licensed contractor to evaluate

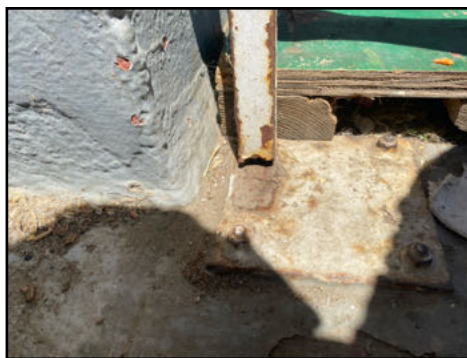
Loose rails - unsafe - needs to be serviced

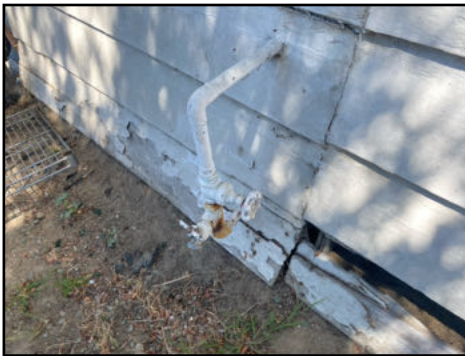
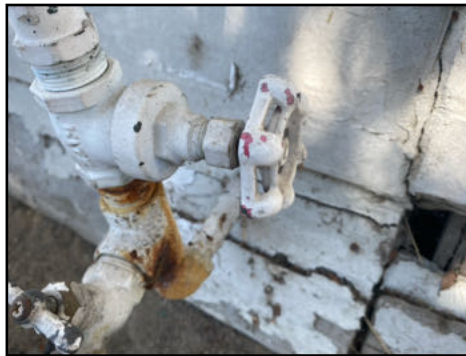
Gate valve present/worn (these types of valves are known to fail internally) - consider upgrading to a ball valve

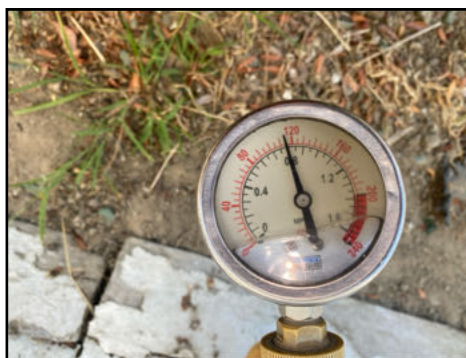
Approximate pounds per square inch: 115 - needs to be serviced

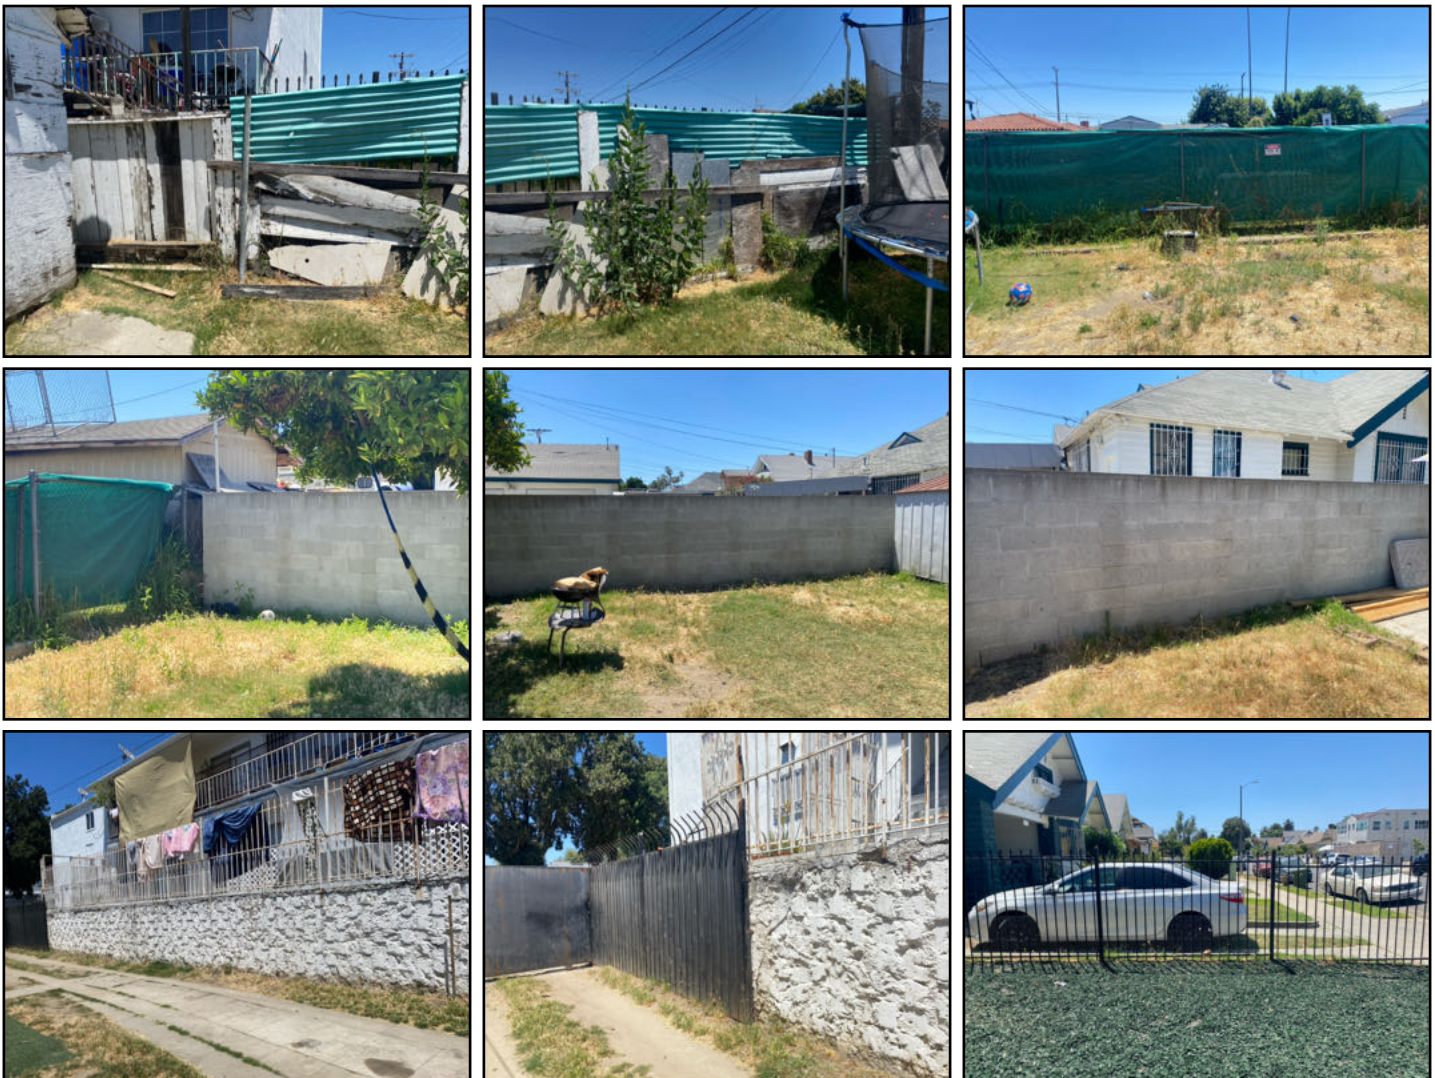
- Visible fencing/wall areas are worn and weathered - typical for the age of the materials
- Cracking/chipping small and typical for age at block - monitor for further cracking and repair as needed
- Earth to wood contact present and will reduce the life of wood fencing
- Wood is worn and stained - typical for age of material
- Cracked/deteriorated wood - recommend wood fencing maintenance
- Loose boards - recommend servicing
- **Damaged fencing/walls - needs to be serviced**

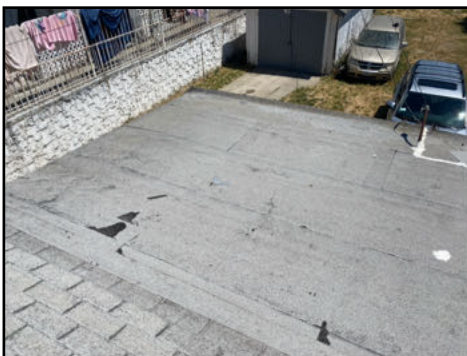
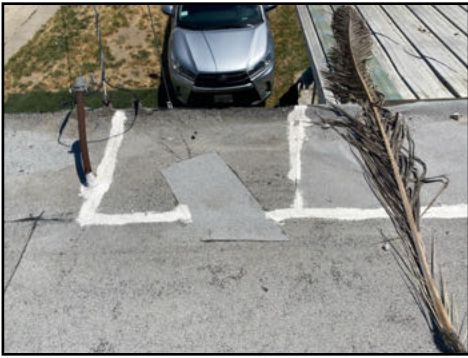
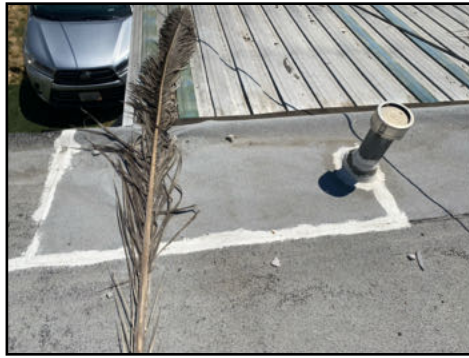
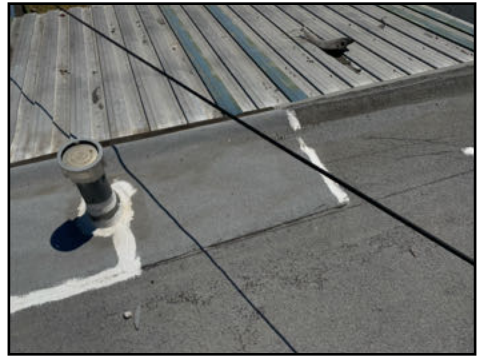
Patching observed in areas on roof materials - inspector is unable to guarantee the adequacy of these repairs - recommend maintaining a continuous water tight seal in these areas

Missing/damaged shingles/tiles in areas - needs to be serviced

Moss growth present in areas - sign of moisture accumulation and lack of sunlight for drying - recommend servicing as part of seasonal maintenance

Exposed nails/staples/screws on roofing material - recommend sealing all fastener heads

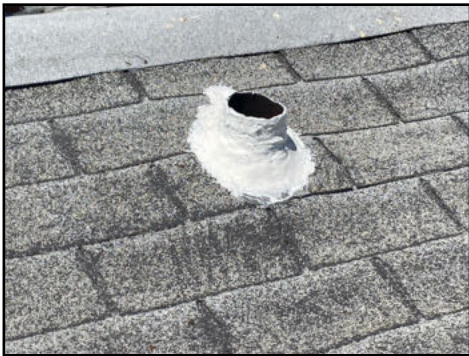
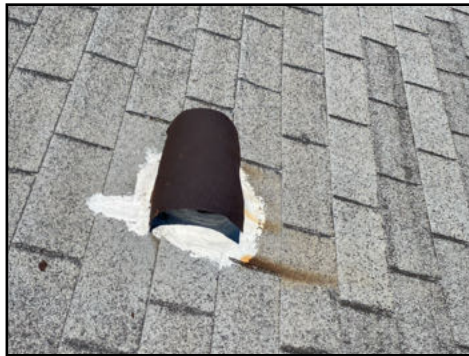
Re-roof covers flashings - irregular installation - needs further evaluation by a licensed roofer

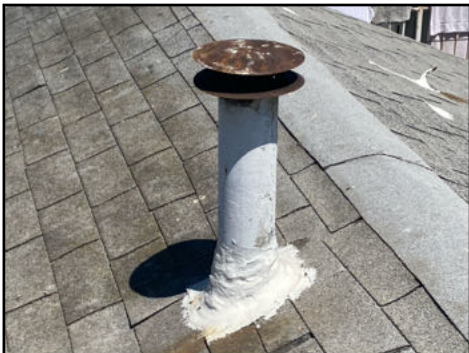
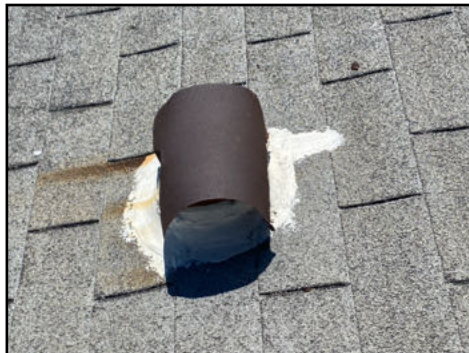
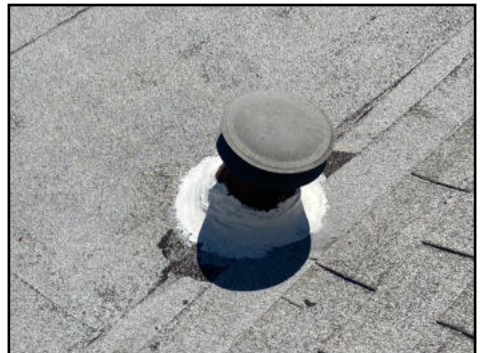
- Worn/weathered cap(s) – recommend seasonal maintenance to ensure that caps do not become loose or develop other defects
- Mastic at vent(s) is weathered and cracked - needs to be serviced and resealed at all penetration points
- Rusted - needs to be serviced
