# Insight Home Inspections

## Home Inspection Report

**27413 Fawnskin Dr**

Inspected on Tue, Aug 7 2018 at 11:20 AM

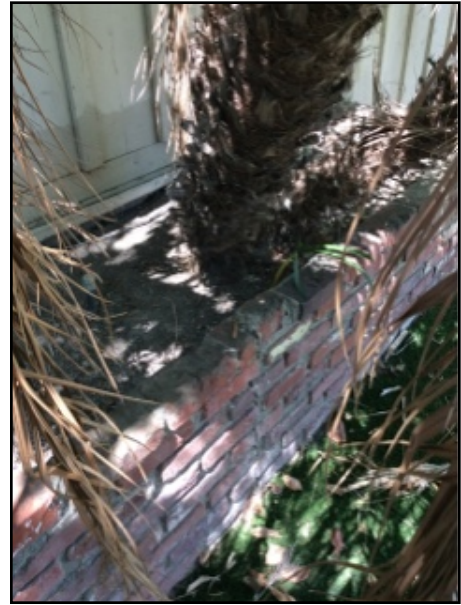
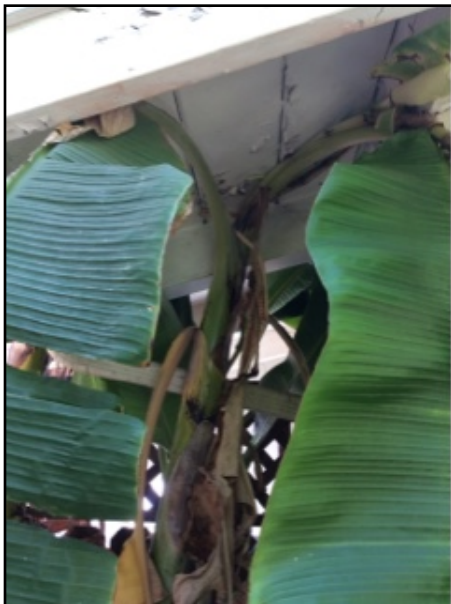
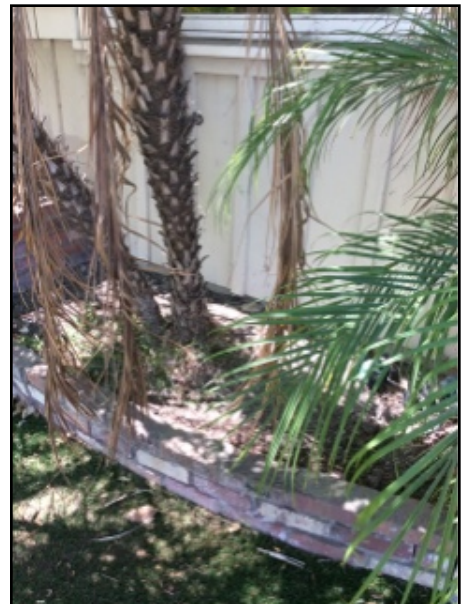
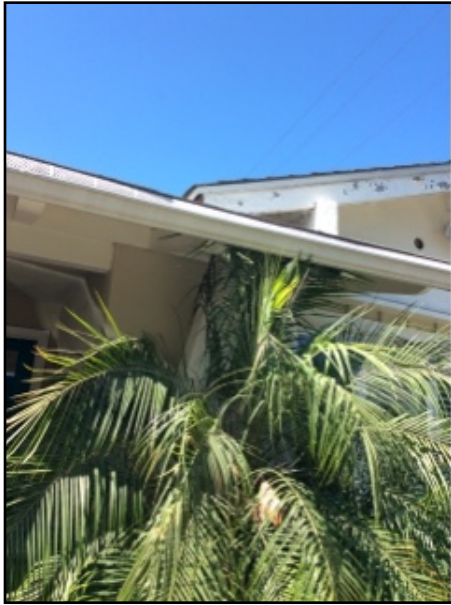
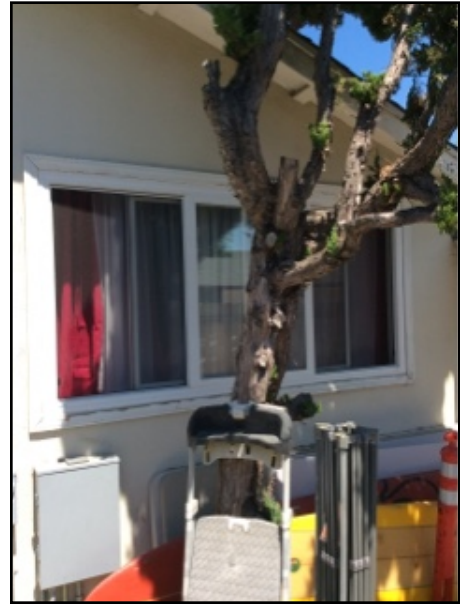
Multiple trees are growing against structure. Recommend removing any tree within 6' of Home to prevent structural damage.

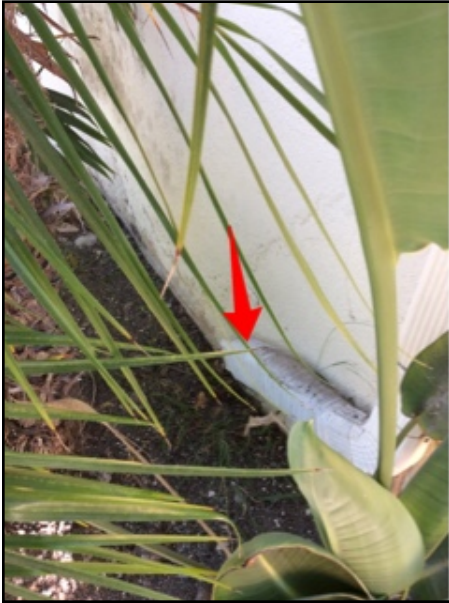
Figure 3-1

Rain gutter downspouts should divert away from structure.

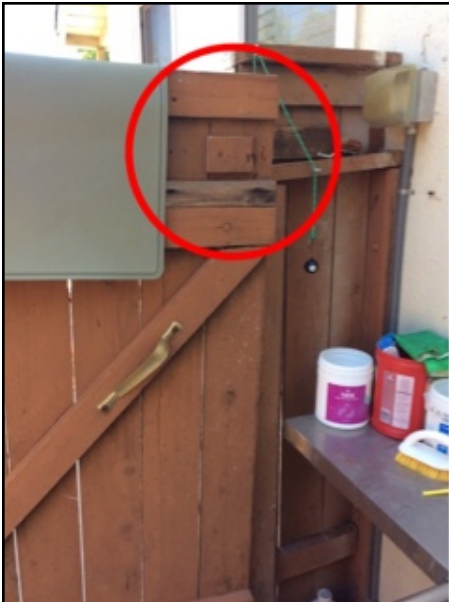
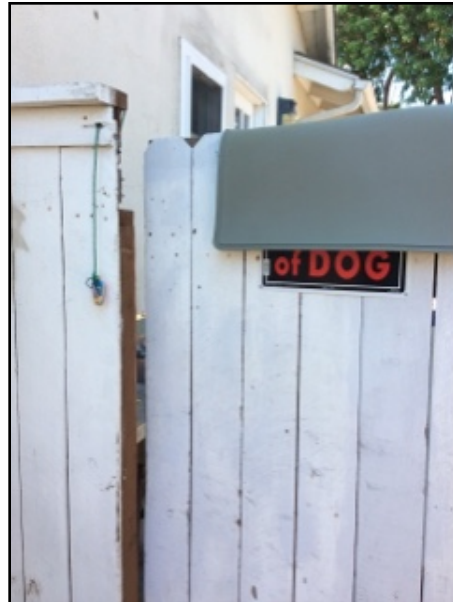
As a pool barrier this gate needs to easily close and latch securely with spring loaded closure.

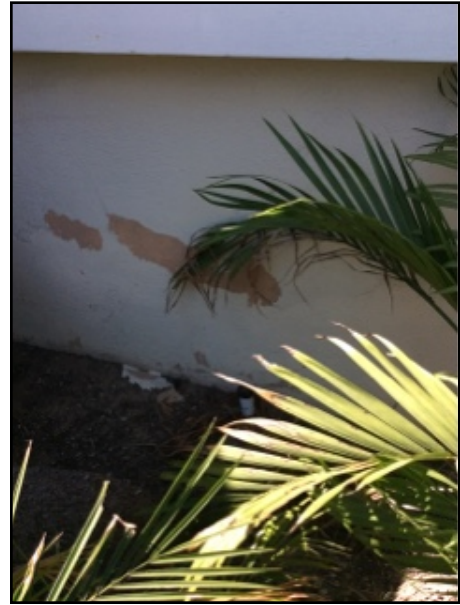
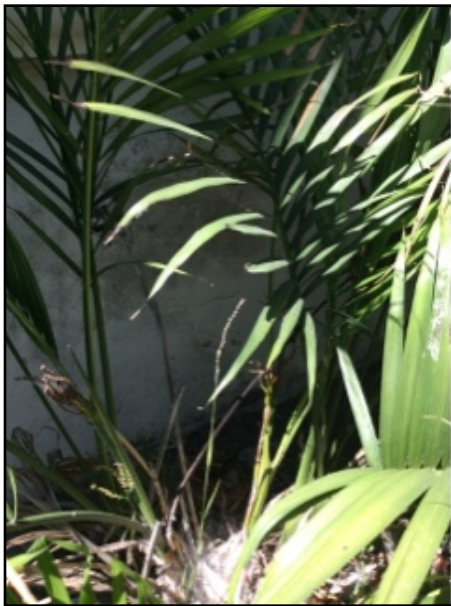
Multiple areas of failing and delaminating paint. Along with open holes and incomplete patch work. Recommend repair to prevent water intrusion.

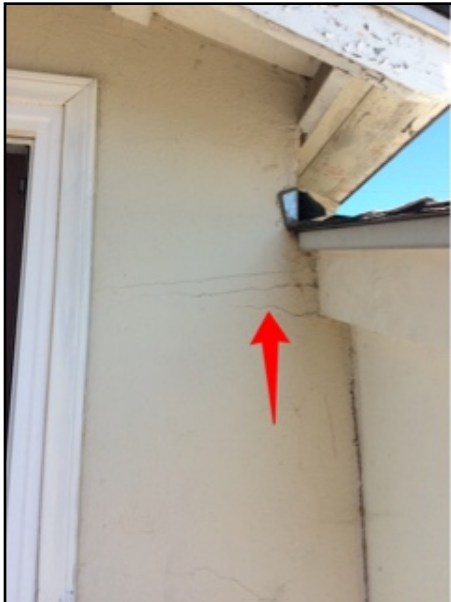
Multiple cracks in stucco. Caused by normal wear, also by potential foundation settling. Recommend further evaluation.

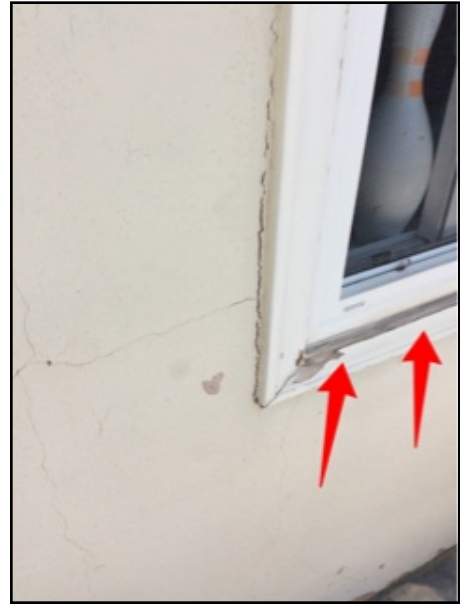
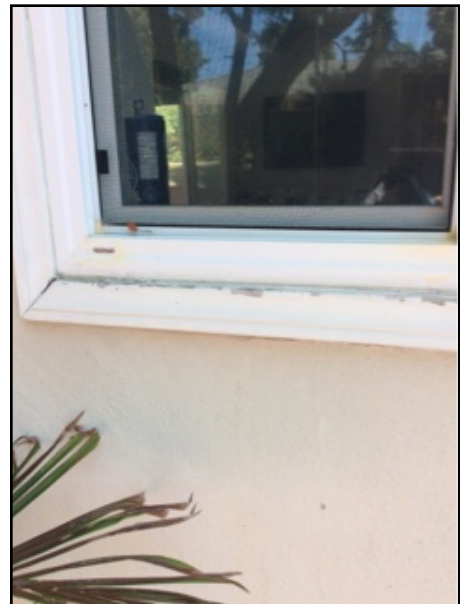
Wood trim needs to be painted and sealed to prevent water intrusion and structural damage.

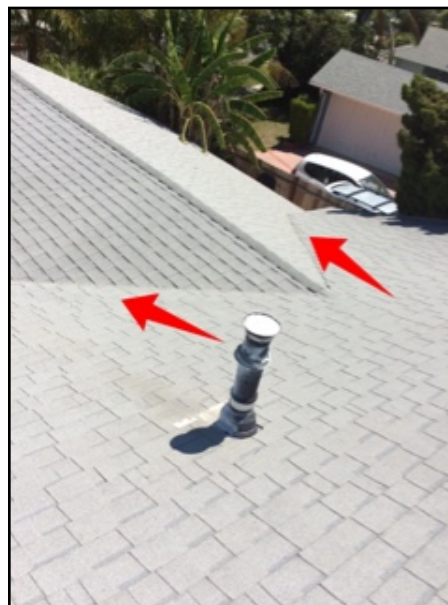
Figure 11-2

Recommend installing valley flashing to aid in proper rain drainage.

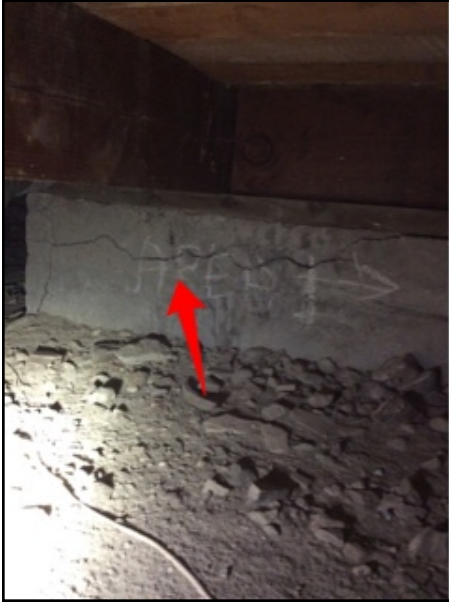
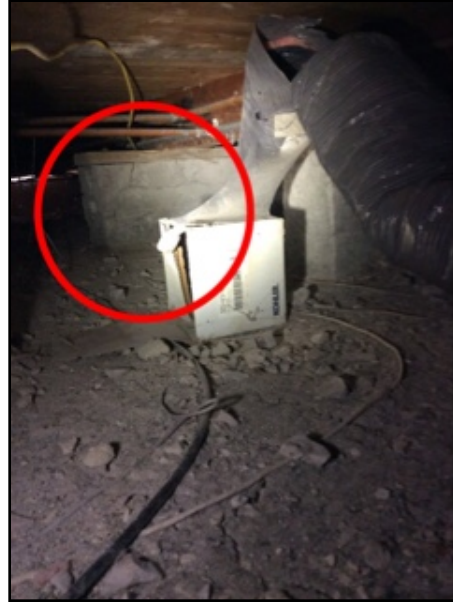
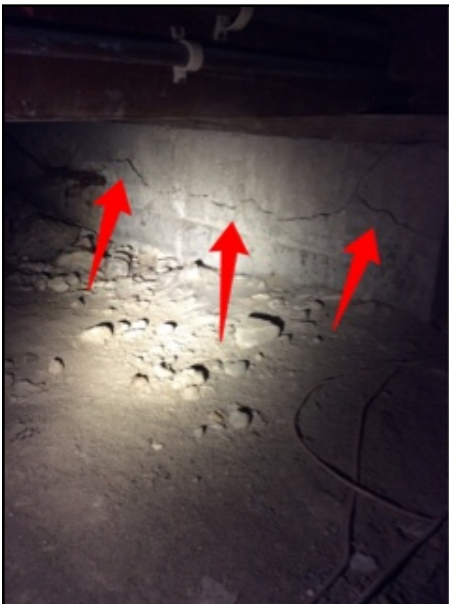
**Comment 15:**  
Major settlement cracks in foundation walls and piers. Recommend further evaluation by a structural engineer.

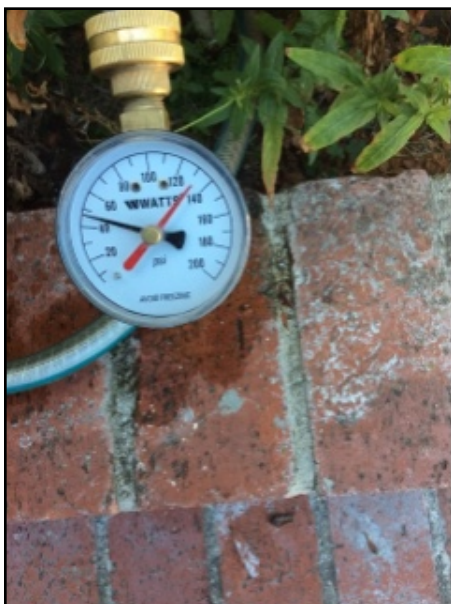
Figure 22-1

Water pressure is satisfactory at 45psi.

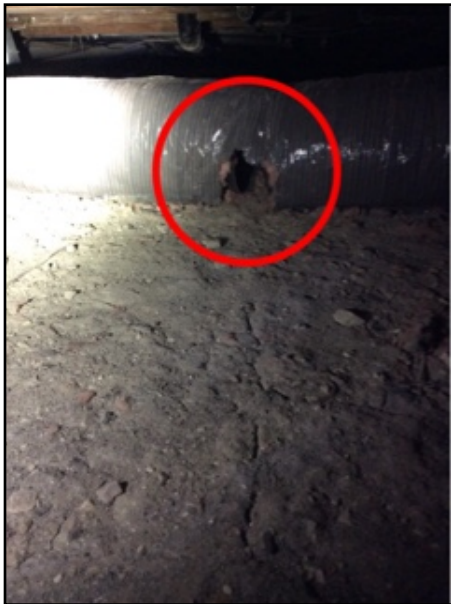
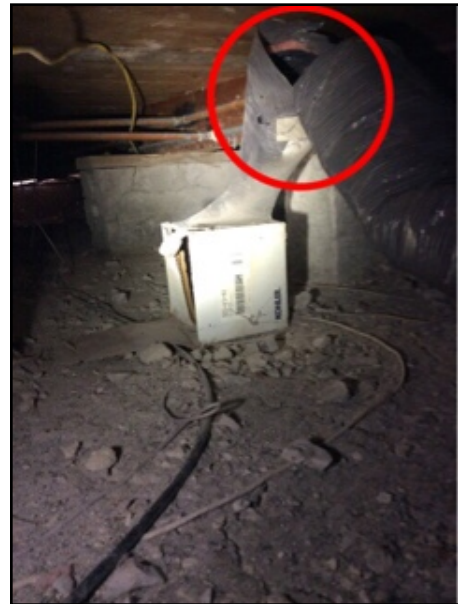
Holes and torn duct work. This will effect efficiency of airflow.

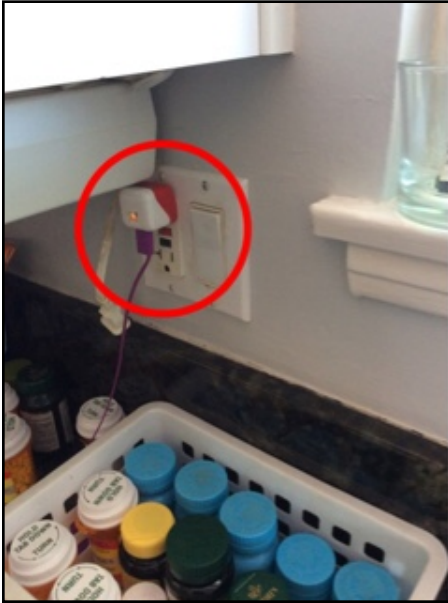
Figure 41-1

**Comment 41:**  
GFCI outlet is not grounded. Recommend repair by a licensed electrician.

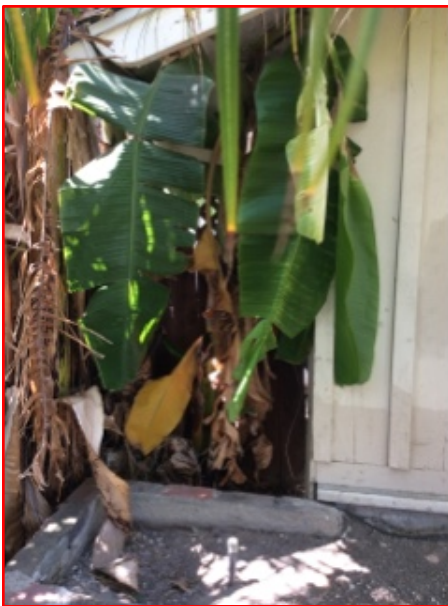
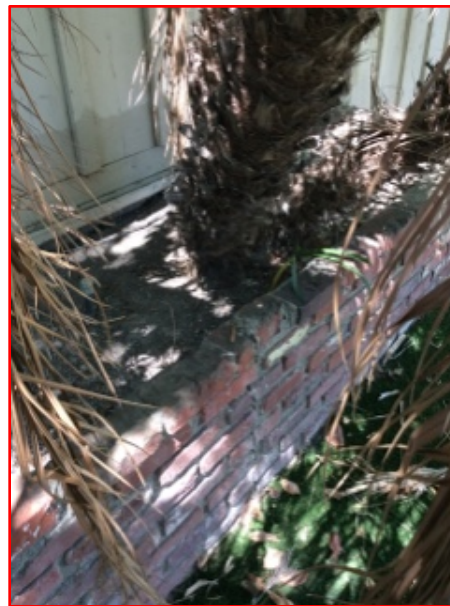
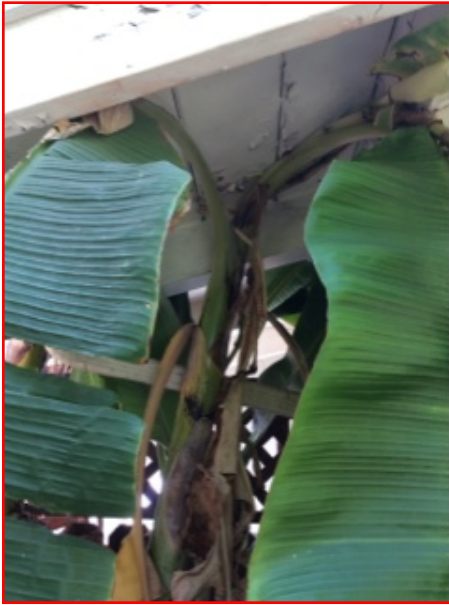
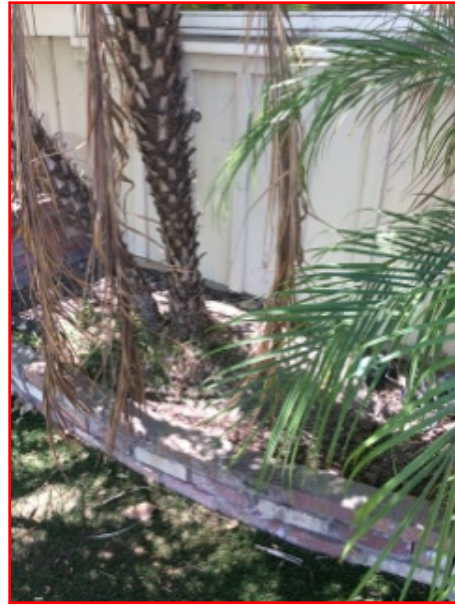
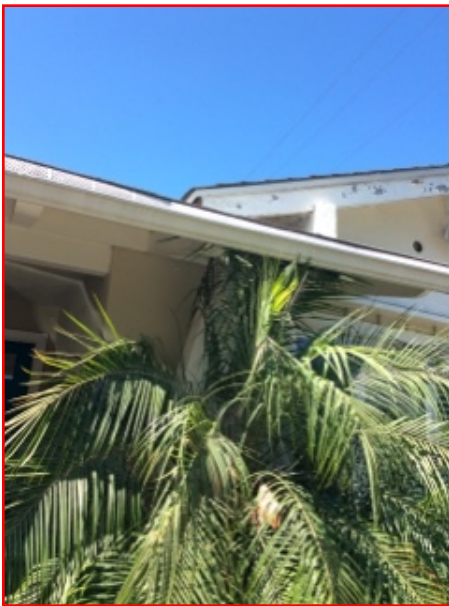
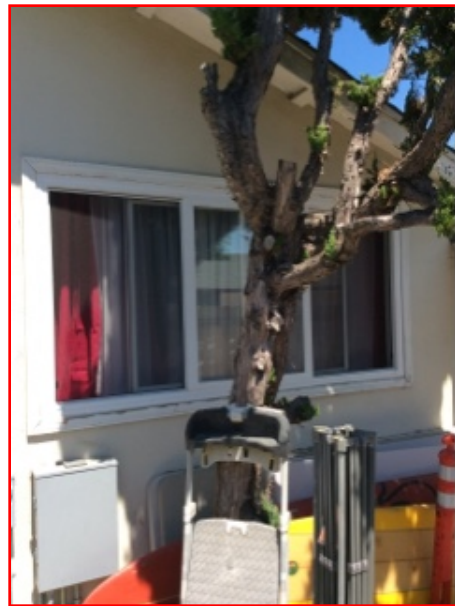
1) Multiple trees are growing against structure. Recommend removing any tree within 6' of Home to prevent structural damage.

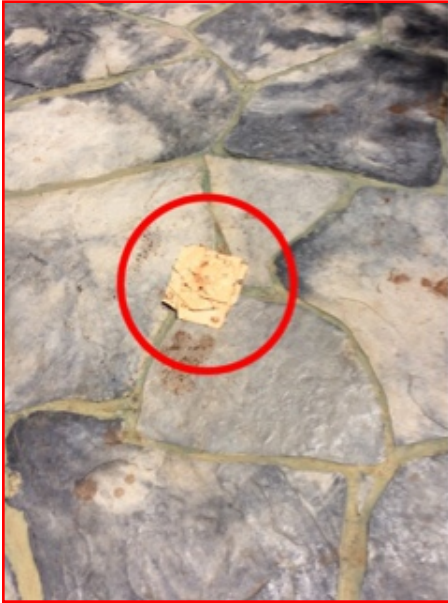
Figure 2-1

2) Recommend cutting pipe flush with ground. Potential trip hazard.

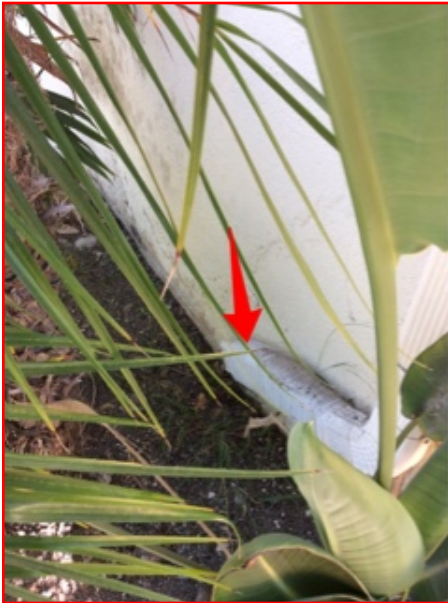
Figure 3-1

3) Rain gutter downspouts should divert away from structure.

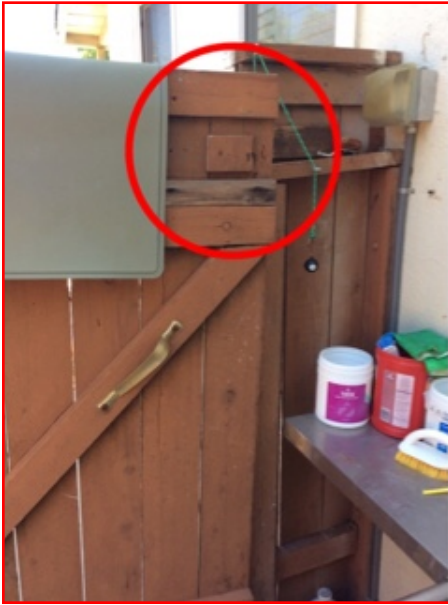
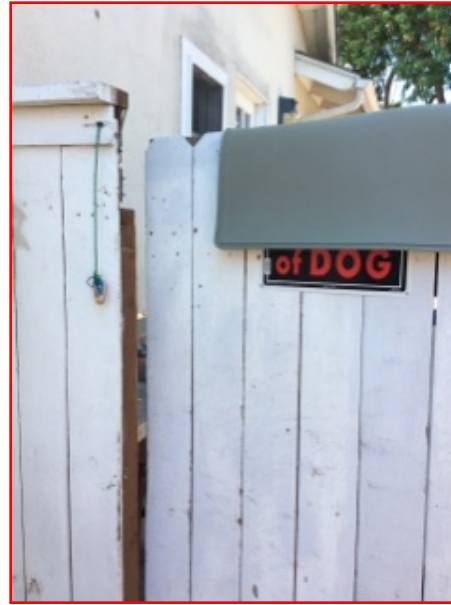
4) As a pool barrier this gate needs to easily close and latch securely with spring loaded closure.

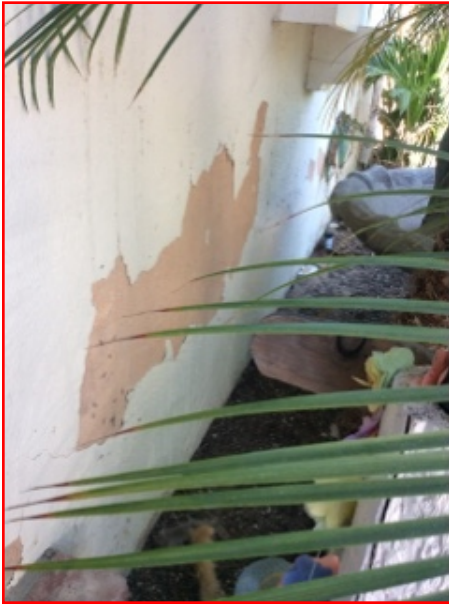
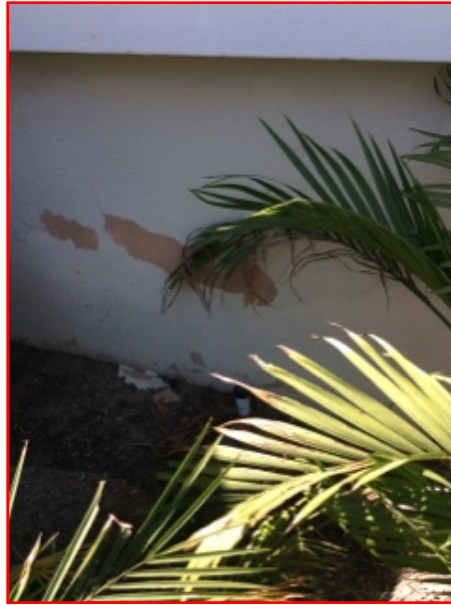
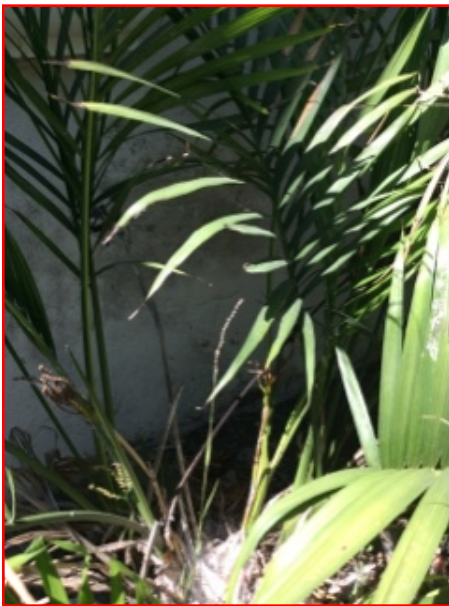
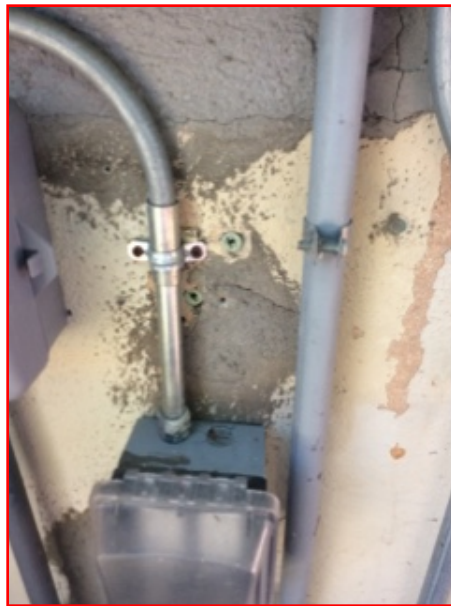
6) Multiple areas of failing and delaminating paint. Along with open holes and incomplete patch work. Recommend repair to prevent water intrusion.

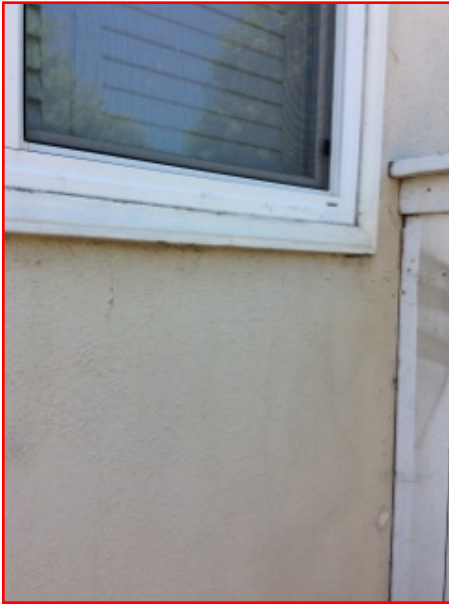
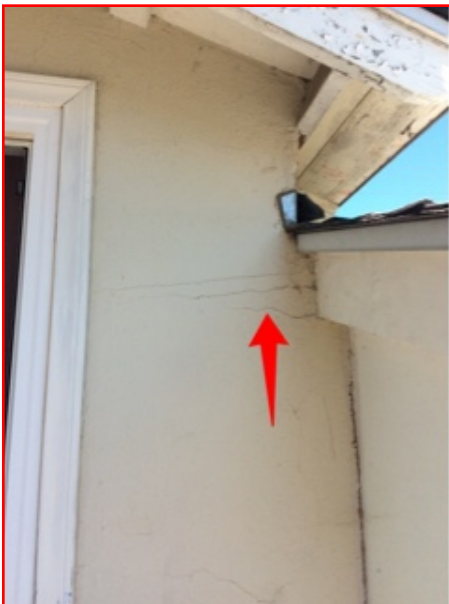
7) Multiple cracks in stucco. Caused by normal wear, also by potential foundation settling. Recommend further evaluation.

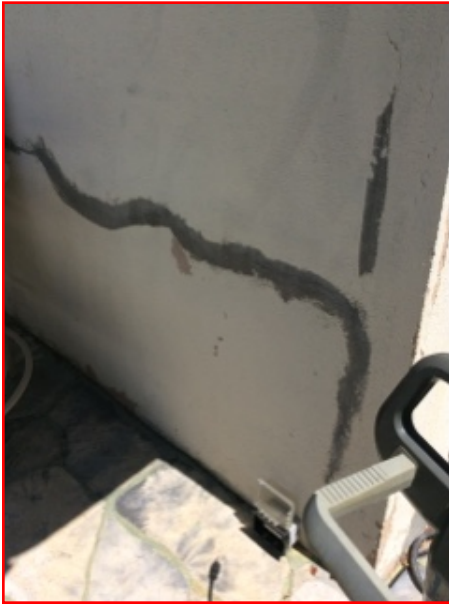
Figure 8-1

8) Patches appear to be from repair from settlement cracks. Recommend further evaluation by a structural engineer.

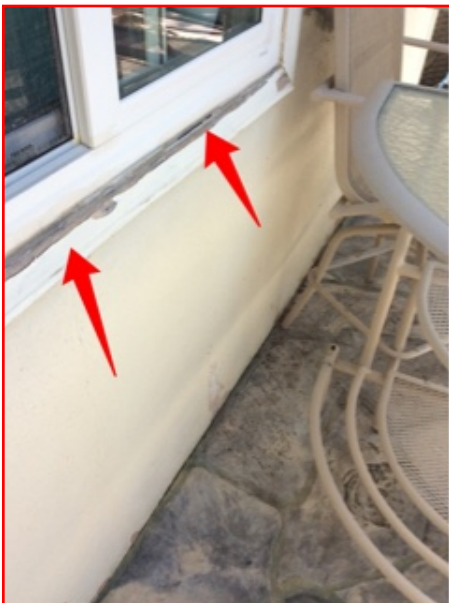
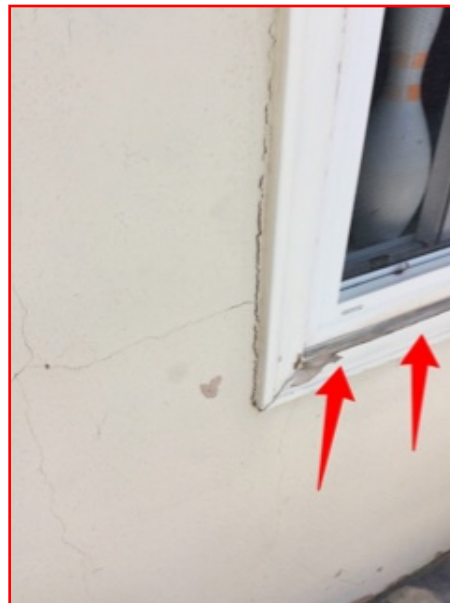
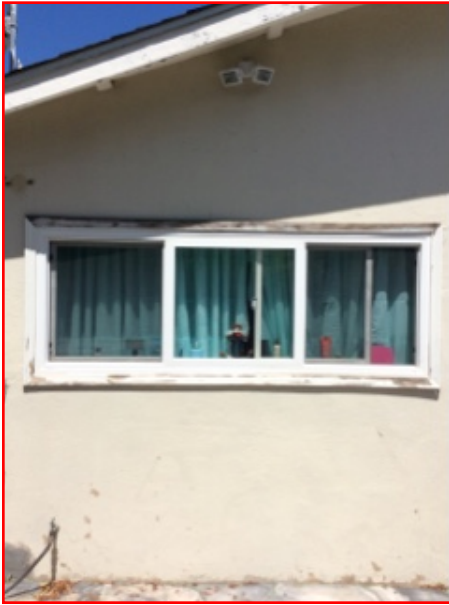
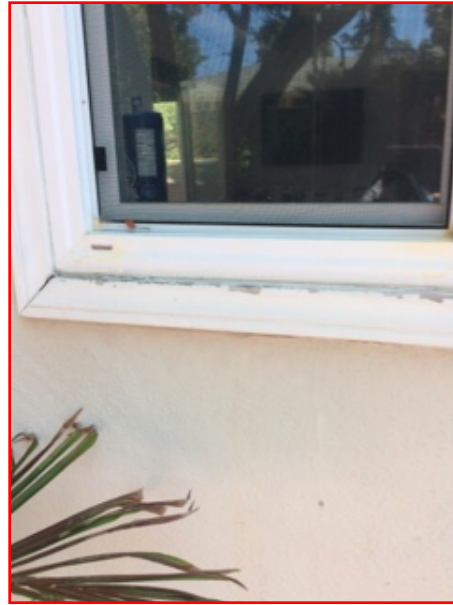
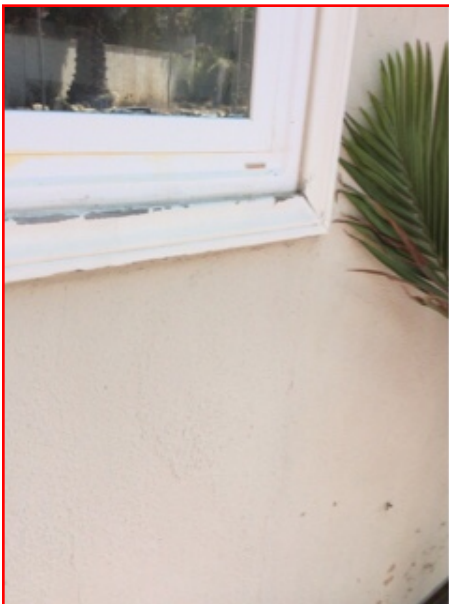
9) Wood trim needs to be painted and sealed to prevent water intrusion and structural damage.

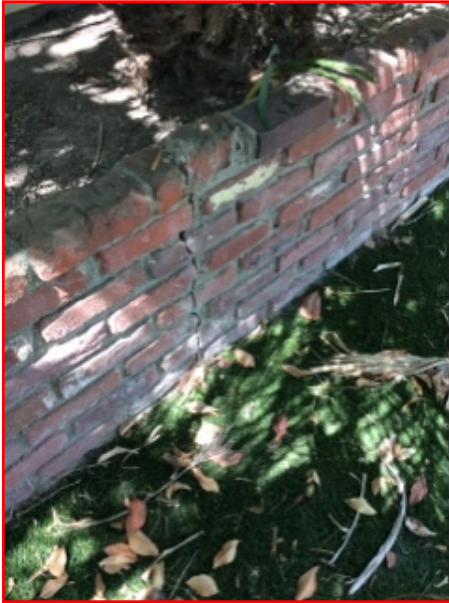
Figure 10-1

10) Broken planter box from over growing tree roots.

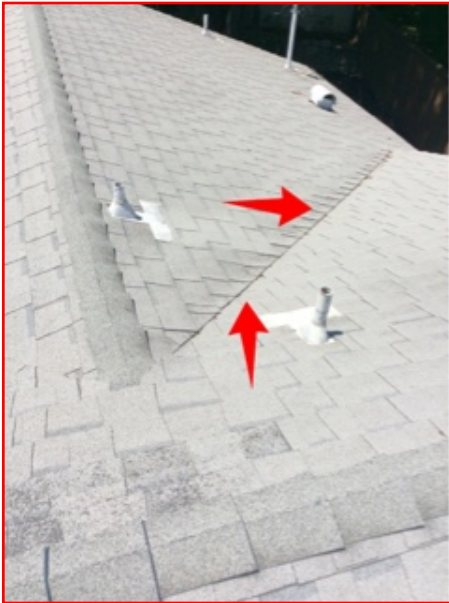
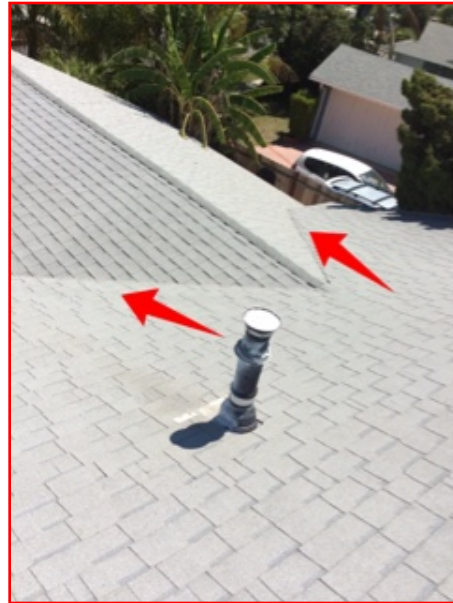
11) Recommend installing valley flashing to aid in proper rain drainage.

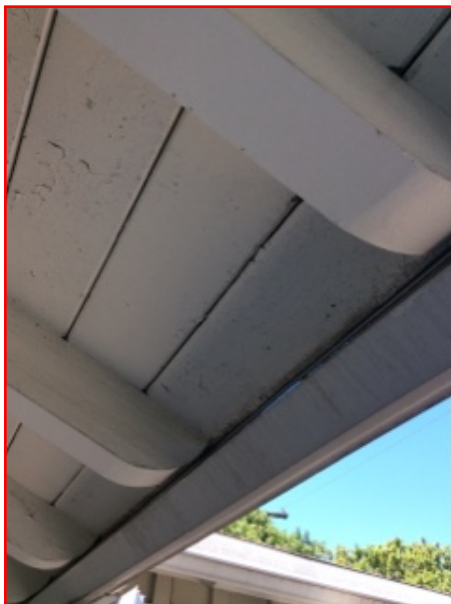
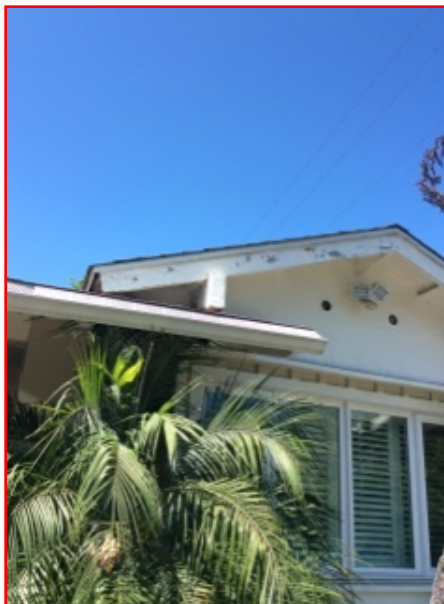
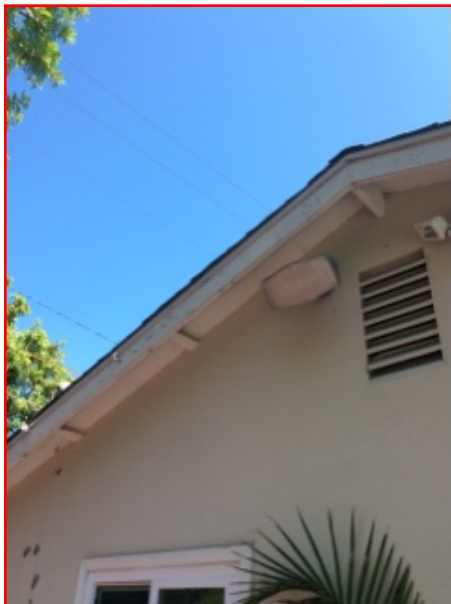
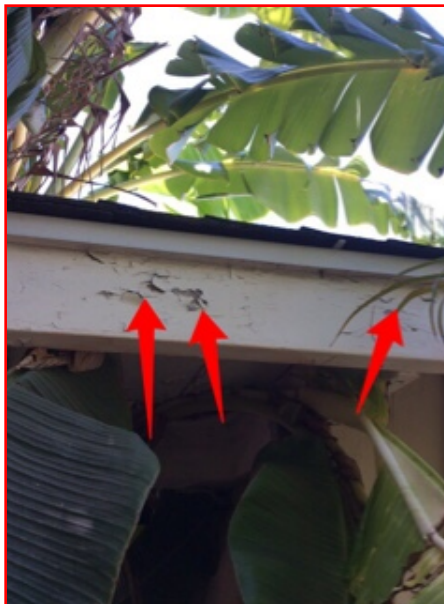
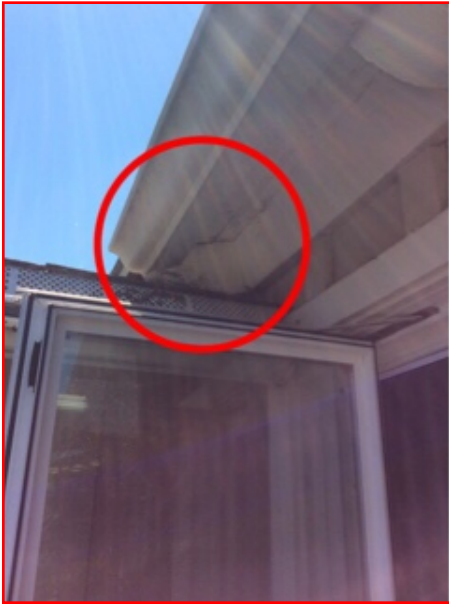
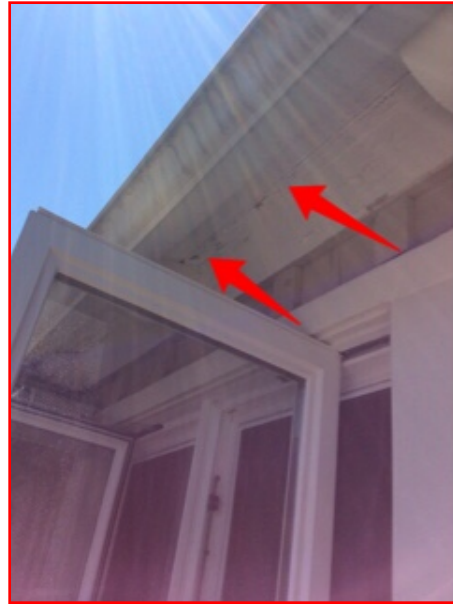
12) Multiple areas of failing paint and delaminating wood along fascia boards and eaves. Recommend further inspection by termite company.

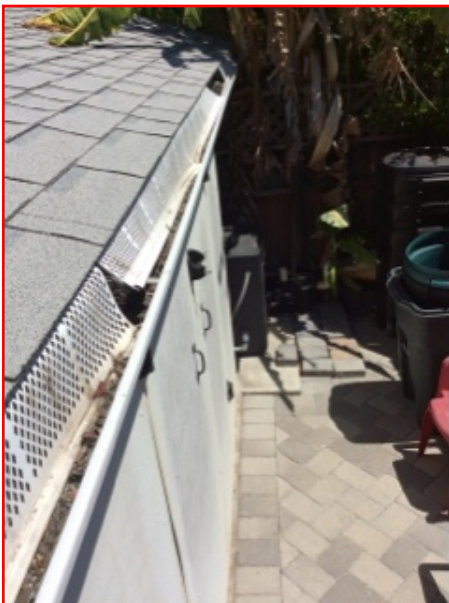
Figure 13-1

13) Recommend cleaning out rain gutters for optimal drainage. Backed up gutters can lead to water intrusion.

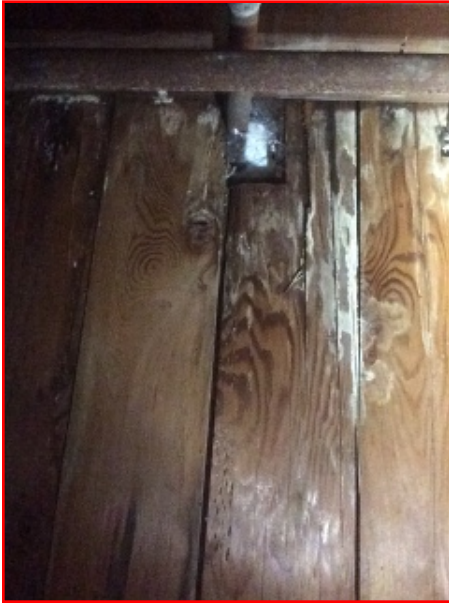
Figure 14-1

14) Dry rot and wood damage underneath bathroom fixtures from water intrusion.

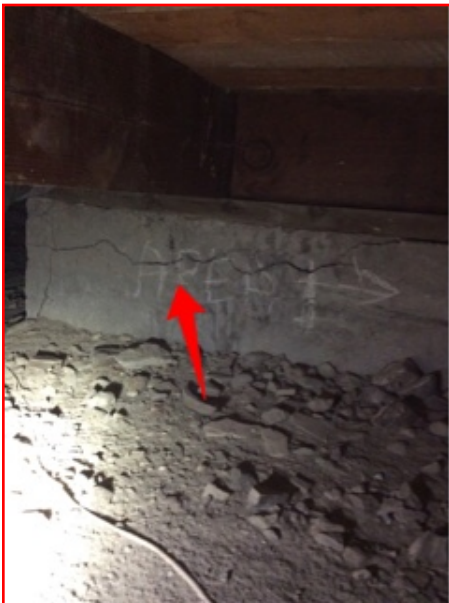
Figure 15-1

15) Major settlement cracks in foundation walls and piers. Recommend further evaluation by a structural engineer.

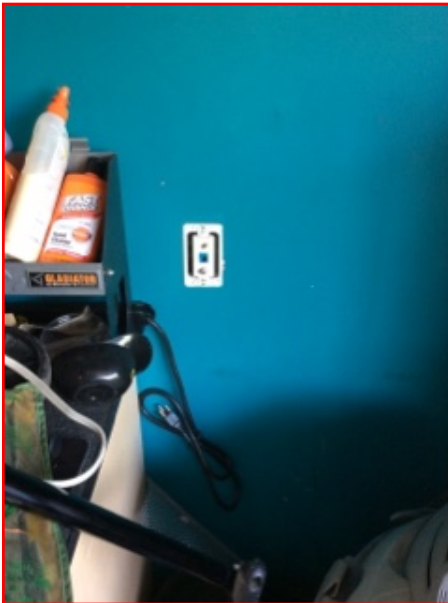
Figure 16-1

16) Missing plate cover.

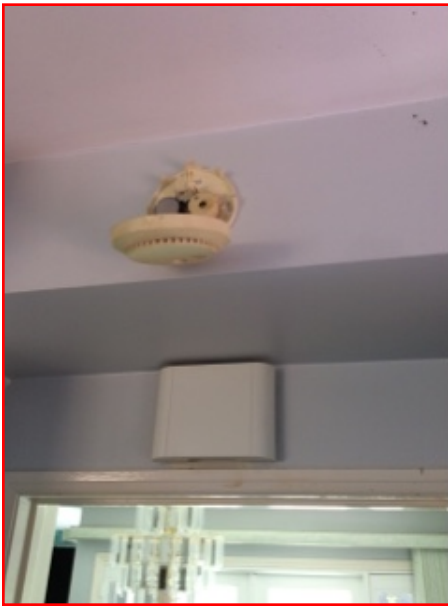
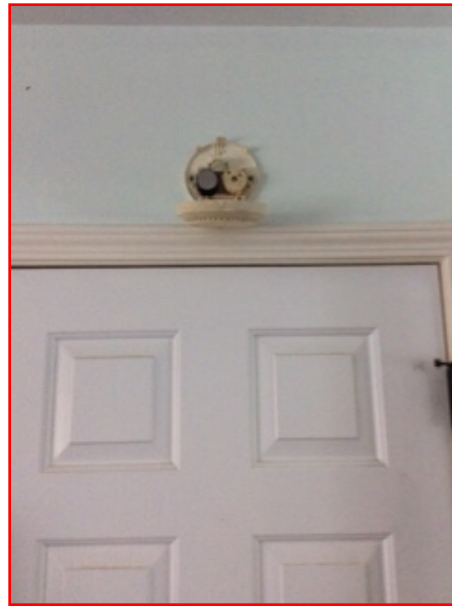
17) All smoke detectors are not functioning and need to be replaced.

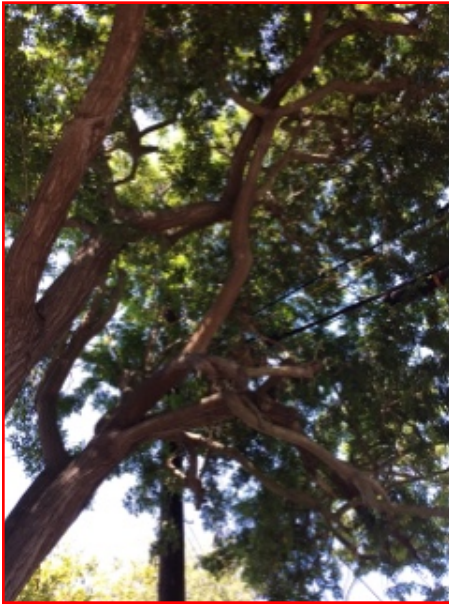
Figure 19-1

19) Tree is posing potential damage to electrical service.

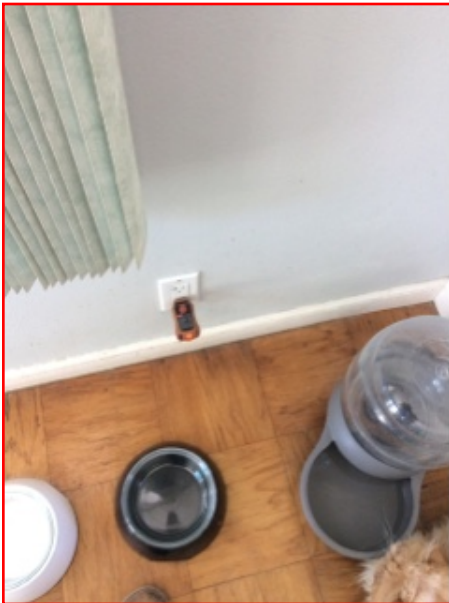
20) Majority of outlets are not grounded. Recommend further evaluation by a licensed electrician.

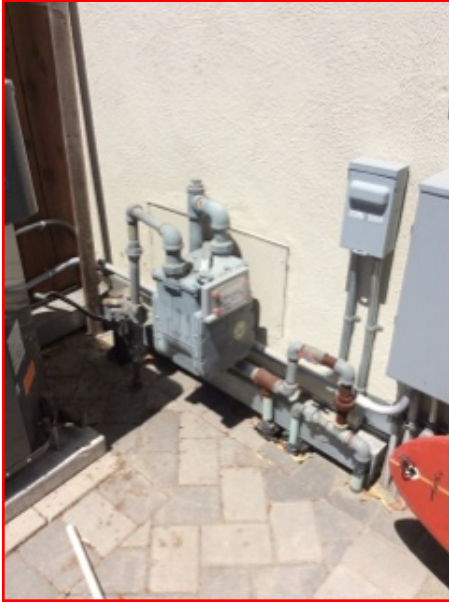
Figure 21-1

21) Appears added valves and plumbing has been installed from gas meter. Recommend further evaluation by gas company to ensure gas plumbing is up to city code.

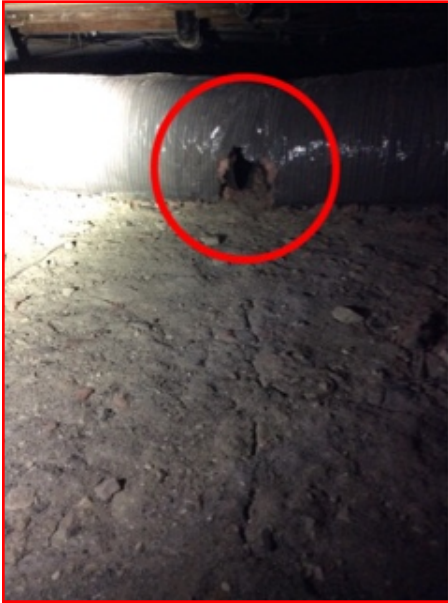
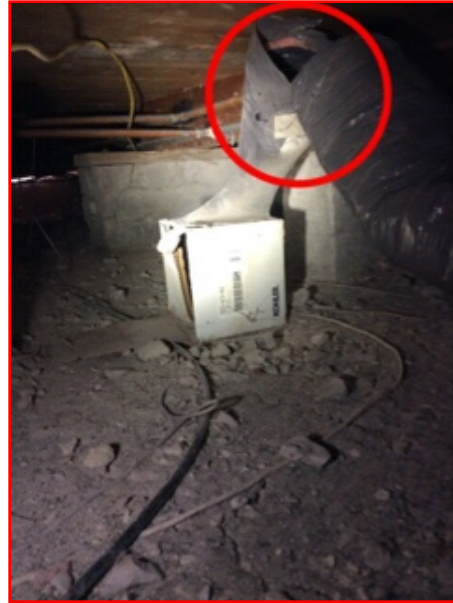
22) Holes and torn duct work. This will effect efficiency of airflow.

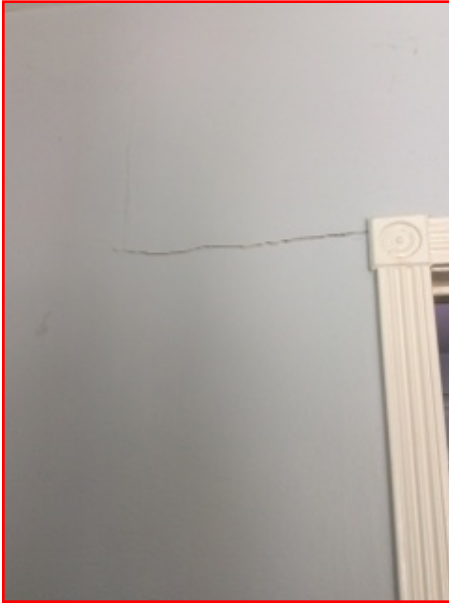
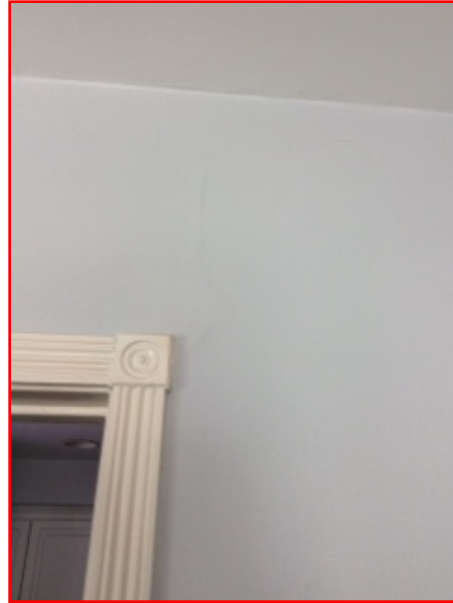
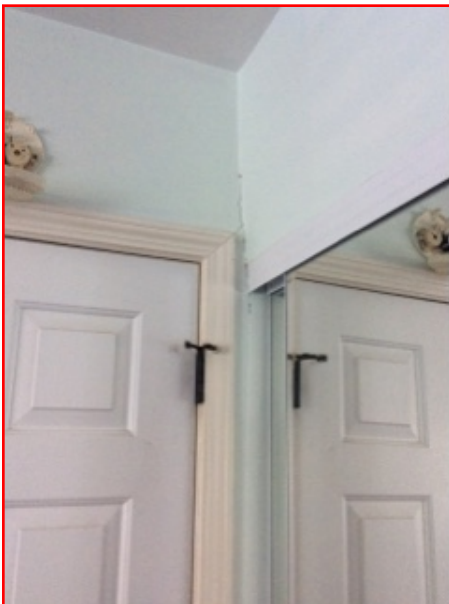
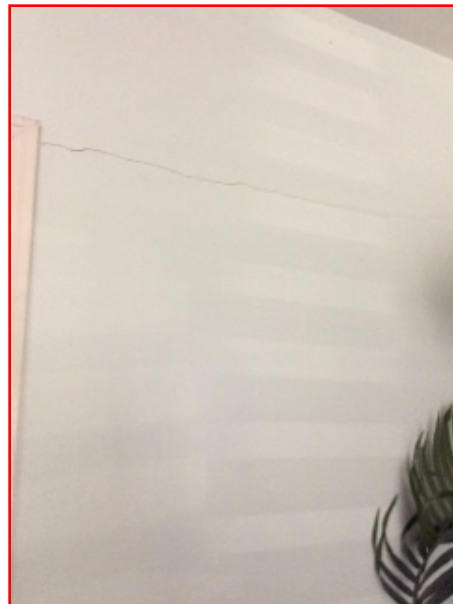
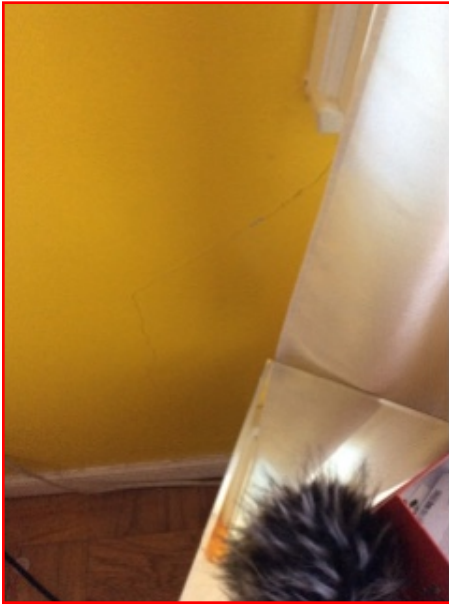
24) Multiple settlement cracks through interior at weak points of structure.

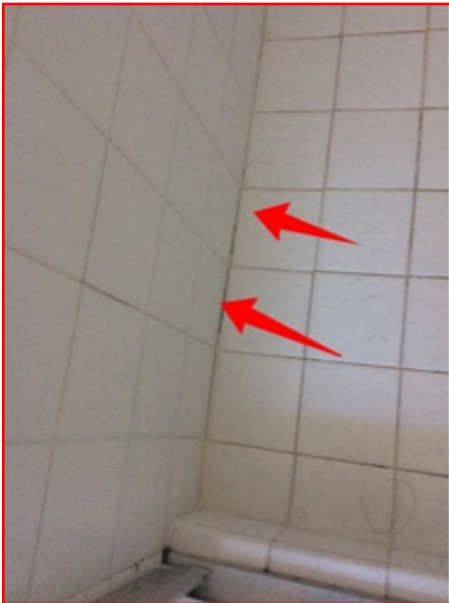
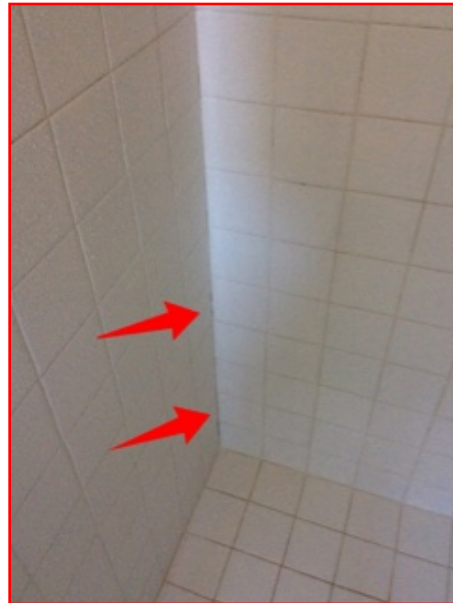
25) Recommend repairing cracks in grout to prevent water intrusion.

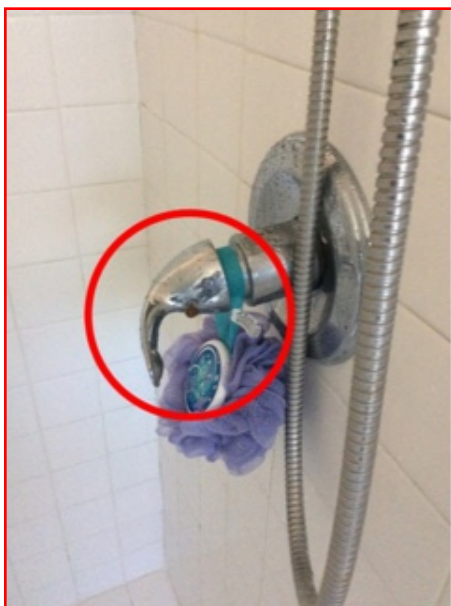
Figure 28-1

26) Loose shower valve handle.

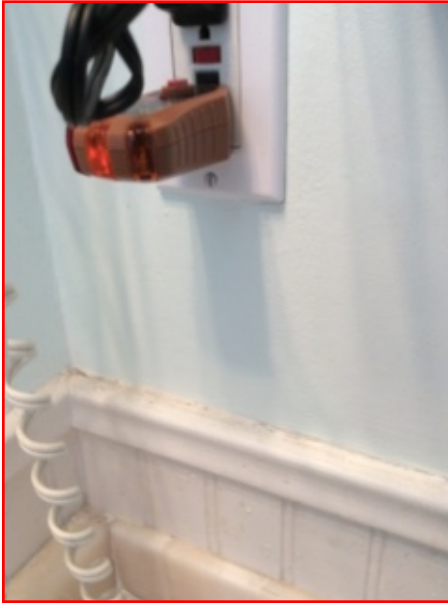
Figure 30-1

GFCI outlet is not grounded. This is a safety issue. Recommend repair.

28) GFCI outlet is not grounded. This is a safety issue. Recommend repair.

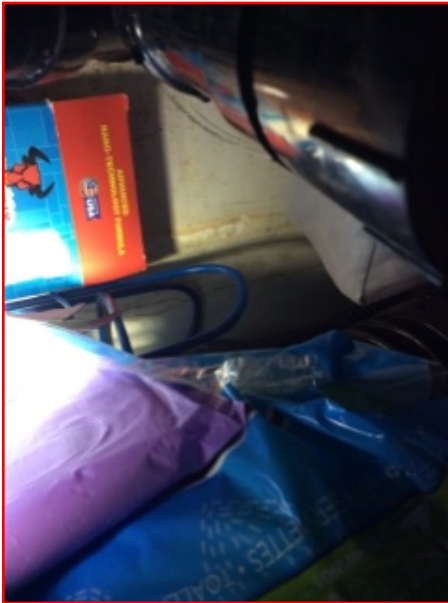
Figure 31-1

Comment 31:  
Obvious water damage. Moisture not present at time of inspection.

29) Obvious water damage. Moisture not present at time of inspection.

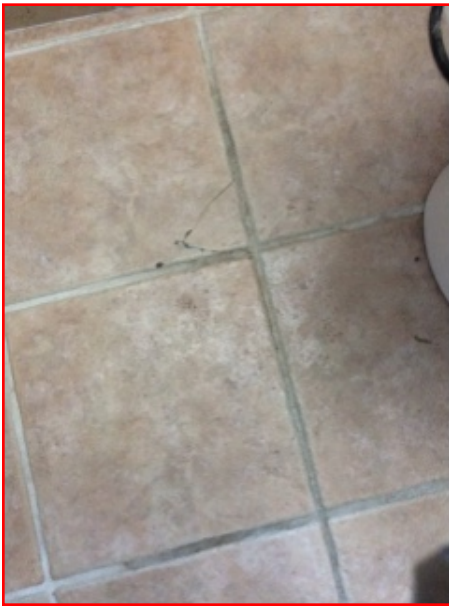
Figure 34-1

Comment 34:  
Single cracked tile in front of toilet.

32) Single cracked tile in front of toilet.

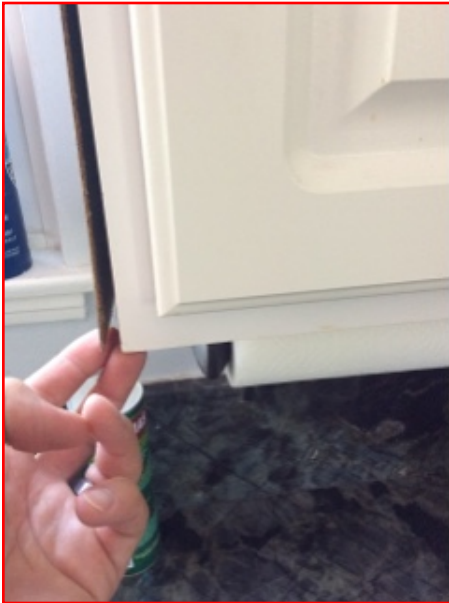
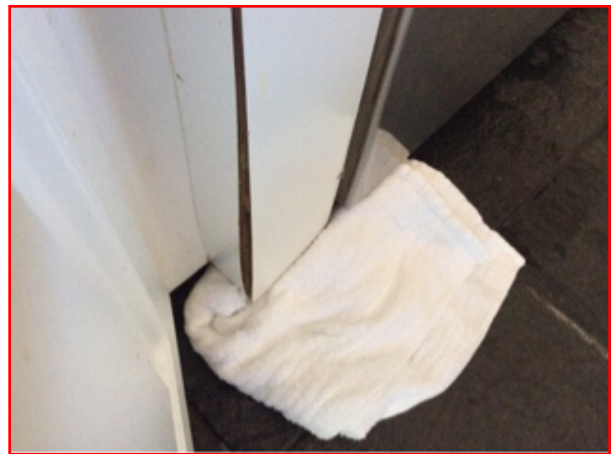
Delaminating portions of cabinets. Recommend repair or replace.

33) Delaminating portions of cabinets. Recommend repair or replace.

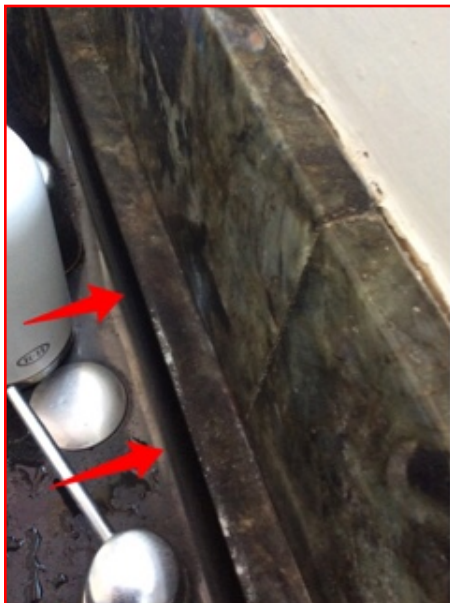
Figure 37-1

Gap behind sink and counter top needs to be sealed. There may possibly be mold growth due to water intrusion. Recommend further evaluation.

35) Gap behind sink and counter top needs to be sealed. There may possibly be mold growth due to water intrusion. Recommend further evaluation.

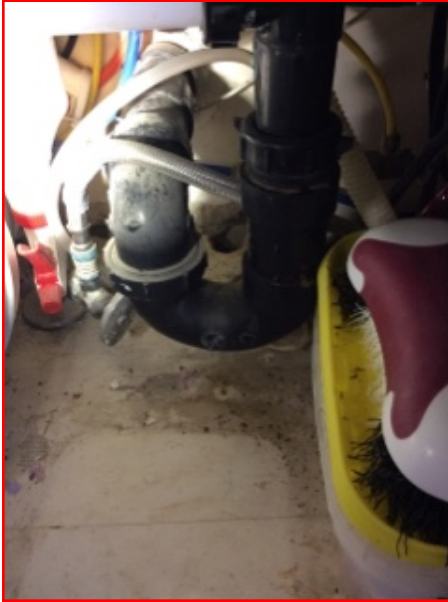
Figure 38-1

Water damage under sink. Recommend further evaluation and testing for mold growth.

36) Water damage under sink. Recommend further evaluation and testing for mold growth.

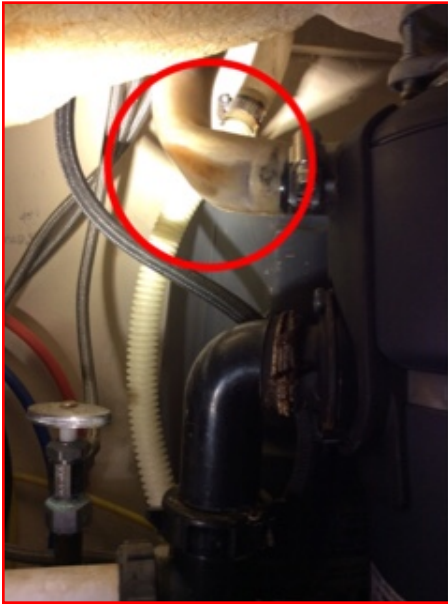
Figure 40-1

Air gap drain line is kinked and clogged. This causing water to exit through the air gap creating flooding over the counter top to the floor. Recommend repair.

38) Air gap drain line is kinked and clogged. This causing water to exit through the air gap creating flooding over the counter top to the floor. Recommend repair.

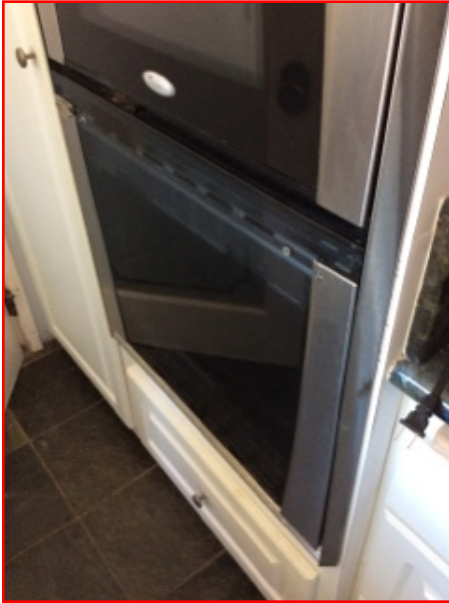
Figure 42-1

Comment 42:  
Missing handle to oven door.

40) Missing handle to oven door.
