# Insight Home Inspections

## Home Inspection Report

**27413 Fawnskin Dr**

Inspected on Tue, Aug 7 2018 at 11:20 AM

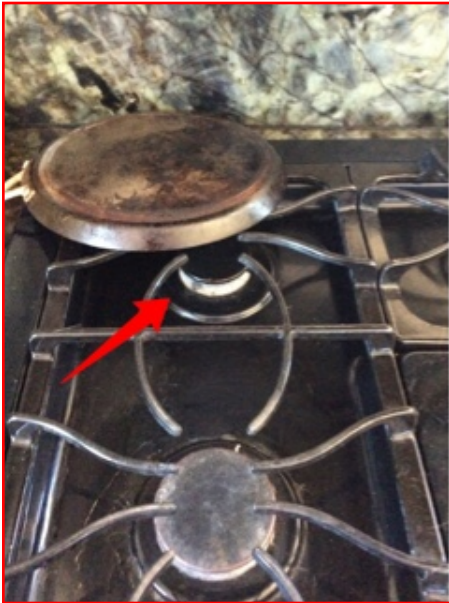
Figure 43-1

Comment 43:  
Bake left burner is not functioning.

41) Bake left burner is not functioning.

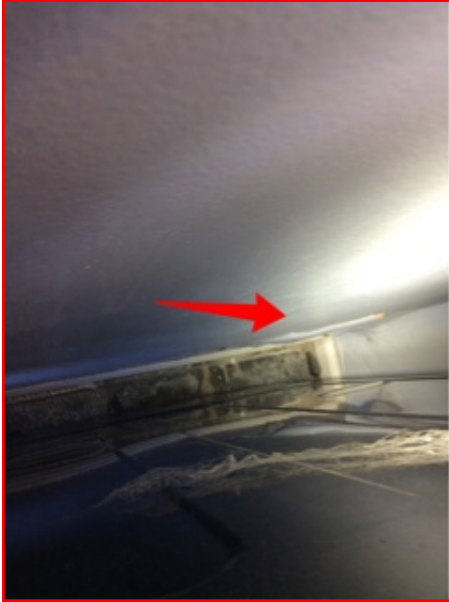
Figure 44-1

Delaminating paint. Possible cause by moisture intrusion. Recommend further evaluation.

42) Delaminating paint. Possible cause by moisture intrusion. Recommend further evaluation.

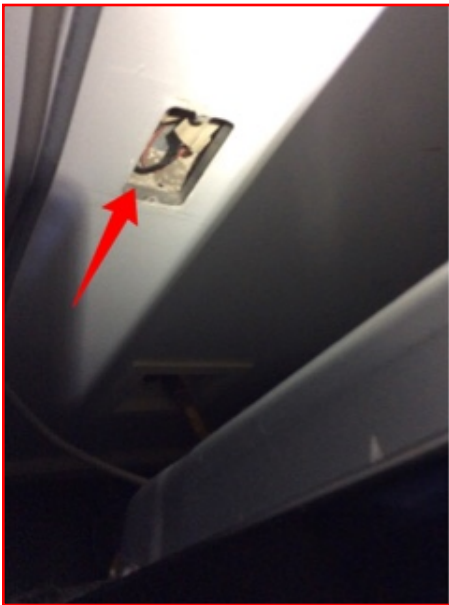
Figure 45-1

Open electrical box. Recommend adding cover plate.

43) Open electrical box. Recommend adding cover plate.

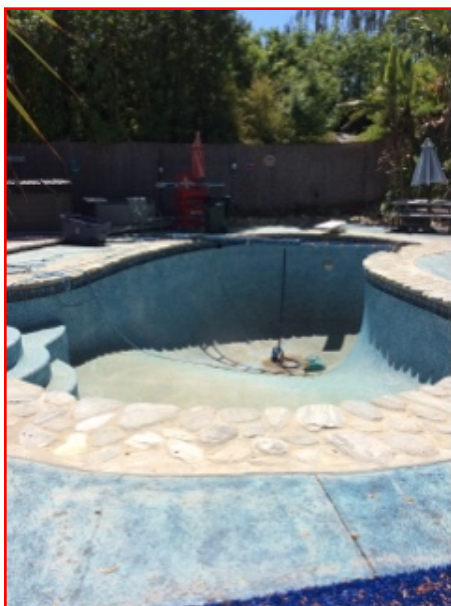
Figure 46-1

44) Unable to test pool equipment, due to pools current conditions.
