Confidential Inspection Report

LOCATED AT:
1637 1st st
Manhattan Beach, California 90266

INSPECTED ON:
Tuesday, March 29, 2022

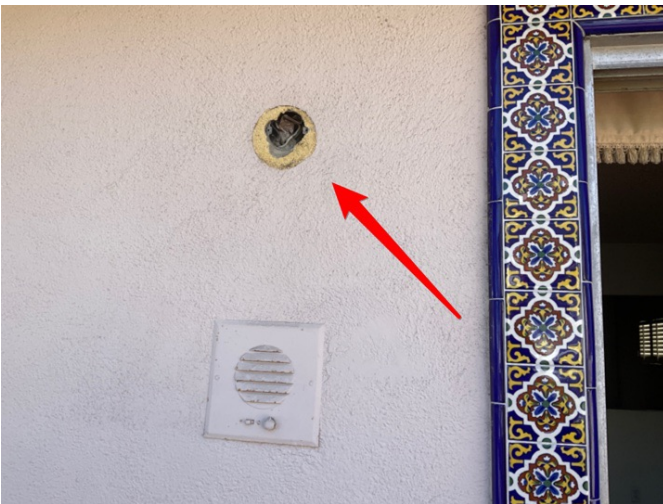
32: An approved weather-resistant cover is required at an open junction box located at the rear patio.

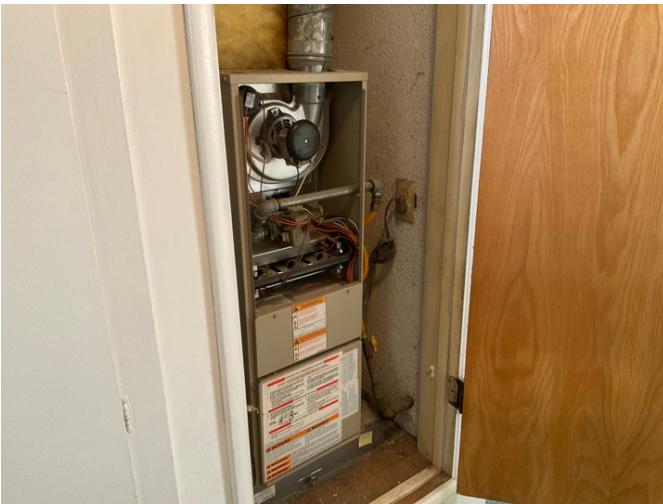
127: Comfort heating is provided by a standard gas-fired forced-air furnace.

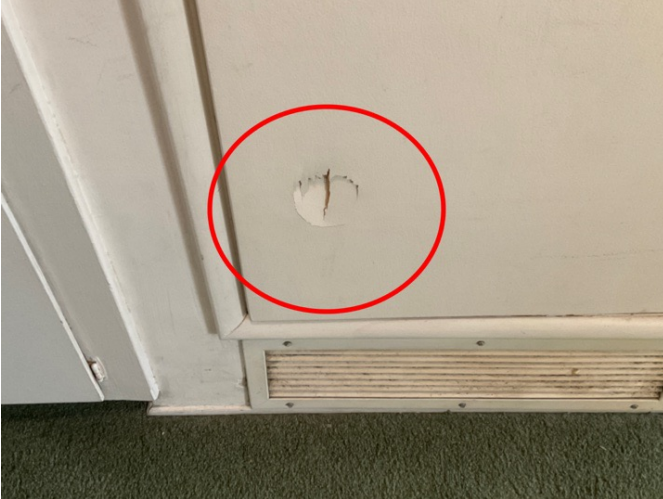
129: The heating system closet door is damaged.

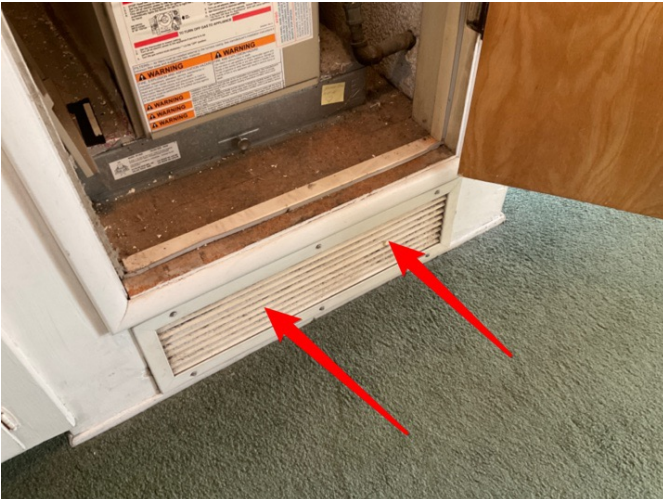
132: The filter is dirty and should be cleaned or replaced.

133: The return-air intake is located within 10' of the furnace closet. Because the furnace closet is not sealed, this can result in a back-draft where bi-products of combustion are circulated into the home. The closet door should be well sealed when closed.

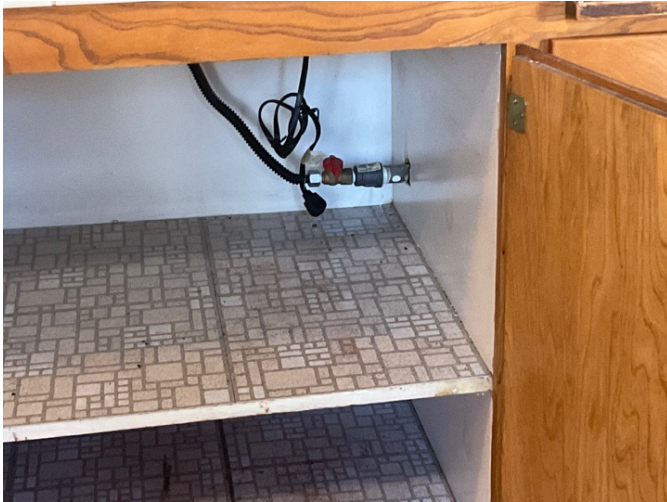
150: The gas was off to the cook top and the unit was unplugged. When tested, the igniters did not respond.

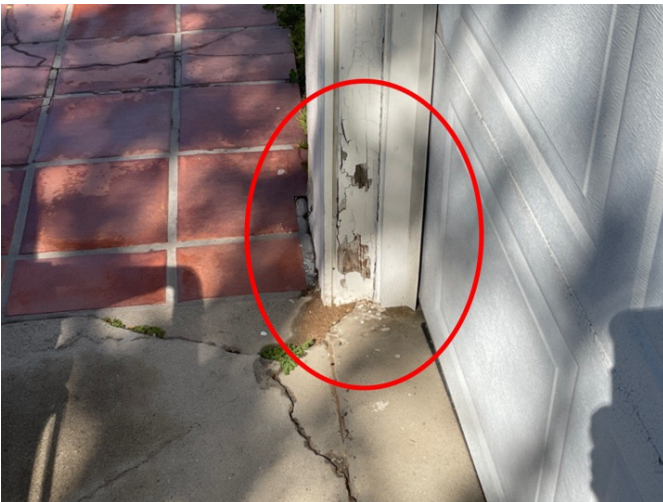
233: The exterior wood trim is in need of preparation and painting.

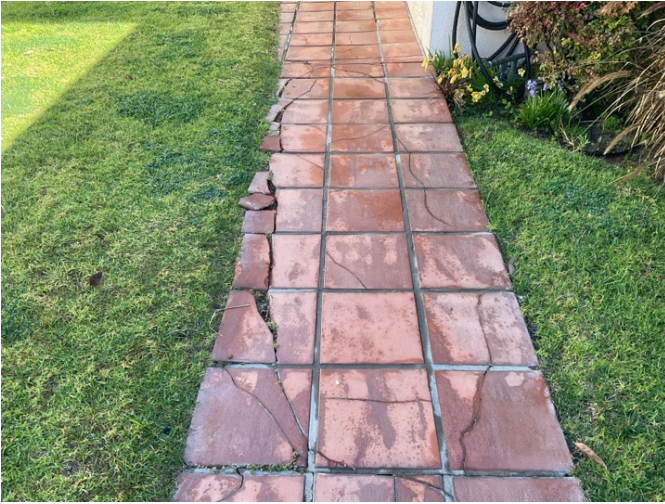
s-15: There are offsets in the walkways that could be considered a trip potential.

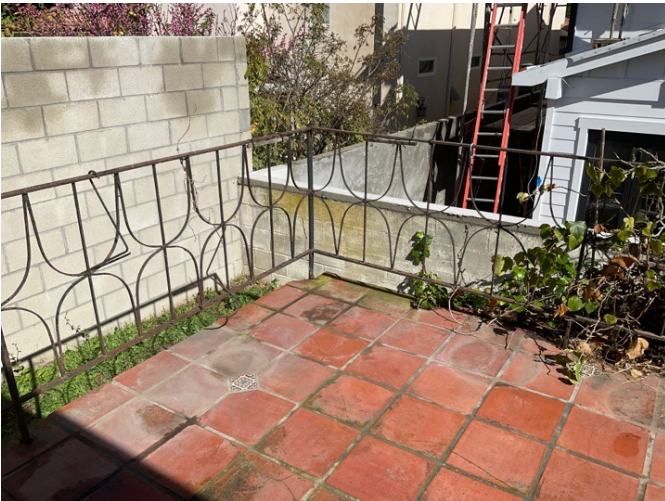
s-30: The guardrails at the rear patio do not conform to current minimum standards. They should be upgraded if young children will be present.

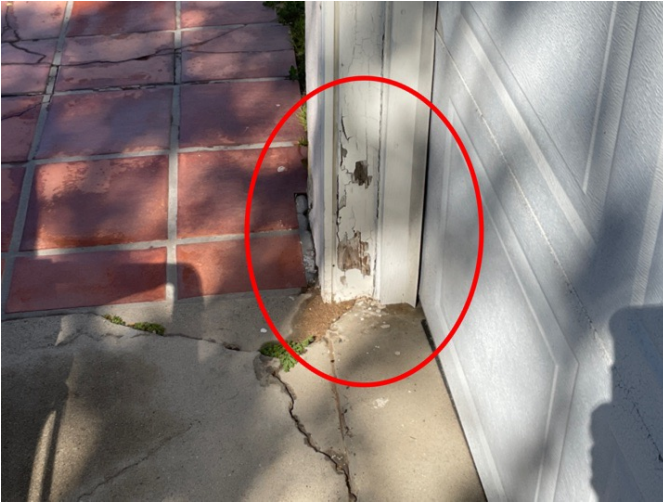
s-233: The exterior wood trim is in need of preparation and painting.
