# Mitch Fredericks Home Inspections

## Mitch Fredericks Home Inspections

**101 Heartwood Way  
Anaheim, CA**

Inspected on Wed, Feb 8 2023 at 2:49 PM

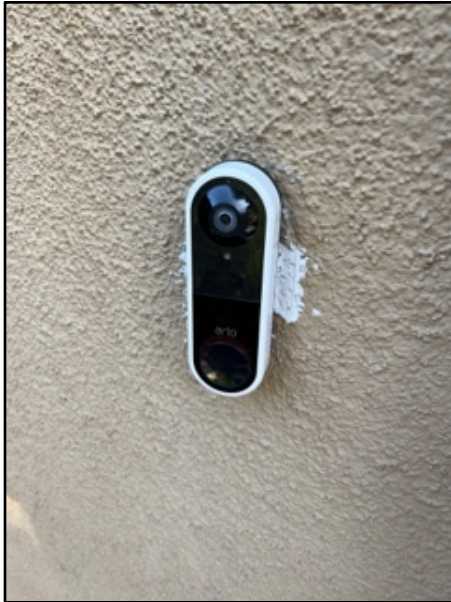
Figure 4-1

The ring doorbell has an app that you could use with your phone to see who's at your door. The bell also will ring inside the home.

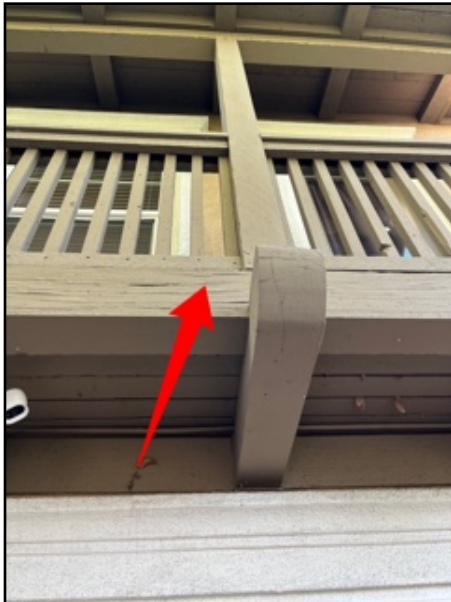
Figure 5-3

Master bedroom balcony wood beams, show paint blistering and possible wood damage. The exterior is maintained by the HOA.

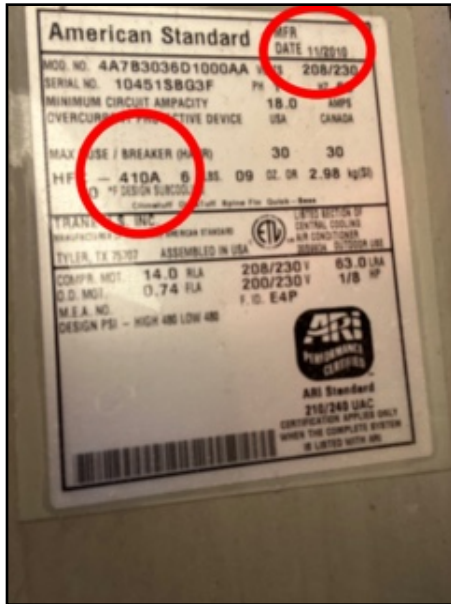
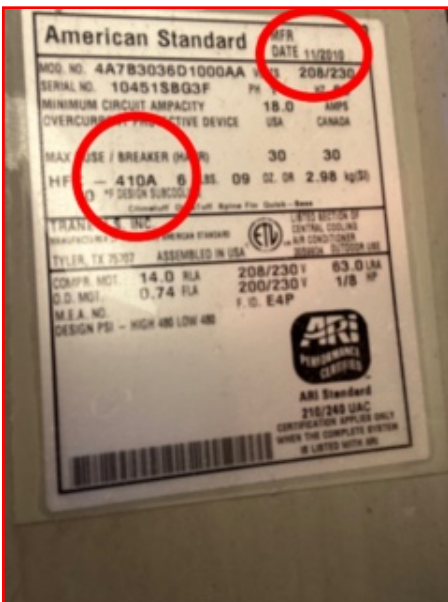
Figure 10-3

The air conditioning did not condense and cool down the house. Air was blowing out at 70°. Recommend a service call to an HVAC company.

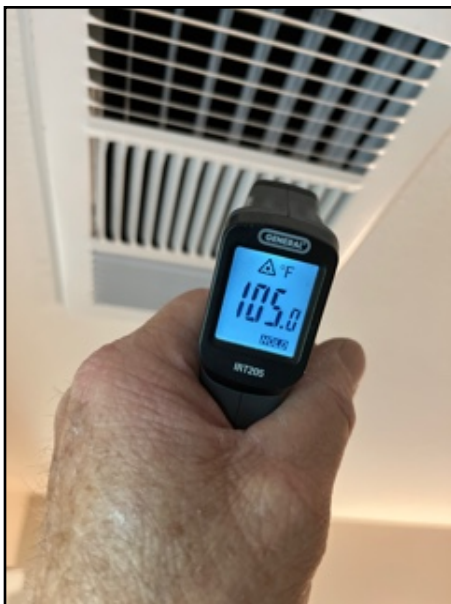
Figure 14-1

Comment 14:  
Heated air is blowing out at 105°.

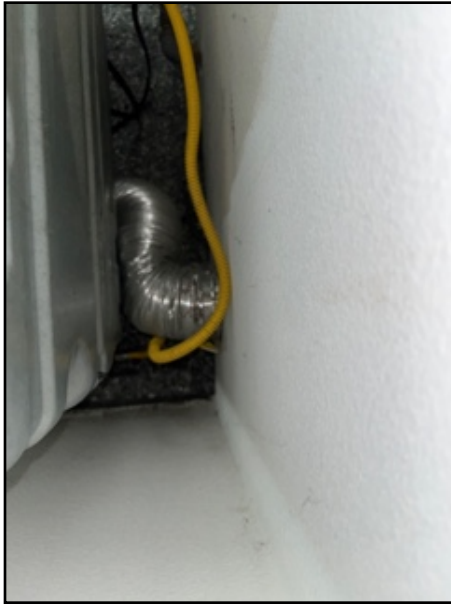
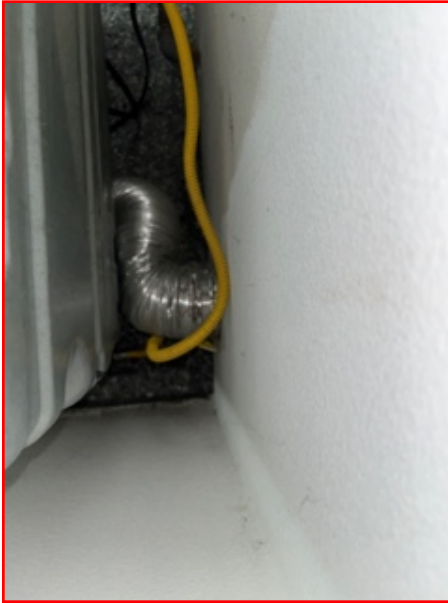
Figure 16-1

Vacuum the dryer vent to clear lint and debris.

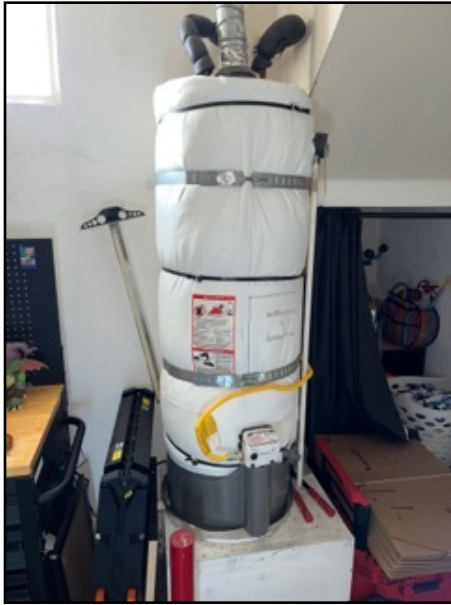
Figure 17-1

The exhaust vent comes up slightly short of reaching the top of the tank. There are two draft hood vents to bring the vent closer to the top of the tank.

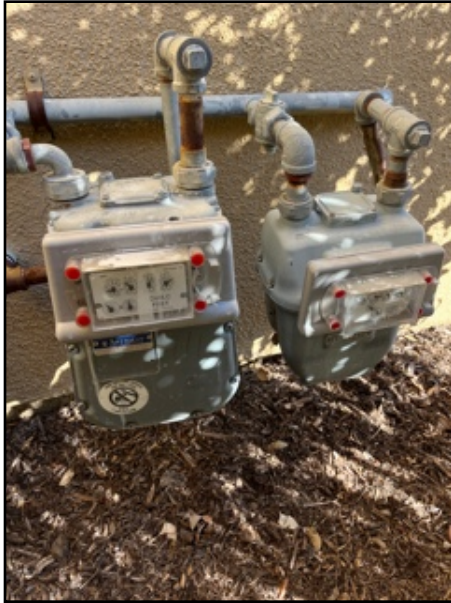
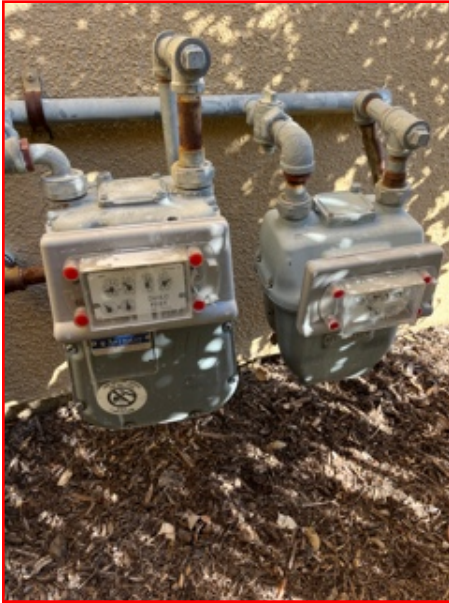
Figure 21-1

Comment 21:  
Gas meter is not clearly marked and labeled.

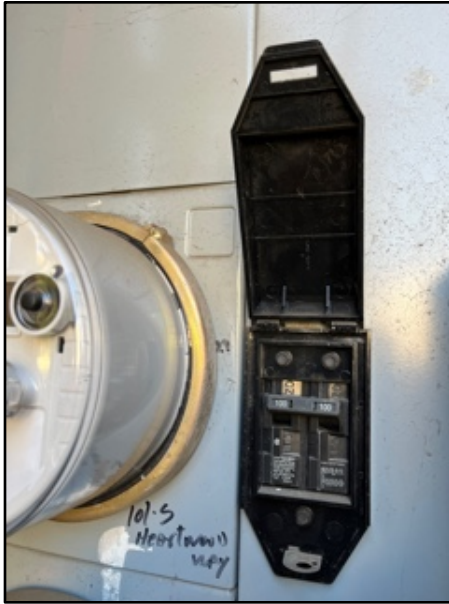
Figure 22-1

Main electrical meter is located at the rear of the building.

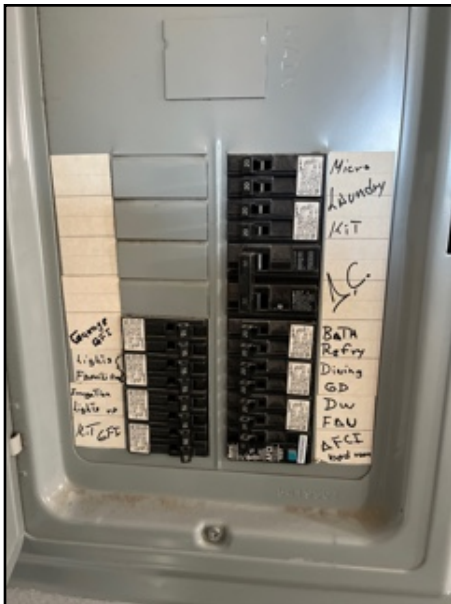
Figure 24-1

Sub panel circuit labeling is complete. No breakers have overheated or have tripped during the inspection.

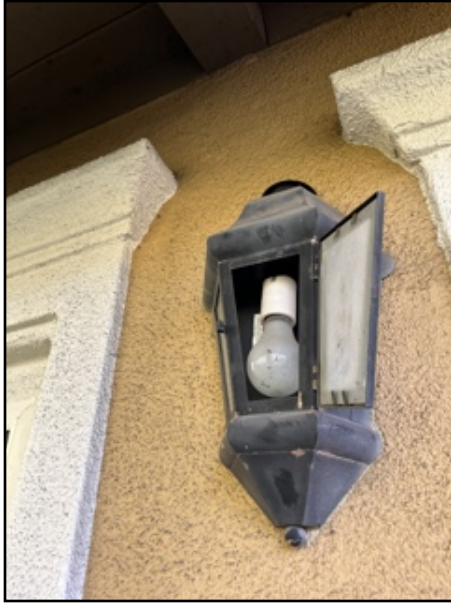
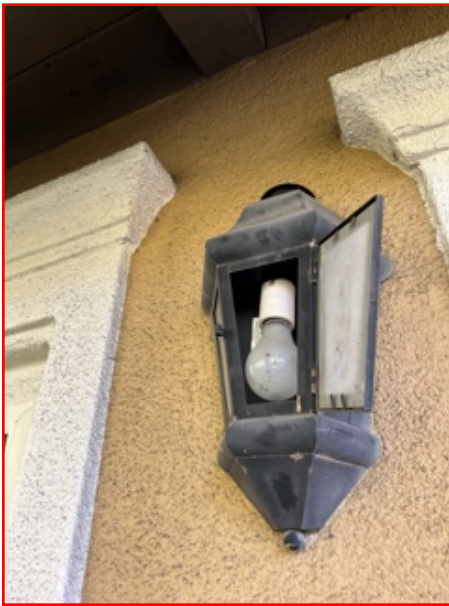
Figure 25-1

Master bedroom balcony porch light does not respond to switch.

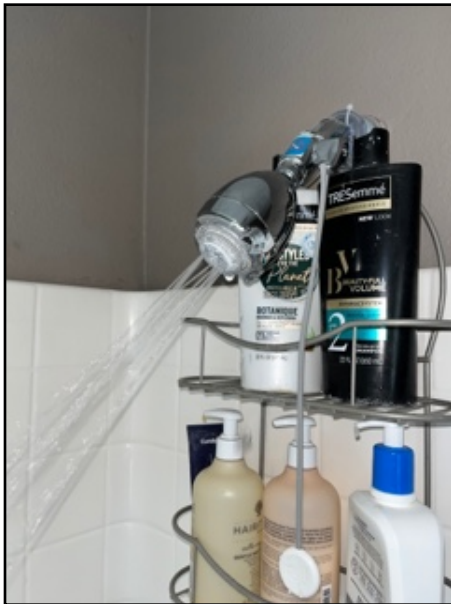
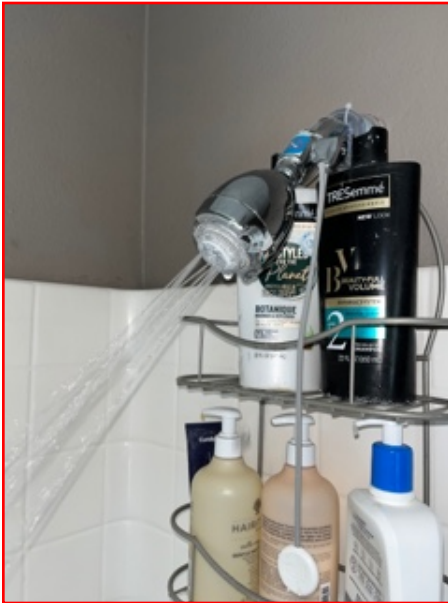
Figure 30-1

Comment 30:  
Hall bathroom shower volume is low.

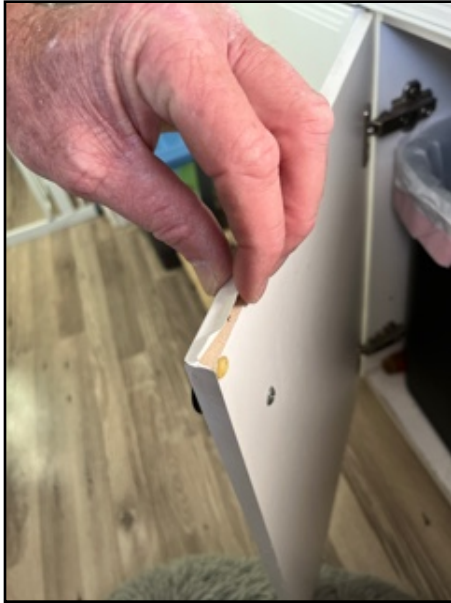
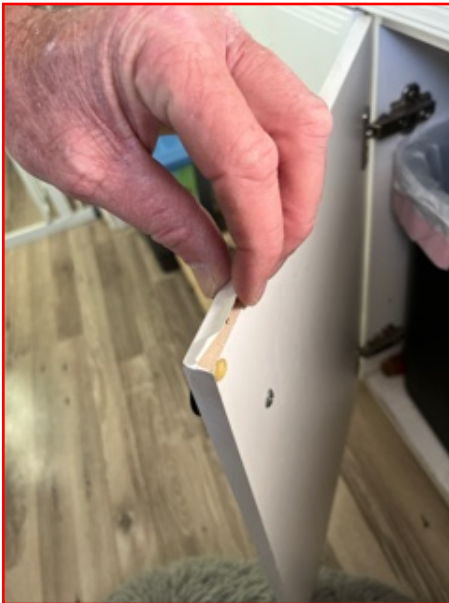
Figure 32-1

Comment 32:  
Hall cabinet doors have the finish peeling.

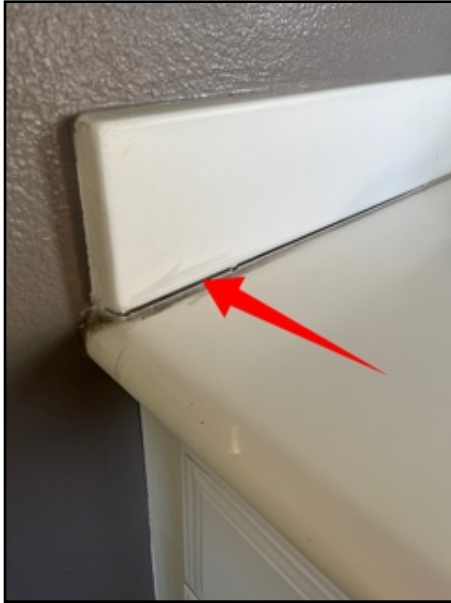
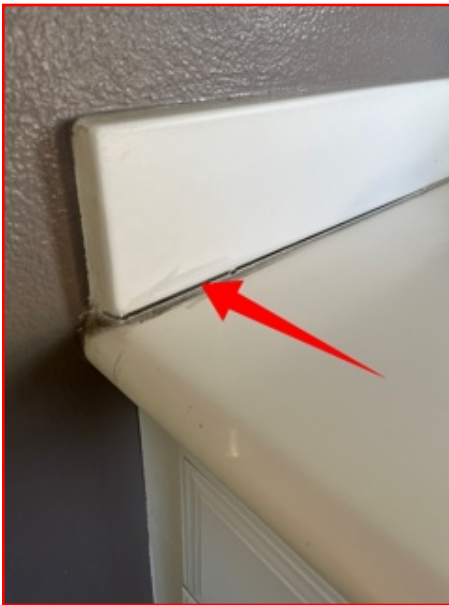
Figure 34-1

Hall bathroom countertop shows separation and needs caulking.

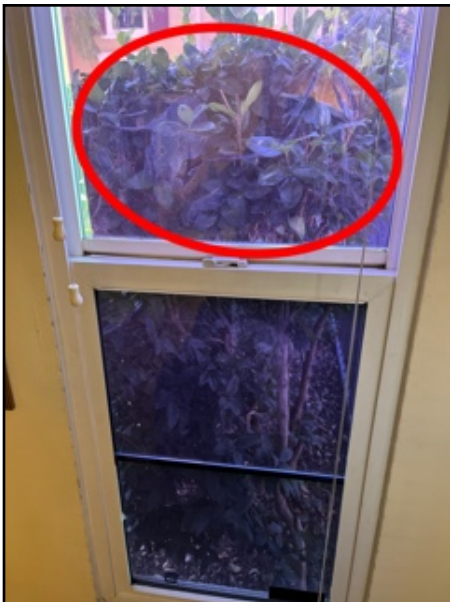
Figure 40-1

Comment 40:  
Living room left side window has tint that is wrinkled and difficult to view through.

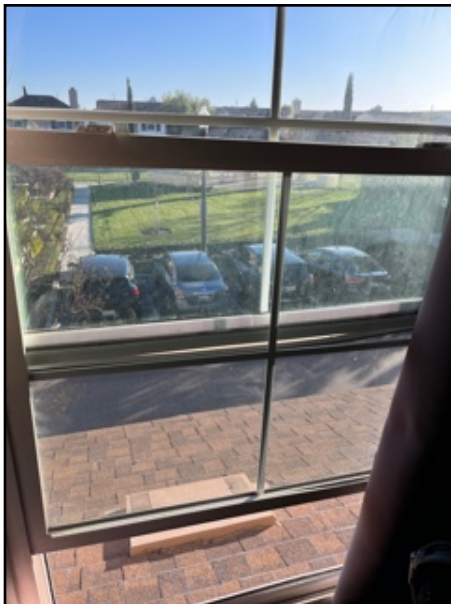
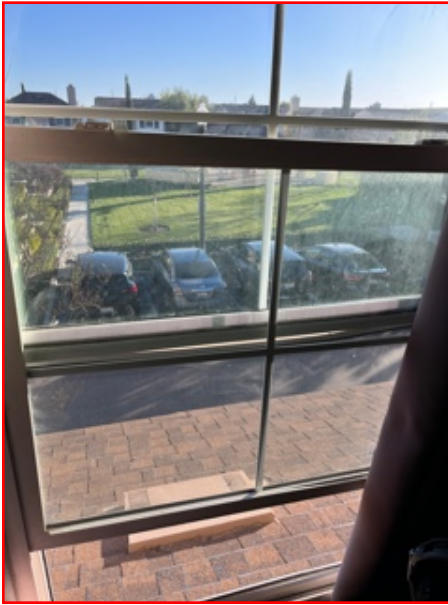
Figure 42-1

Front right bedroom window counterbalance has fallen out.

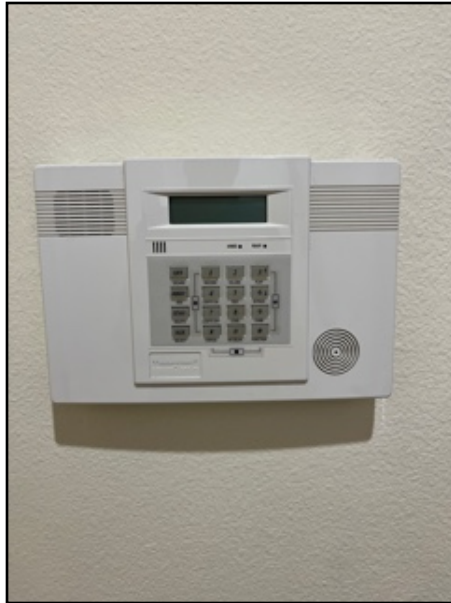
Figure 43-1

Comment 43:  
Security system was not tested during inspection.

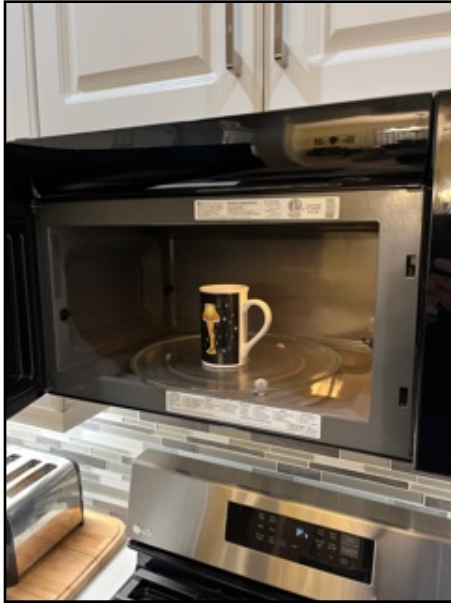
Figure 46-1

Comment 46:  
Cup of water heats in microwave.

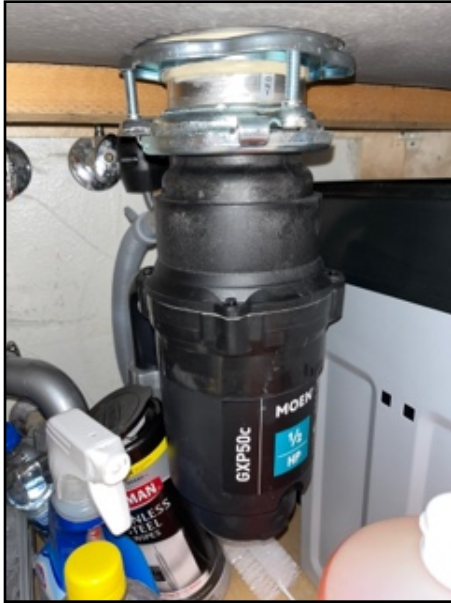
Figure 49-1

Garbage disposal runs at full speed with no audible bearing noises.

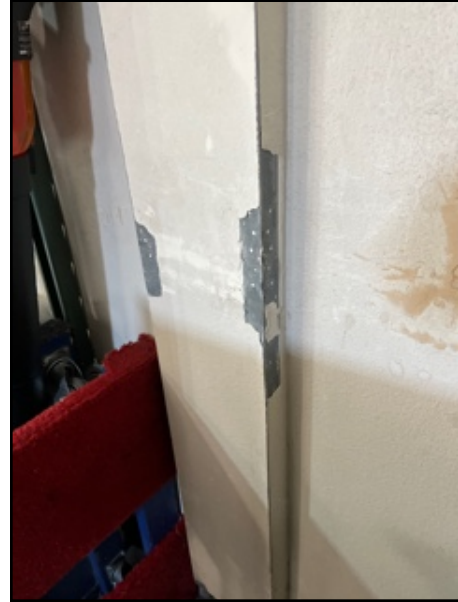
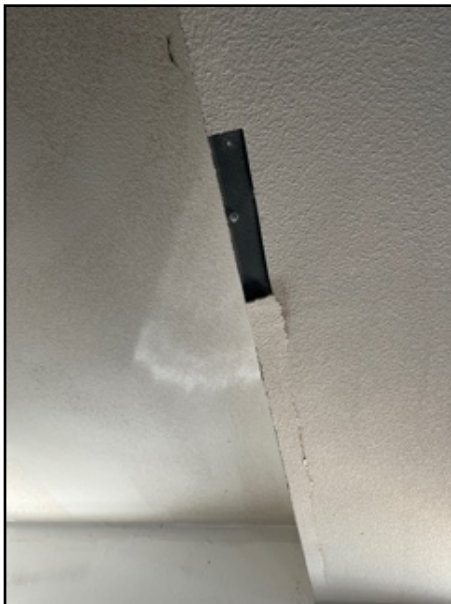
The garage walls and ceiling shows texture and paint peeling off of the metal corner beads.

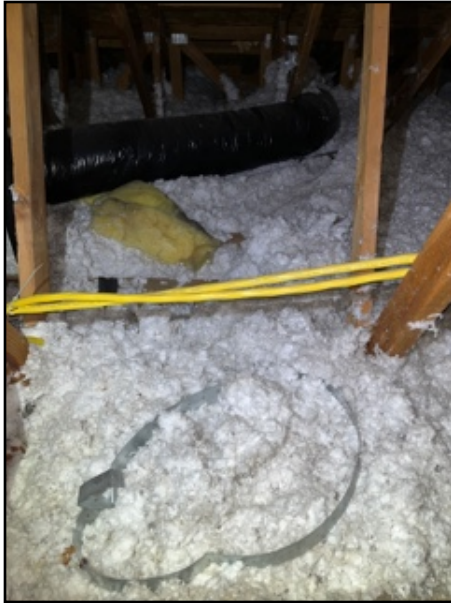
Figure 54-1

Blown in insulation between the joist and rafters appears sufficient.

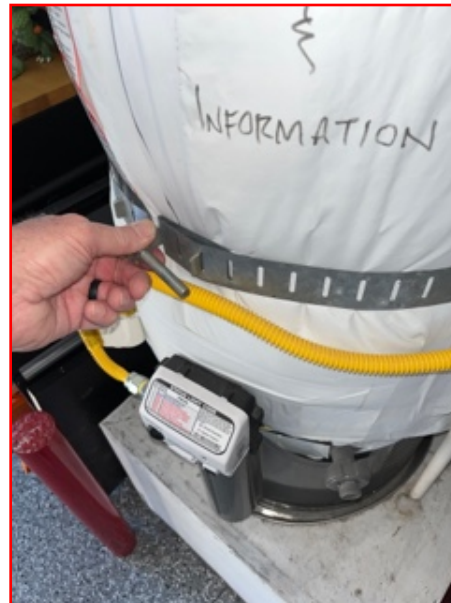
Figure 18-2

Lower earthquake strap is loose and should be tightened.

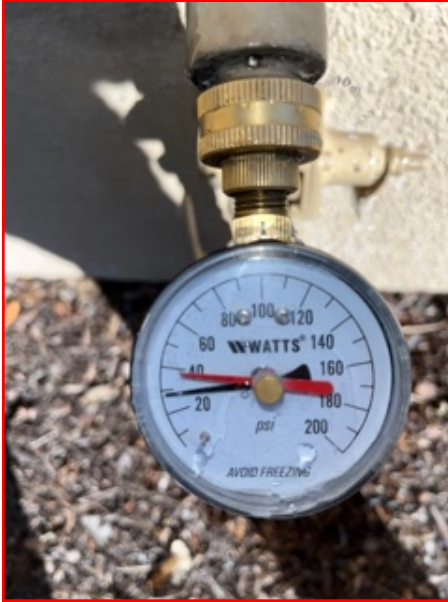
Figure 20-1

10) Water pressure is low at 30 psi. Water pressure should be between 65 and 75 psi. This home has a regulator that needs to be adjusted.

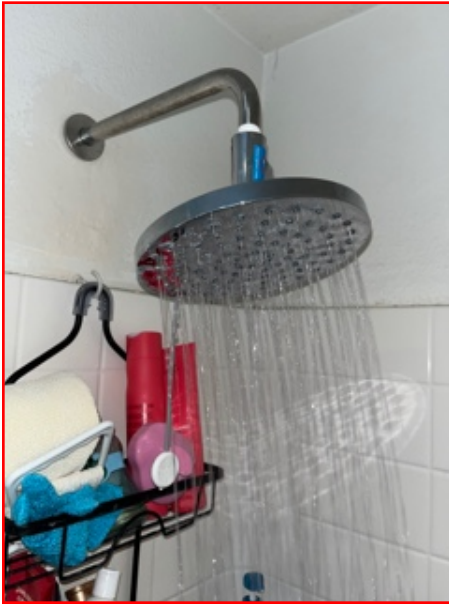
Figure 31-1

17) Master bathroom shower has low volume.

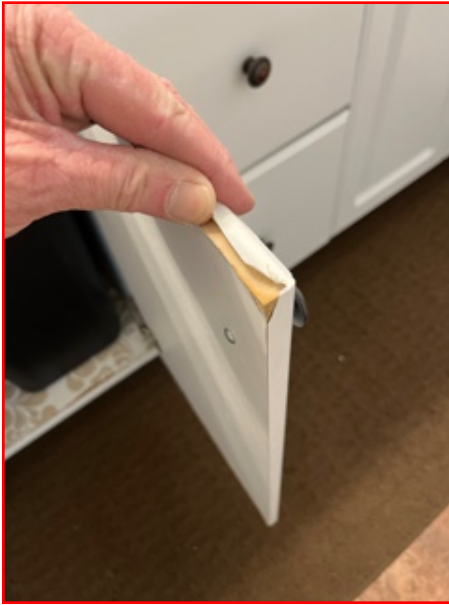
Figure 33-1

19) Master bathroom cabinet door shows finish peeling.

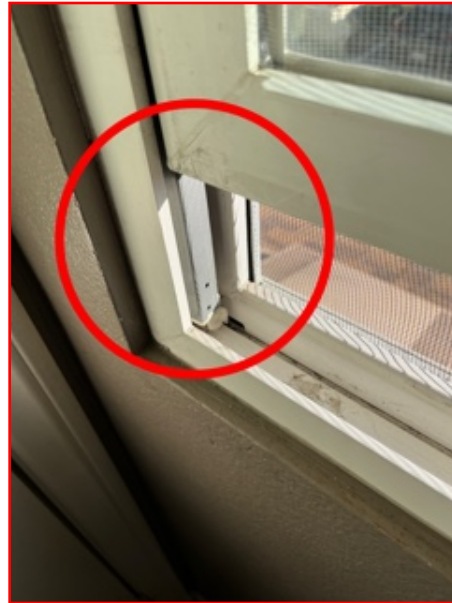
Figure 41-2

Upstairs hall bathroom window counter balance is falling out. Repairs are needed to the window at this time.
