Jul 9th, 2024

25321 Terreno Dr., Mission Viejo, CA, 92691

# Home Inspection Report

Joseph Kennison / Loyalty Inspections

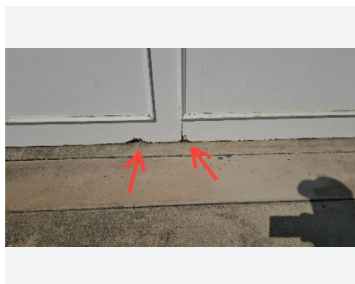
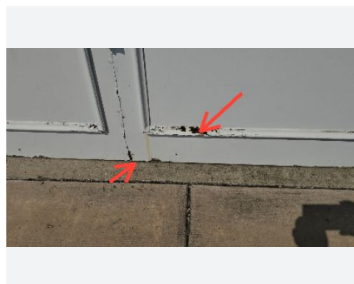
Door damaged

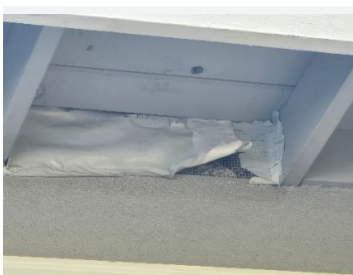
Vent covered - recommend having uncovered.

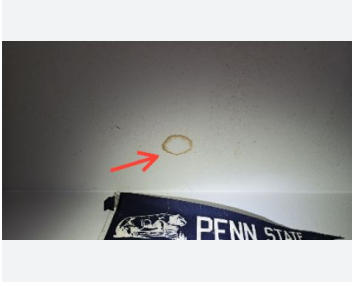
Moisture stain

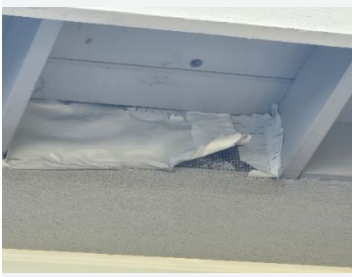
Vent covered - recommend having uncovered.
