Inspection reference: 3850 E. 15th St., LB, CA 90804

# **Confidential Inspection Report**

**3850 E. 15th St.**  
**Long Beach CA 90804**

**February 29, 2024**

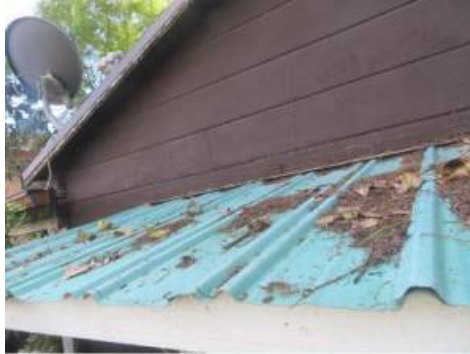
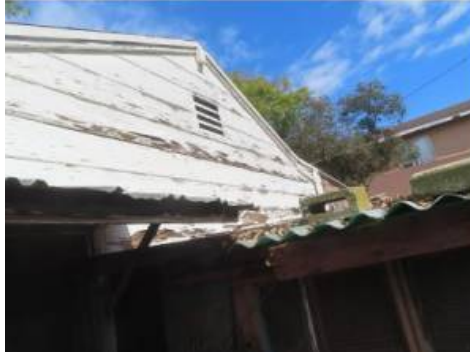
DEFERRED: Moisture damage.

MAINTENANCE: Some loose or peeling paint viewed. We recommend painting at this time to protect the wood from further deterioration and to enhance its appearance.

DEFERRED: Portions of the walls are covered with thick vegetation and were not viewed.

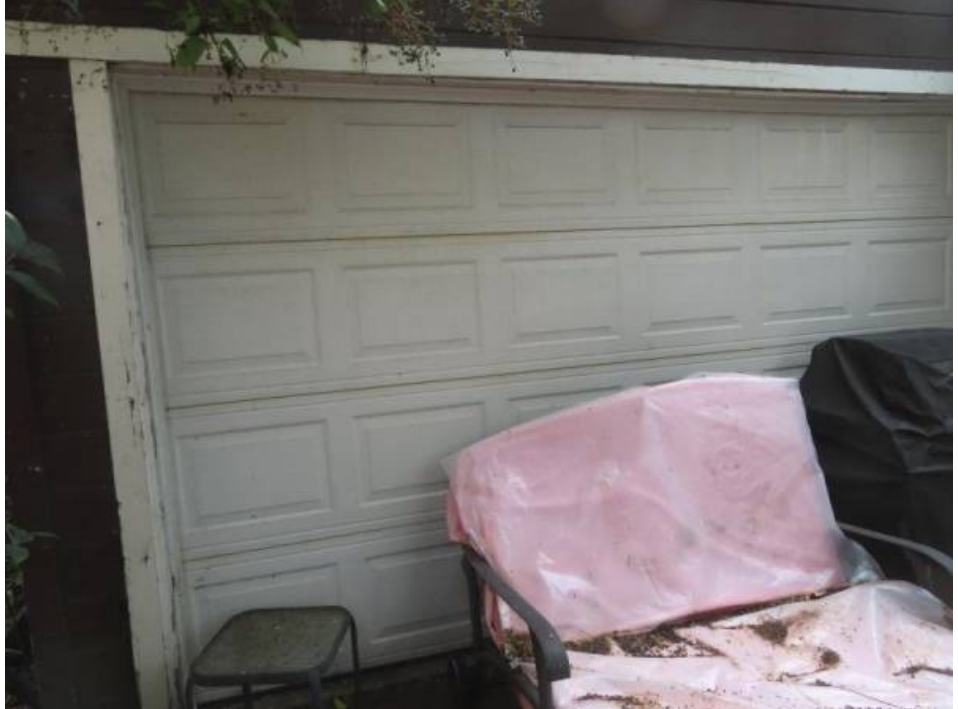
*Sectional/Roll-up*

SERVICEABLE.

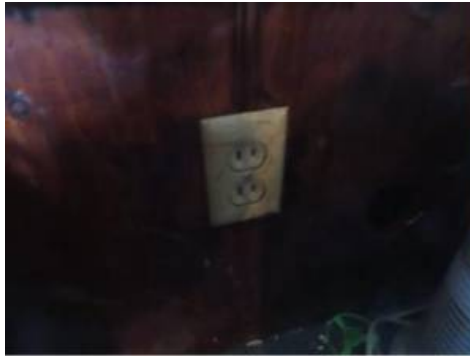
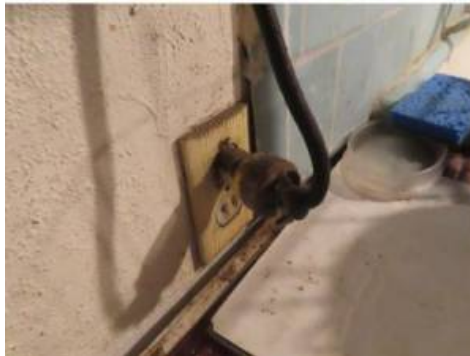
DEFECTIVE: Cover plate is missing or damaged at one or more locations. Risk of accidental contact with energized parts. We recommend installing or replacing damaged cover plates as needed at this time.

Kitchen. Stove and refrigerator share the same outlet.

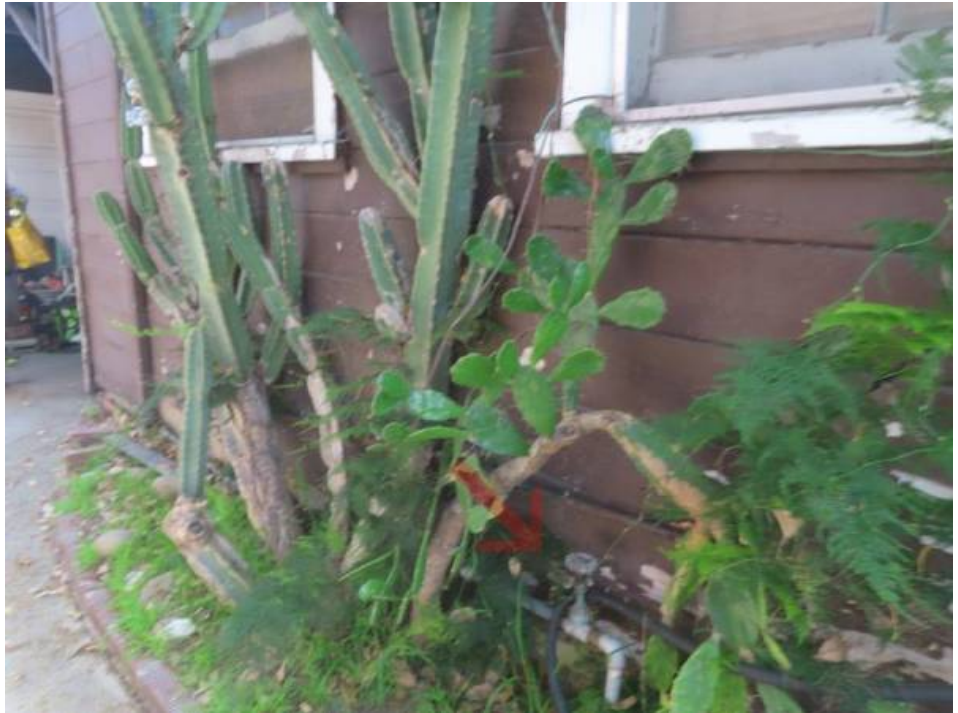
*Main shutoff valve*

Present, not operated.

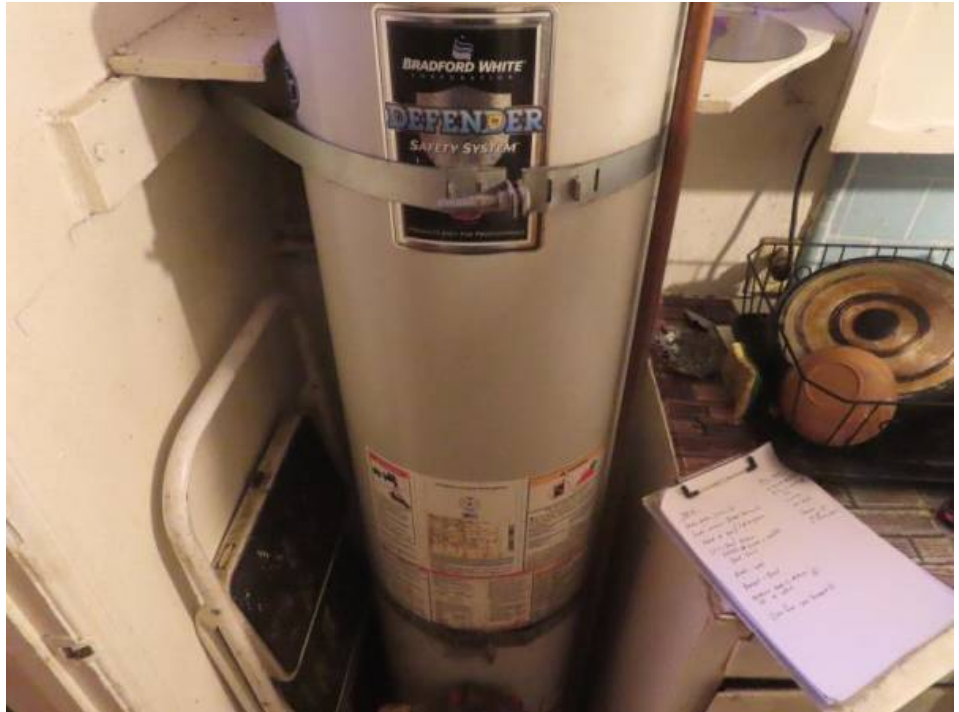
<i>Location</i>	Laundry room.
<i>Year of manufacture</i>	2008.
<i>Capacity</i>	30 gallons.
<i>Fuel</i>	Natural gas.
<i>Seismic bracing</i>	SERVICEABLE.

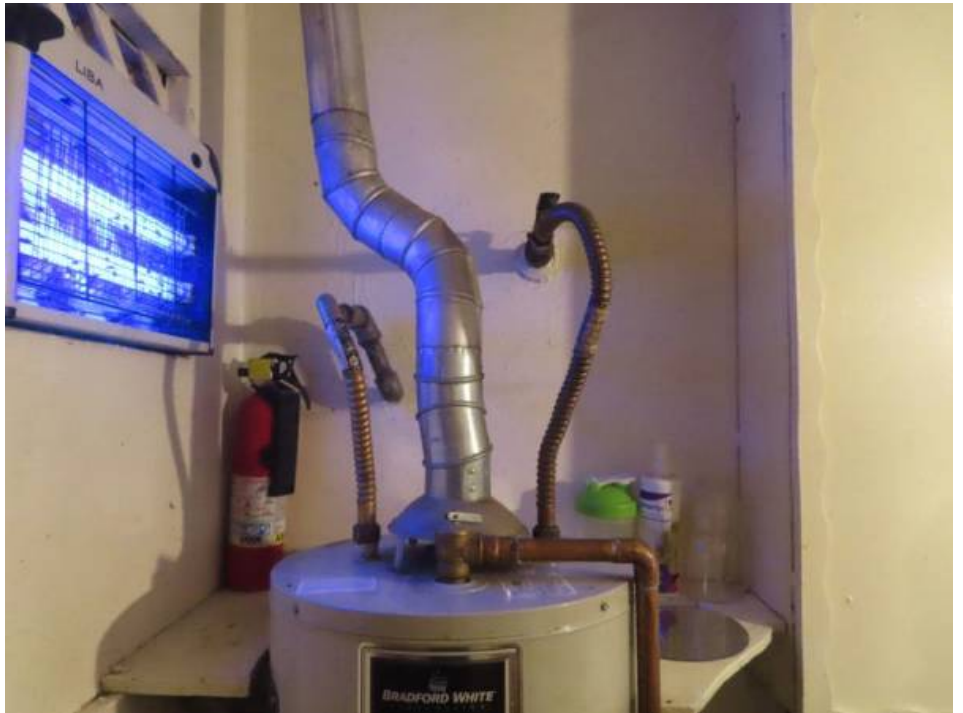
*Water connections*

SERVICEABLE.

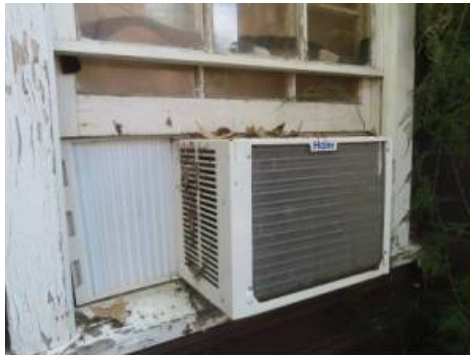
Bedroom.

DEFERRED: Window mounted or other non central cooling present. These are not within the scope of our inspection and are not inspected.

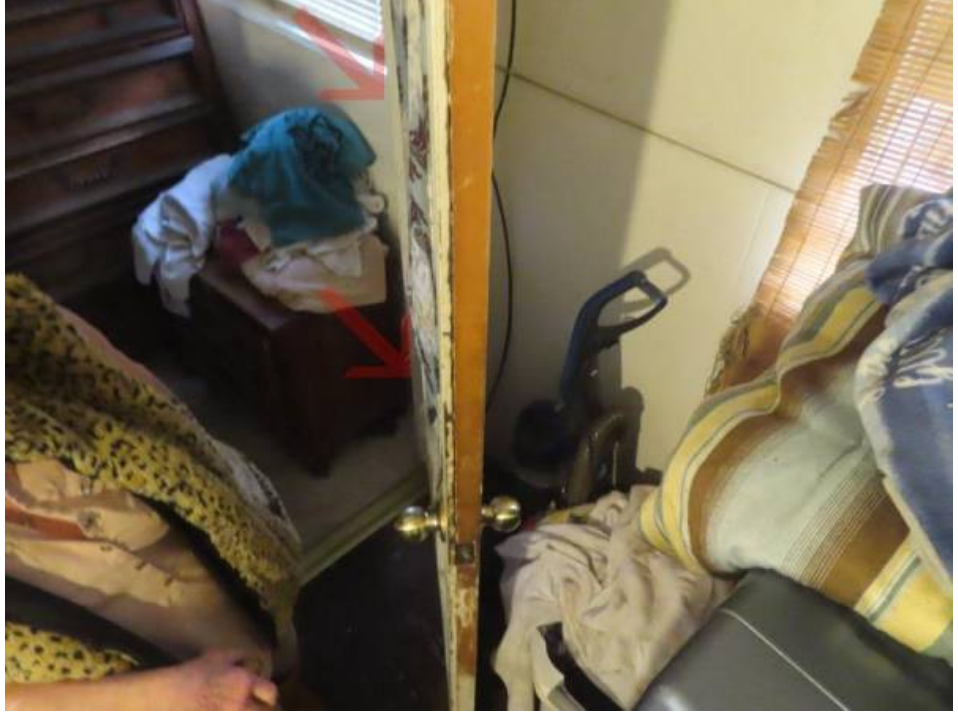
*Interior doors*

MAINTENANCE: Some doors rub, stick or don't latch. Some shaving/trimming/adjustment is needed.

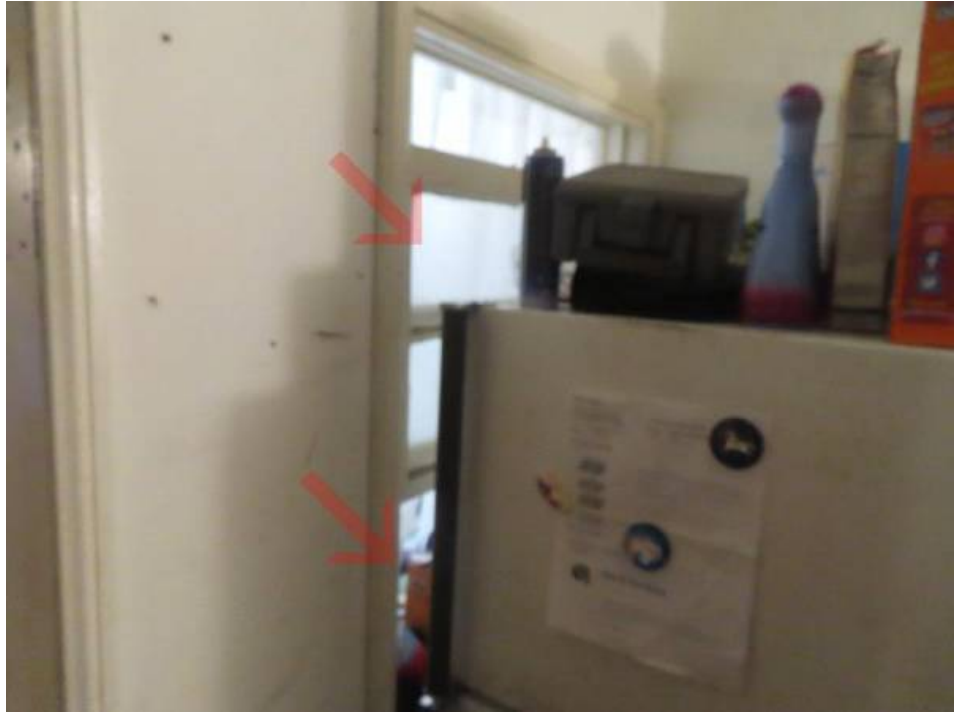
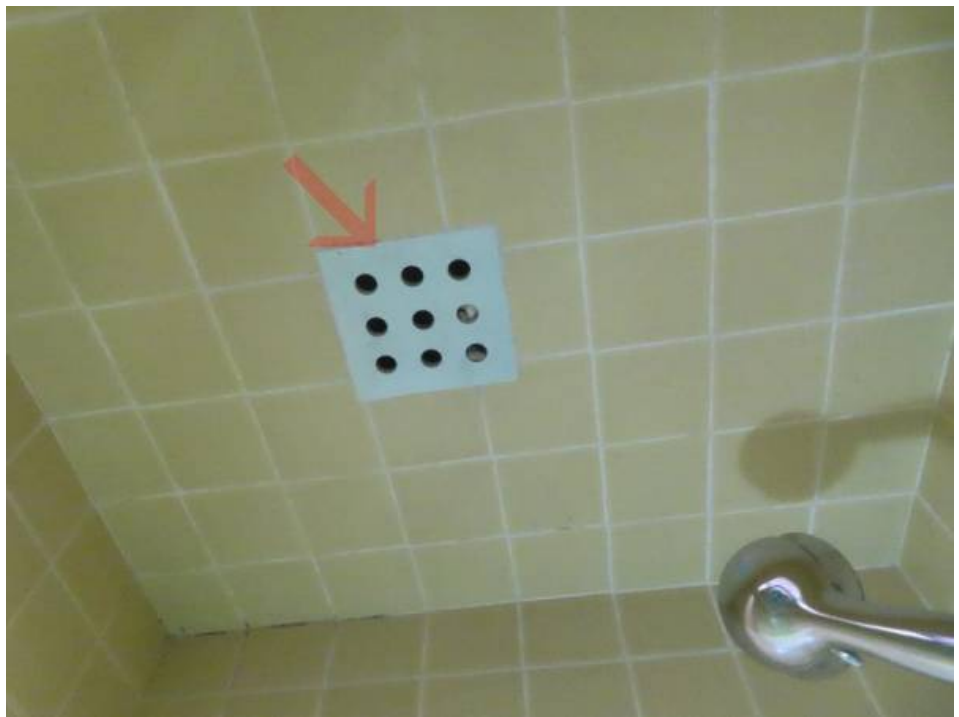
2nd bedroom.  
Window is into hallway, not to exterior.  
SERVICEABLE. Ventilation shaft.

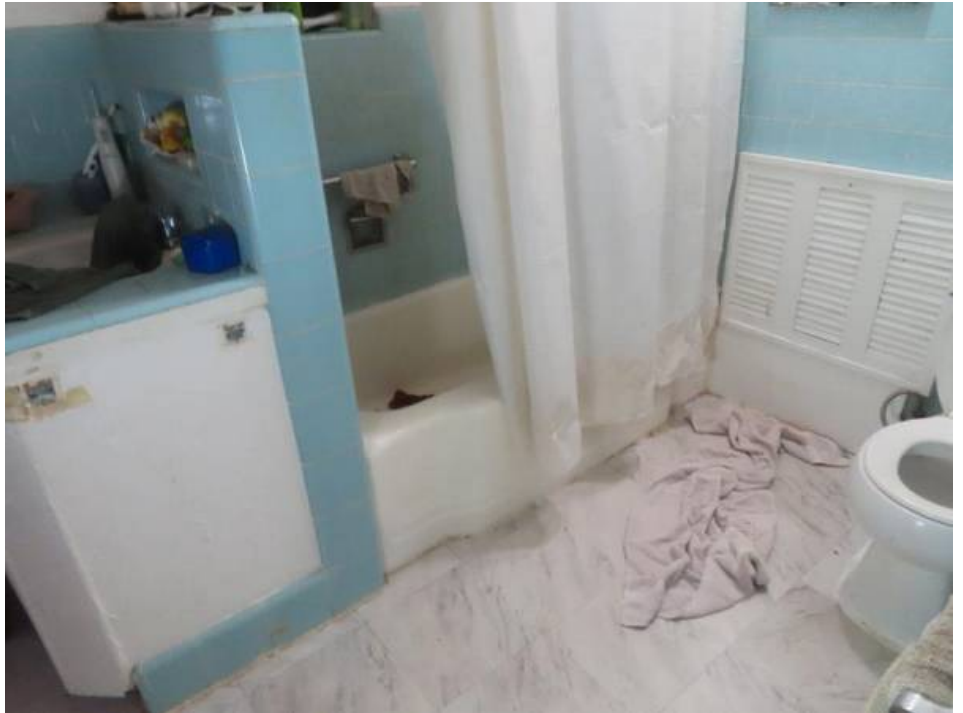
Master bathroom,  
Full bath.

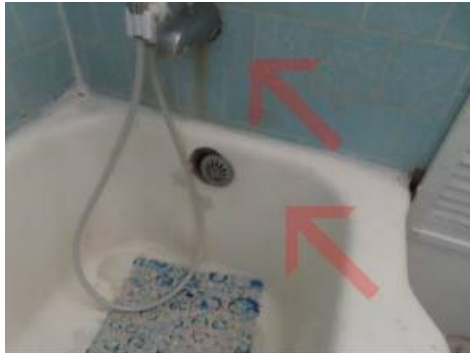
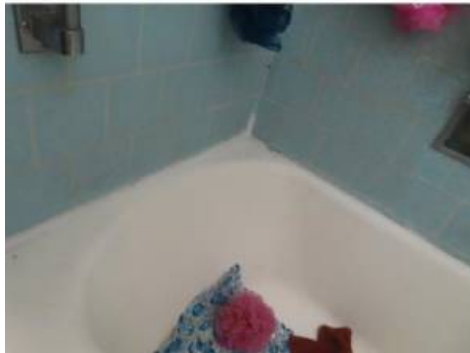
Master bath.  
Glaze is peeling.

SERVICEABLE. Finish is chipped, peeling or possibly stained.  
Tub only, no shower installed.
