# INSPECTION REPORT

For the Property at:  
**1085 COLORADO DRIVE**  
MERCED, CA 95340

Inspection Date: Wednesday, September 24, 2025

RE: Report No. 8446  
1085 Colorado Drive  
Merced, CA  
95340

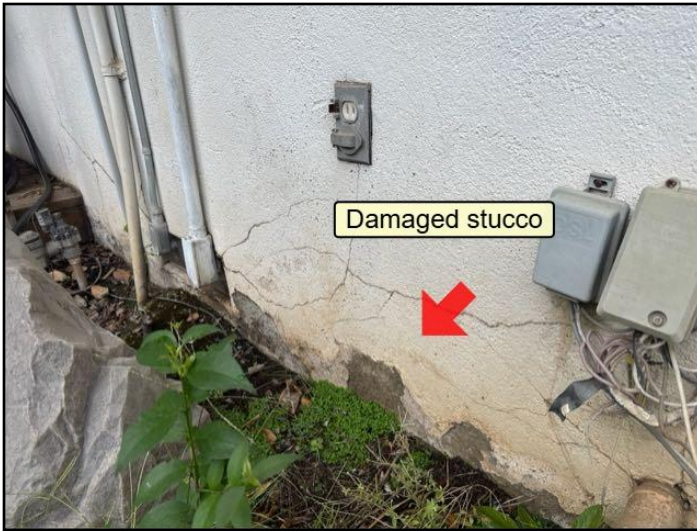
26. Crumbling

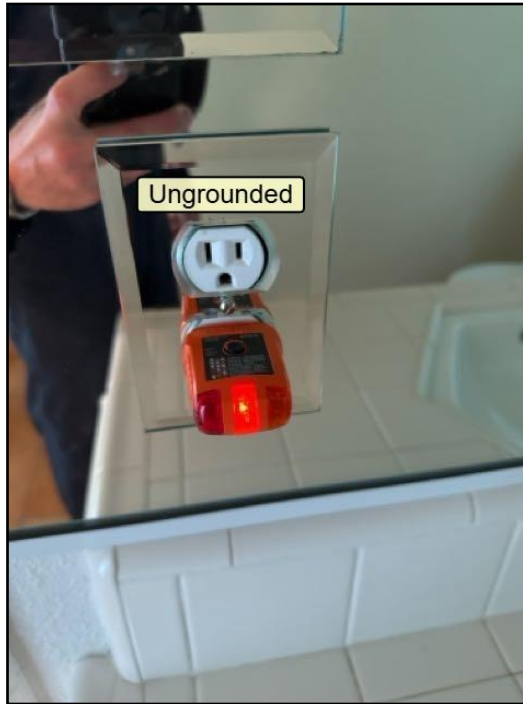
46. Ungrounded

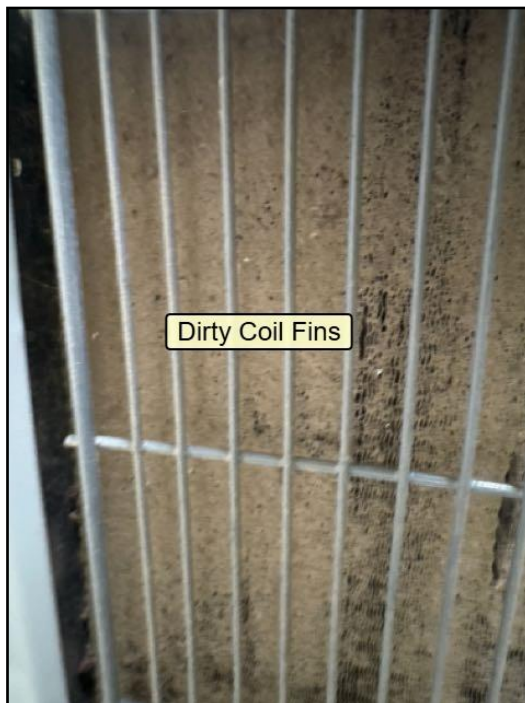
60. Coil dirty

21. Condition: • [Coil dirty](#)

Condenser fins dirty. Repairs recommended by a licensed contractor.

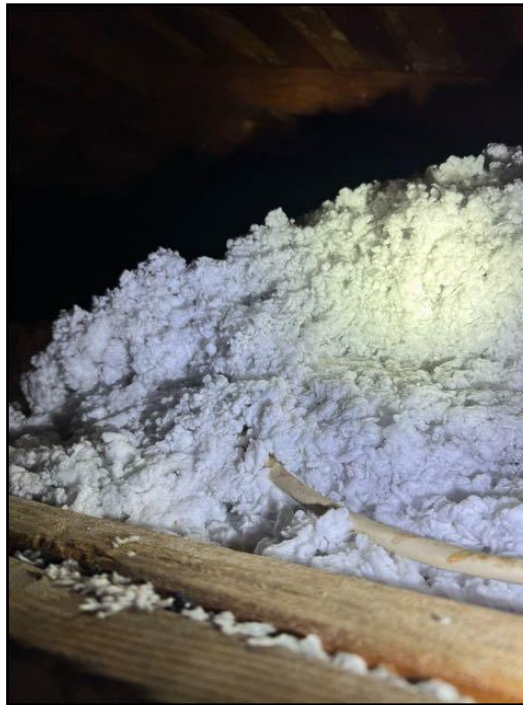
61. Blown-in Fiberglass

- Blown-in Fiberglass
- Appears Serviceable

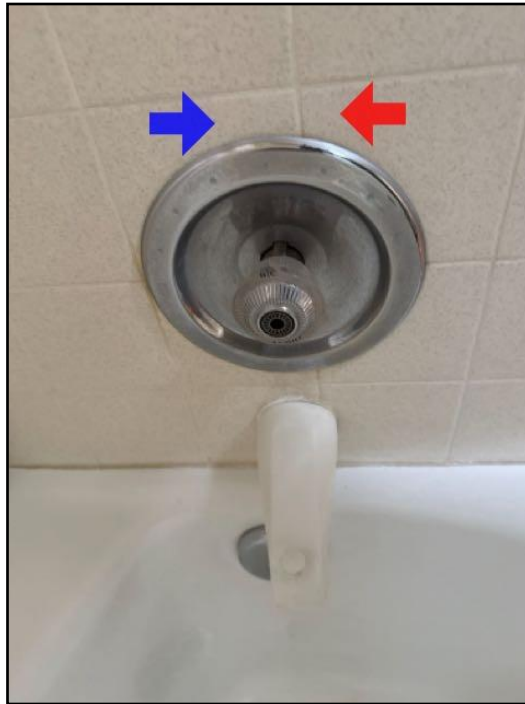
74. Hot/cold Reversed

**27. Condition:** • Hot/cold Reversed

Repairs are recommended by a qualified handyman or a licensed plumbing contractor.

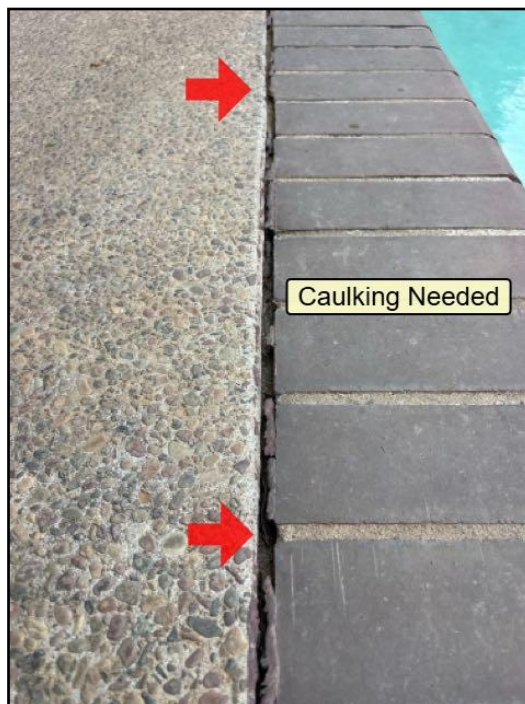
99. Caulking

44. Condition: • Caulking

Recommend caulking cracks to prevent water intrusion. Repairs recommended by a qualified handyman or a licensed pool contractor.
