INSPECTION REPORT

For the Property at:
27356 ALPEN DR
LAKE ARROWHEAD, CA 92352

Inspection Date: Friday, August 27, 2021

RE: Report No. 1107
27356 Alpen Dr
Lake Arrowhead, CA
92352

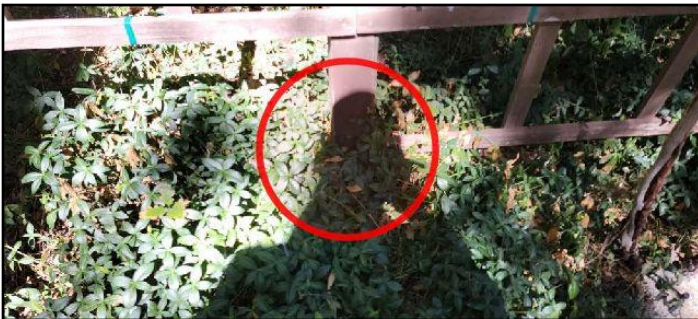
7. Condition: • [Wood/soil contact](#)

24. Wood/soil contact

Task: Service

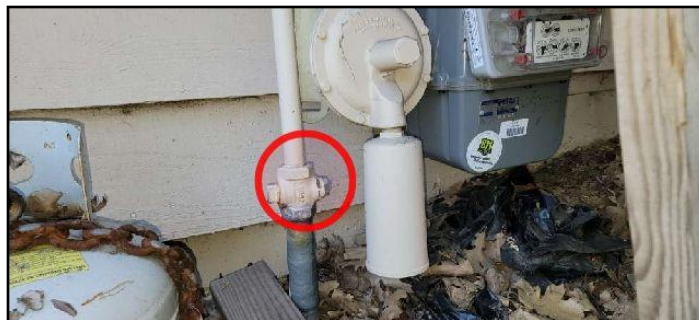
67. Gas meter

Main fuel shut off valve at the:

- Gas meter
