**KEYS  
PROPERTY INSPECTIONS**

# Inspection Report

**Property Address:**  
6557 Babcock Ave  
North Hollywood CA 91606

<b>Date:</b> 6/5/2024	<b>Time:</b> 09:00 AM	<b>Report ID:</b> 2024060501
<b>Property:</b> 6557 Babcock Ave North Hollywood CA 91606	<b>Customer:</b> Casey Covenant	<b>Real Estate Professional:</b> Casey Covenant

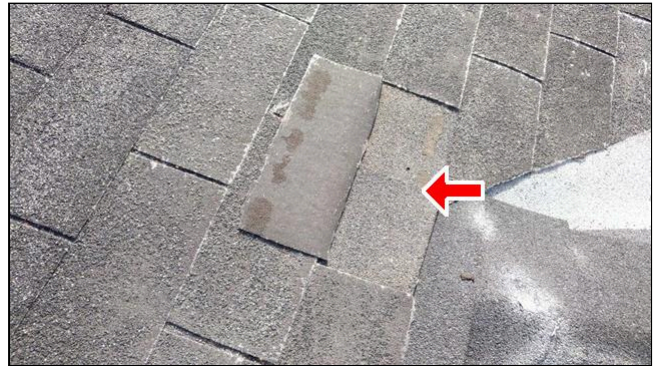
1.0 Item 2(Picture)

(2) Areas of temporary repairs, missing / damaged roofing material, uplifted roofing material and general wear observed at rooftop surfaces. Maintenance and further review by a qualified roofer is recommended at this time.
-

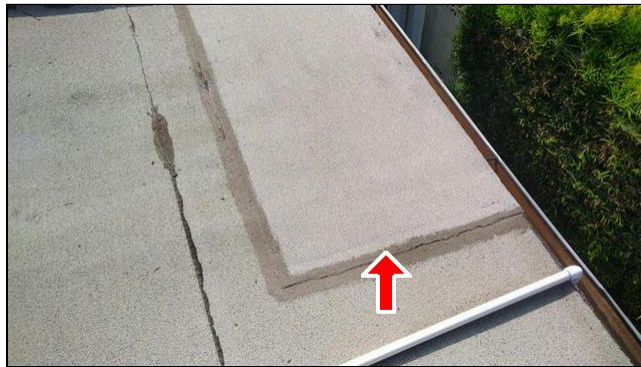
1.0 Item 6(Picture)

(3) Evidence of repairs observed. We are unable to determine the cause or effectiveness of these repairs.

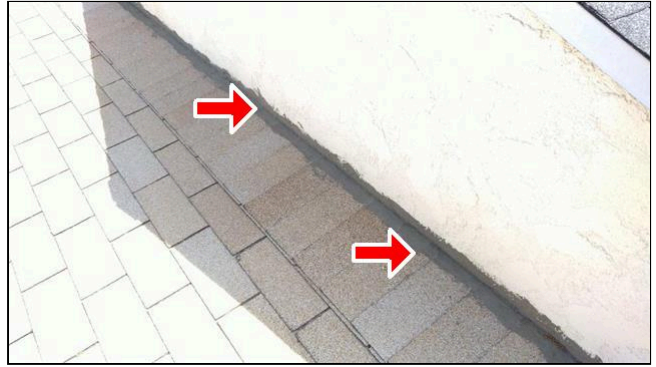
1.1 Item 2(Picture)

Improper flashing installations observed in a number of areas. Recommended correcting.

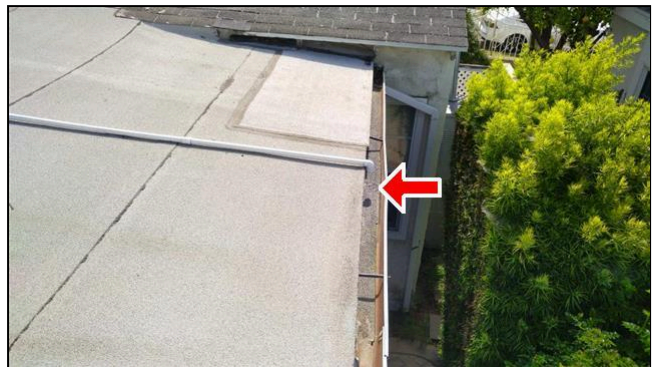
1.3 Item 2(Picture)

(1) Rear gutter is rusted / deteriorated and missing end cap. Recommend maintenance.

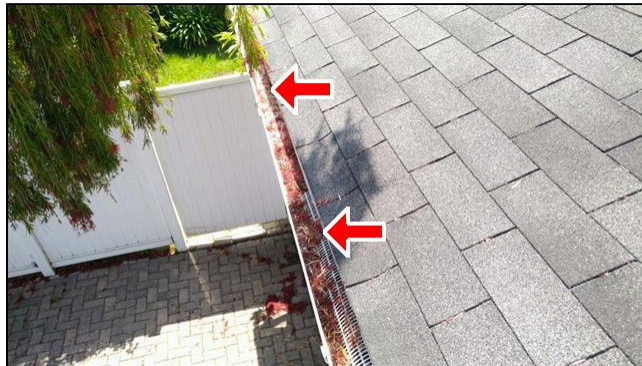
1.3 Item 4(Picture)

(2) Garage roof gutter is clogged / covered with debris. Suggest maintenance.

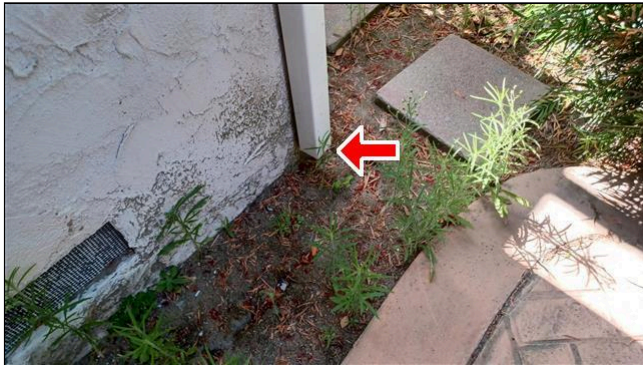
1.3 Item 5(Picture)

🏠 (3) Kickouts are not installed to divert water away from the structure. Recommend installing.

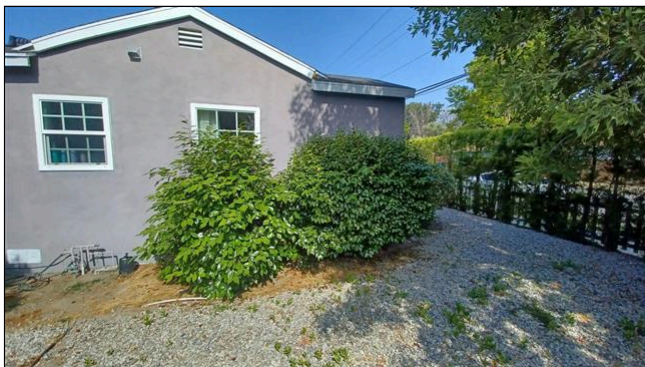
2.0 Item 4(Picture)

(3) Vegetation is contact with the wall cladding in areas. Suggest maintenance.

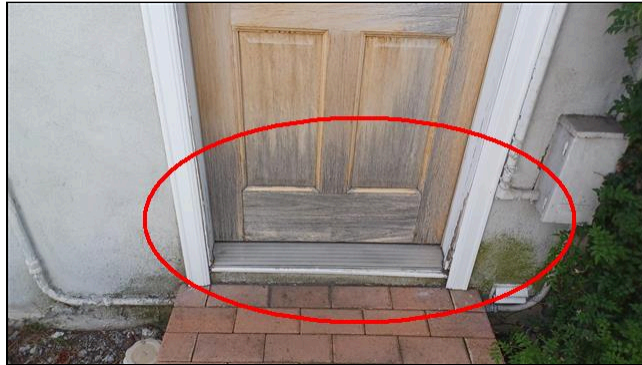
2.1 Item 1(Picture)

The rear exterior door/door frame is weathered and generally worn. Suggest maintenance.

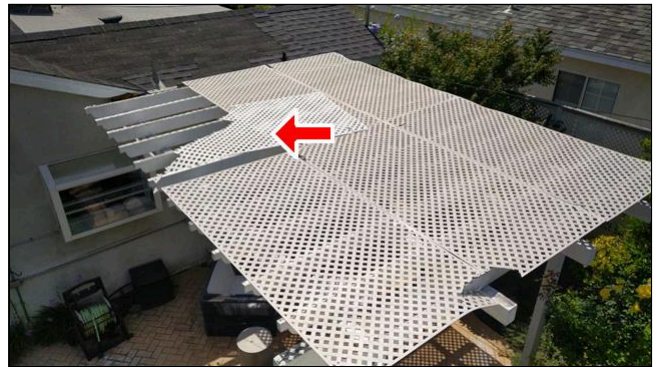
2.3 Item 2(Picture)

(1) Deterioration/damaged observed at patio trellis framing and cover. Recommend repairs.

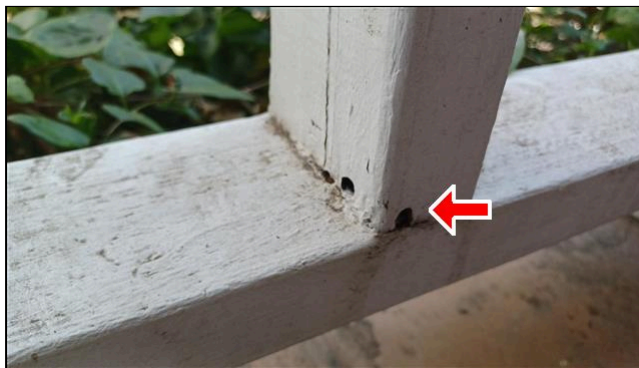
2.3 Item 4(Picture)

📍 (2) Deterioration observed at the front porch railings. Recommend correcting.

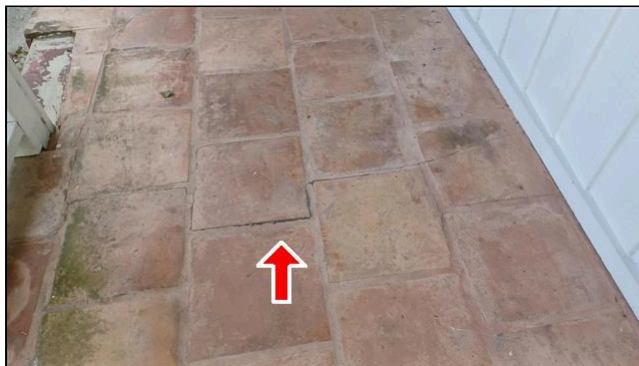
2.4 Item 2(Picture)

(1) Inadequate slope observed at front, rear, sides, and garage. This can cause or contribute to water intrusion or deterioration. I recommend correcting landscape or the installation of area drains to divert moisture away from structure.

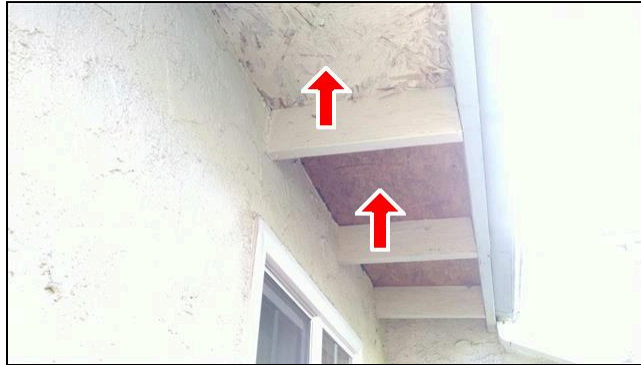
2.5 Item 1(Picture)

(1) Improper plywood soffit application observed at left side. Suggest correcting.

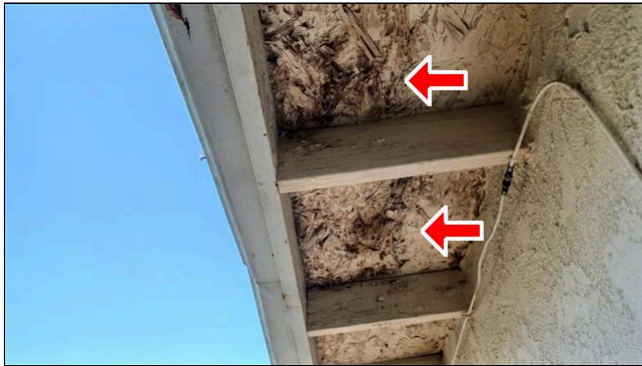
2.5 Item 2(Picture)

📍 (2) Wood damage/deterioration observed in a number of areas. Further review by a qualified termite specialist is recommended at this time.

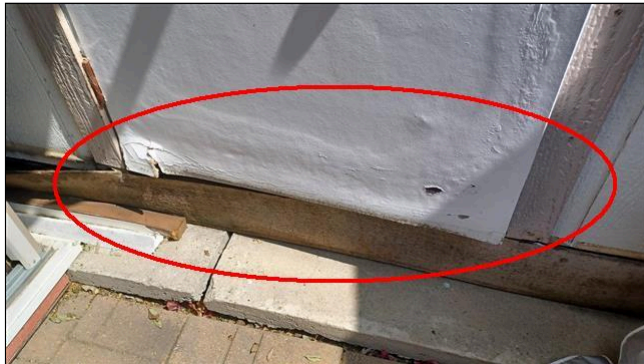
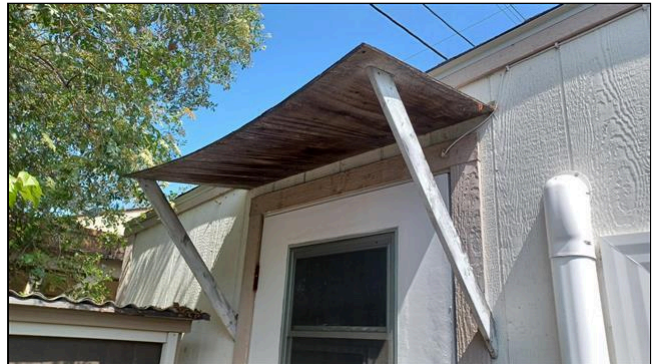
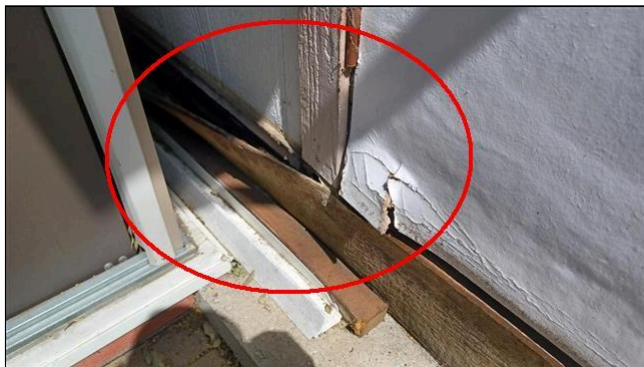
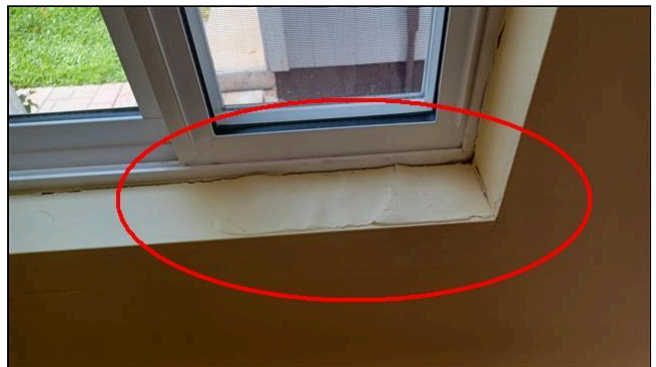
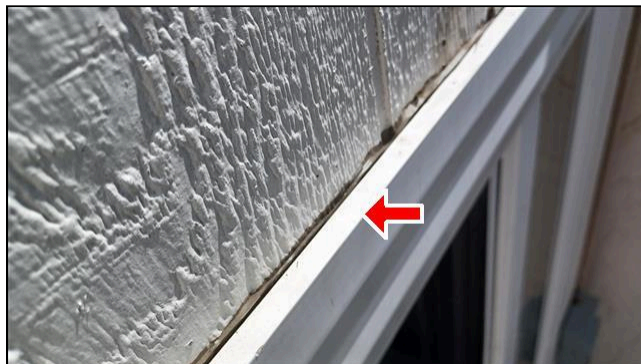
🏠 (2) Inspection of outbuildings and storage sheds are beyond the scope of this inspection. However deterioration was observed at the rear studio doors, wood siding, windows frame, and overhang. Recommend repairs.

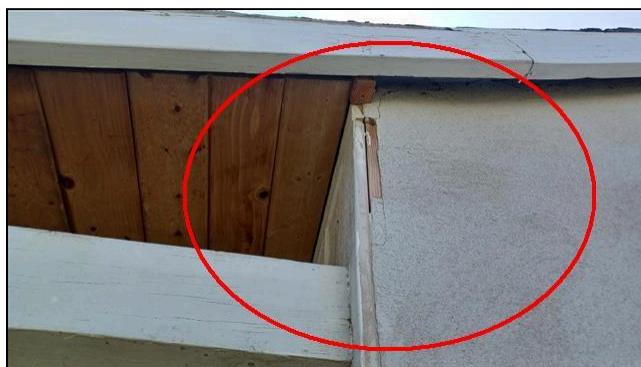
2.7 Item 8(Picture)

(3) Exposed framing components observed at the front. Suggest correcting.

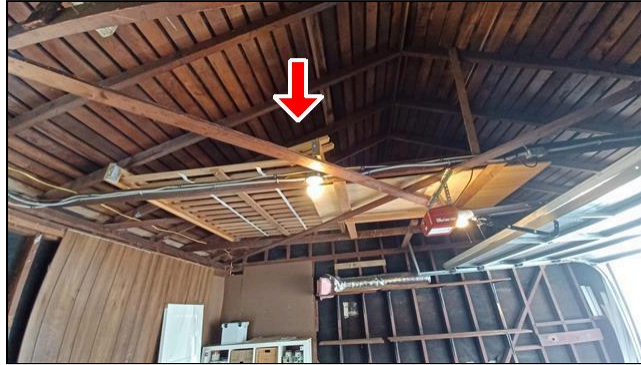
3.0 Item 1(Picture)

🏠 (1) Storage racks are hung from roof framing at garage. Recommend correcting or installing supporting structural members by a qualified contractor/roofer.

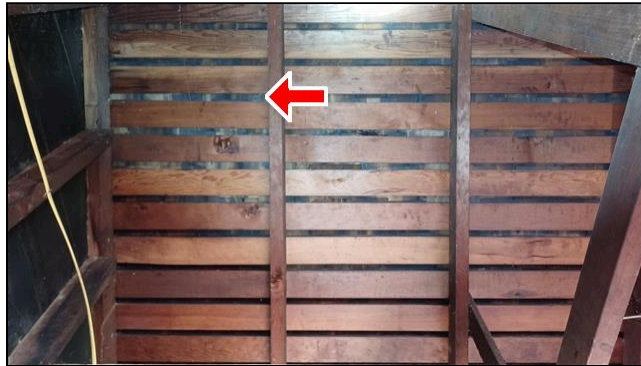
3.0 Item 2(Picture)

🏠 (2) Wood shakes/shingles are installing under newer roofing material. Recommend correcting.

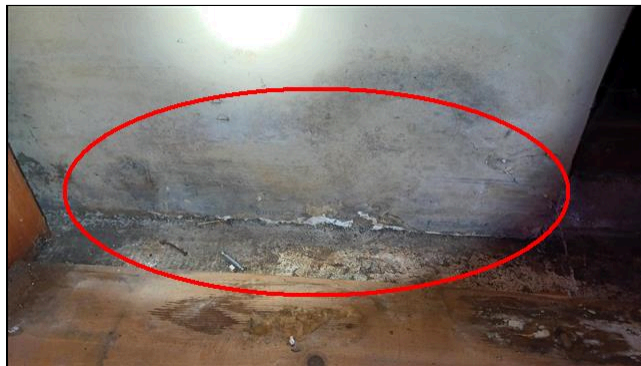
3.1 Item 1(Picture)

🏠 Moisture damage/moisture intrusion observed at the garage wall. Recommend repairs.

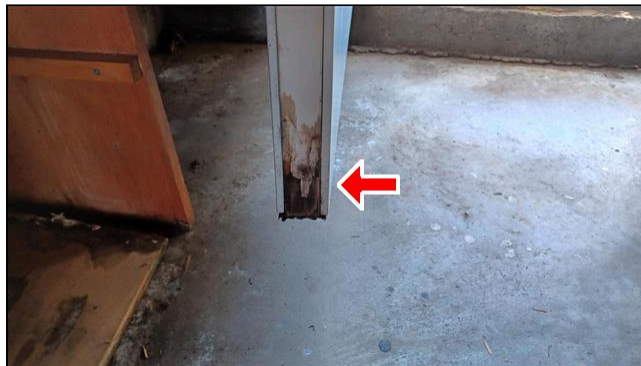
3.4 Item 1(Picture)

Deterioration observed at the garage service door. Suggest maintenance.

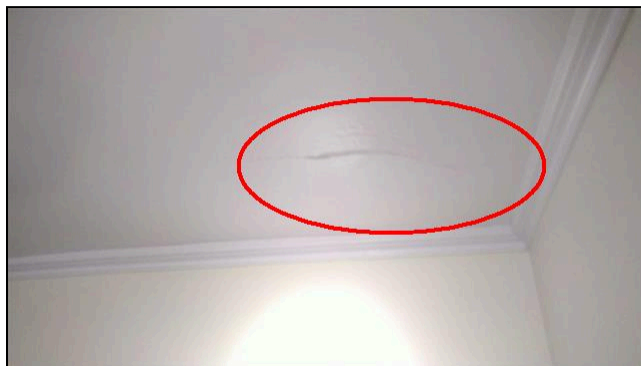
4.0 Item 1(Picture)

🏠 (1) Moisture staining observed at the kitchen ceiling. Recommend repair and correcting condition.

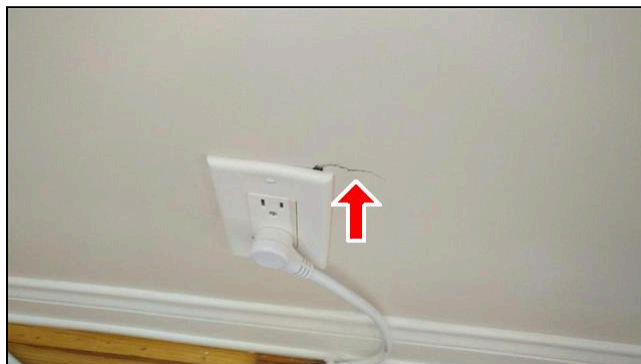
4.0 Item 2(Picture)

(2) Typical cracking observed at the walls/ceiling in a number of areas. Repairs are suggested.

(3) Minor damage and blemishes observed in a number of areas. Suggest maintenance.

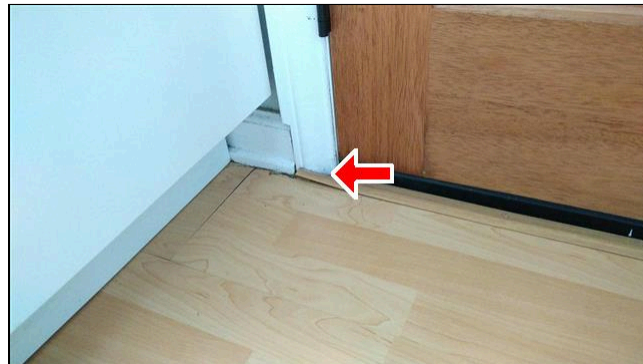
4.1 Item 2(Picture)

(3) Damaged/lifted floor trim observed at laundry exterior door. Suggest maintenance.

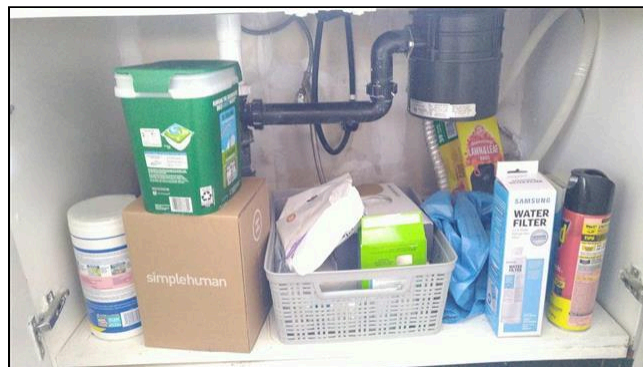
4.2 Item 1(Picture)

(1) Limited review of cabinet areas due to personal items.

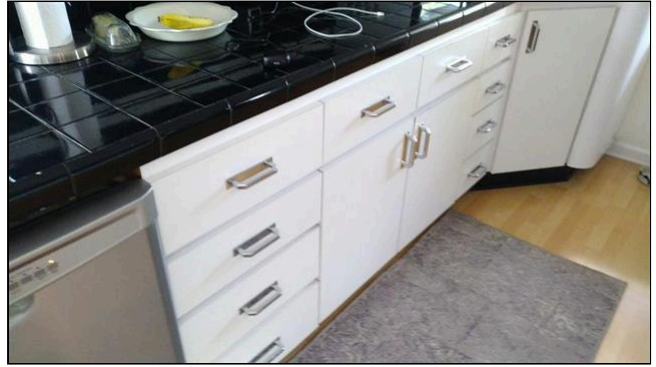
4.2 Item 3(Picture)

(2) The cabinetry is older and generally worn. Suggest maintenance or updating.

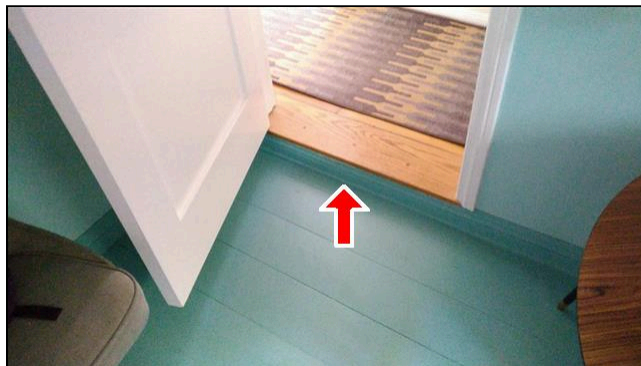
4.4 Item 1(Picture)

Door swings over step at office area. Suggest correcting.

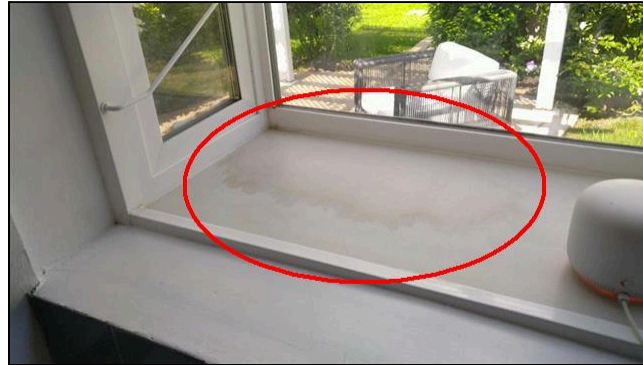
4.5 Item 1(Picture)

📍 (2) Moisture staining/leak observed at kitchen garden window. Recommend repair.

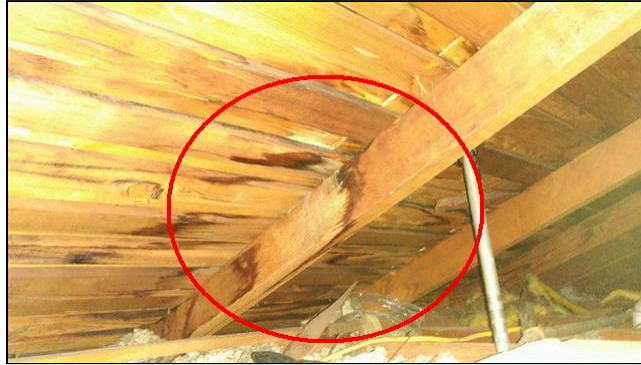
5.5 Item 1(Picture)

🏠 Moisture stains observed at the attic framing/sheathing. Further review by a qualified roofer is recommended at this time.

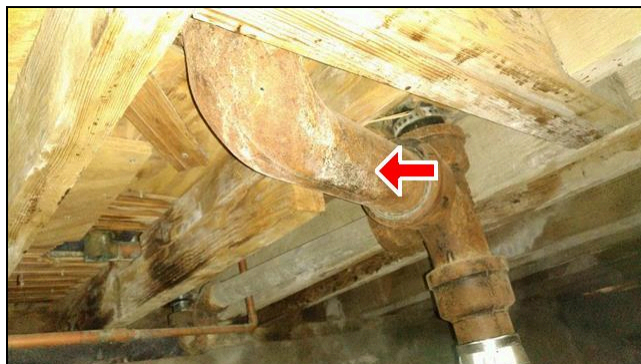
6.2 Item 1(Picture)

Cast iron/galvanized waste lines are beyond their intended service life. Suggest verifying overall condition and remaining life with a qualified plumber.

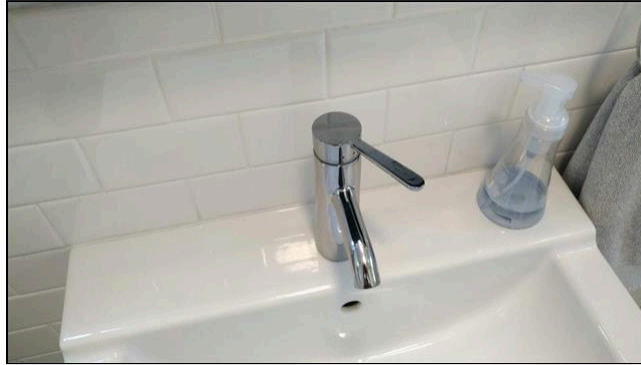
6.3 Item 1(Picture)

🏠 (1) Water hammer / vibrations observed at laundry area bathroom sink faucet. Recommend correcting.

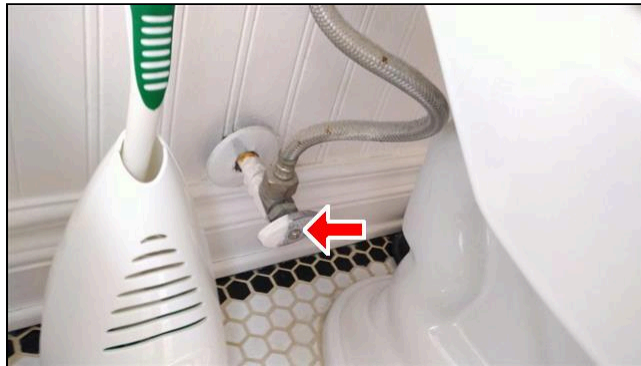
6.3 Item 2(Picture)

(2) Outdated valves observed at a number of plumbing fixture shut off locations. Suggest updating.

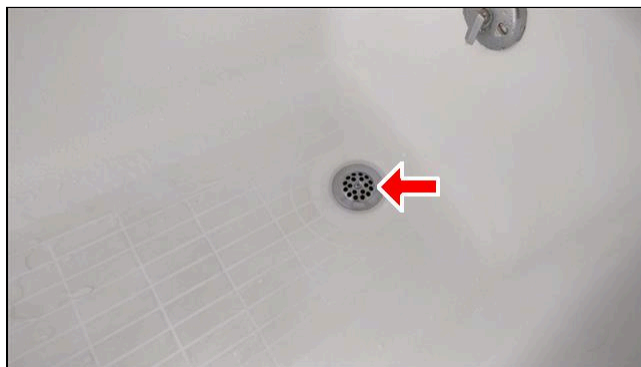
6.4 Item 1(Picture)

🏠 (1) The hallway bathroom tub drains slowly. Recommend maintenance.

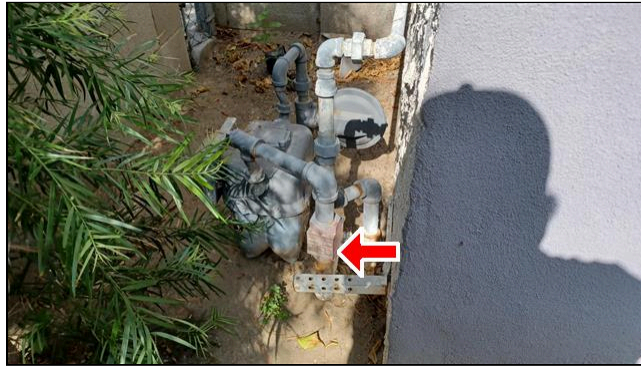
6.5 Item 3(Picture)

(3) An automatic seismic shut off valve is installed. Testing these devices and testing for gas leaks throughout the system is beyond the scope of the general inspection.

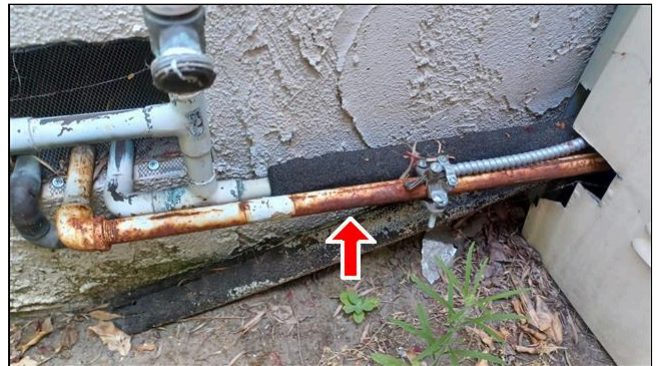
6.5 Item 5(Picture)

(4) Gas piping is corroded at a number of areas. Suggest maintenance.

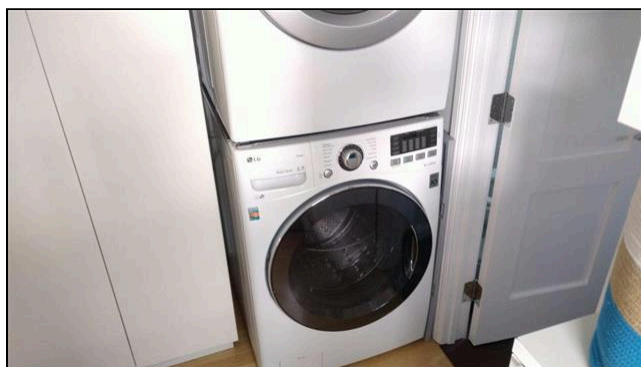
6.6 Item 1(Picture)

(1) Washer connections located. The faucet and drain were not tested. Suggest verifying condition prior to the end of the inspection period.

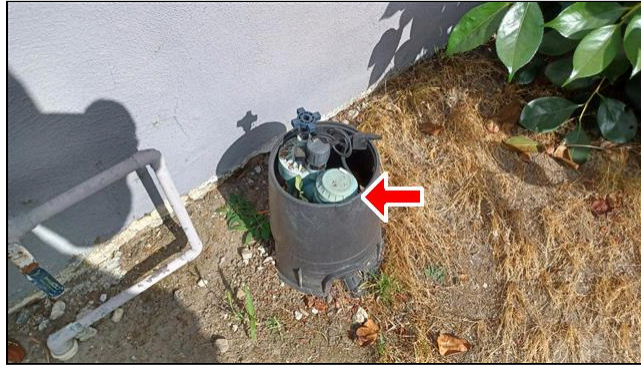
6.7 Item 1(Picture)

The sprinkler system is controlled by a timing device, which falls outside the scope of this inspection. It is Suggested to verify the system's performance.

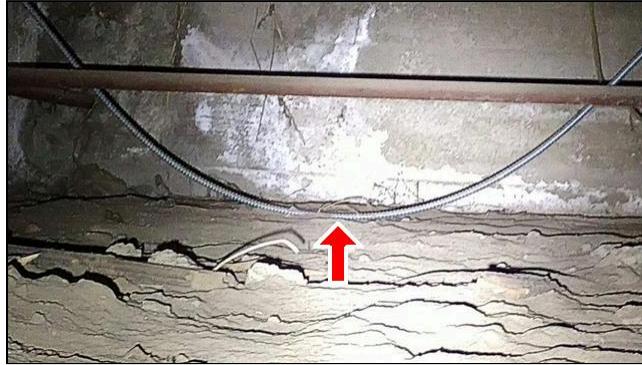
7.2 Item 4(Picture)

🏠 (3) Electrical wiring/ conduit is improperly secured and lying on crawl space floor. Recommend correcting.

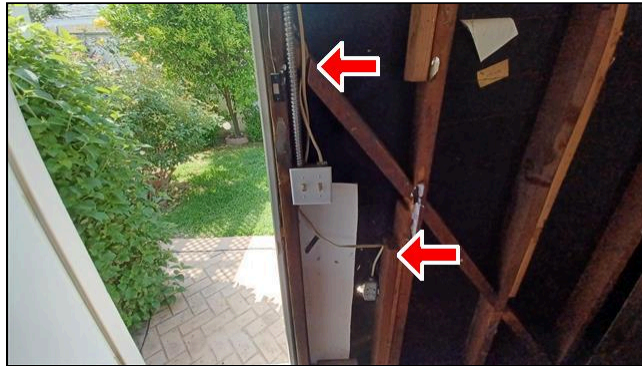
7.2 Item 5(Picture)

🏠 (4) Exposed/unprotected wiring observed at the garage . Recommend correcting.

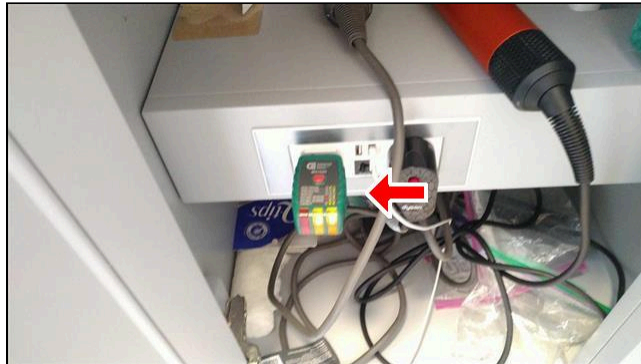
7.4 Item 1(Picture)

📌 (2) Ground fault circuit interrupted protected outlets (GFCI) are not installed at hallway bathroom cabinet and garage. Recommend correcting.

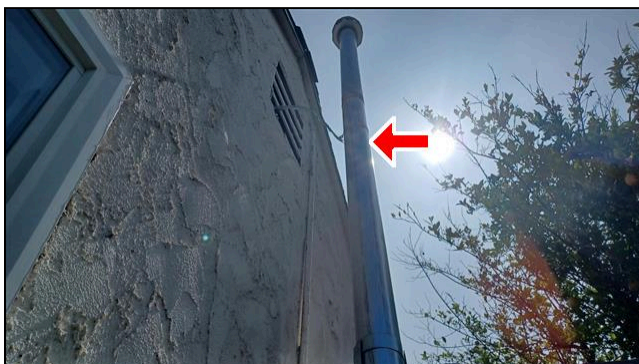
8.0 Item 1(Picture)

The vent pipe is improperly secured. Recommend correcting.

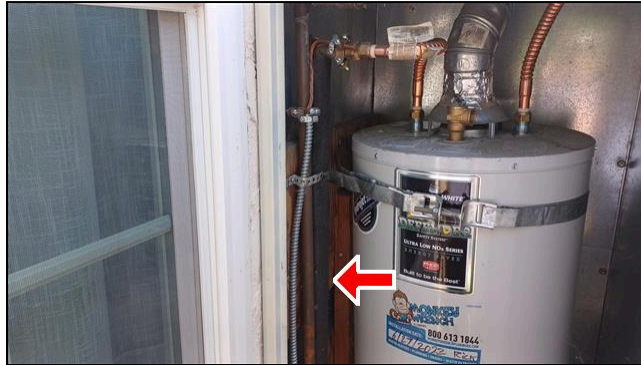
8.1 Item 1(Picture)

(1) Limited review of supply lines due to insulation wrap.

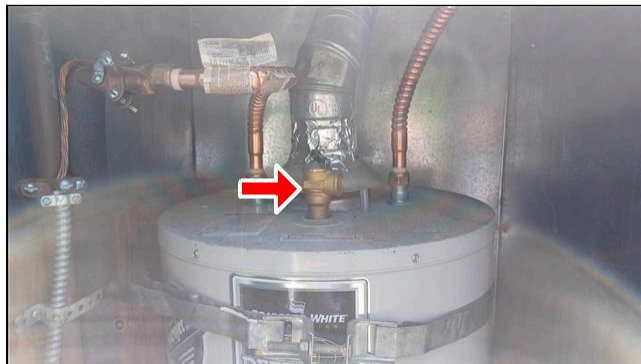
8.2 Item 1(Picture)

🏠 A temperature pressure release valve drain line is not installed- safety issue. Recommend installing.

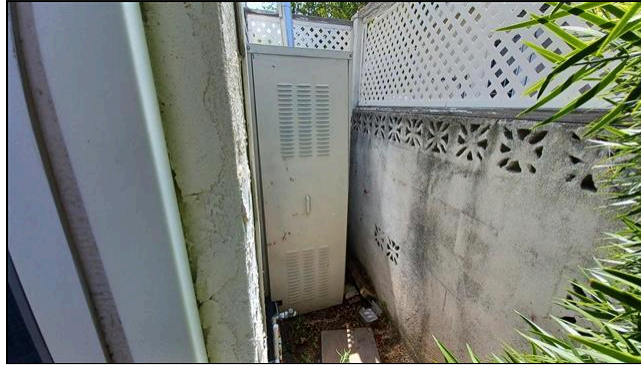
8.5 Item 1(Picture)

The water heater is installed less than 5 feet from the adjacent property. Suggest relocating.

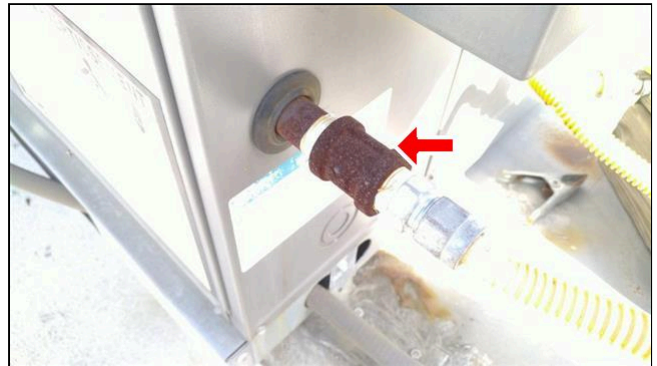
9.0 Item 4(Picture)

(3) Gas line connection at rooftop is rusted. Suggest updating.

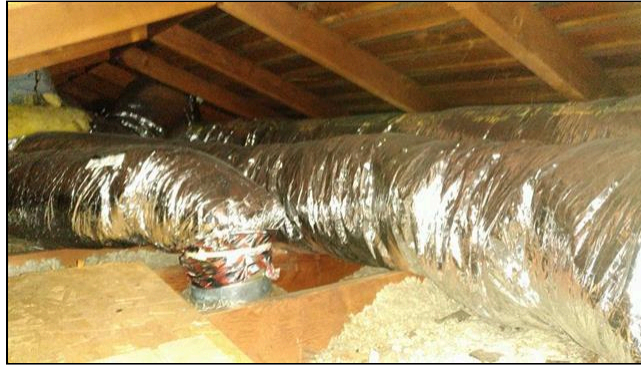
9.3 Item 2(Picture)

(3) The ductwork is improperly supported/lying on attic floor. Suggest correcting.

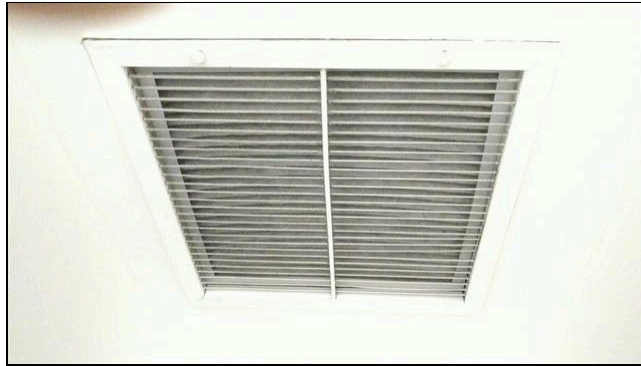
9.3 Item 3(Picture)

🏠 (4) The debris seen in the vents indicates the need for cleaning ducts. Recommend maintenance.

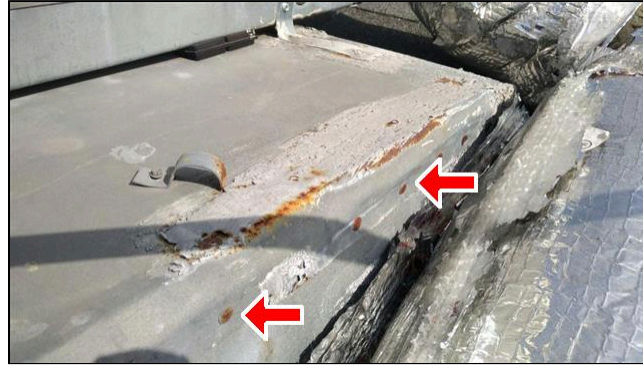
9.4 Item 2(Picture)

🏠 (3) Exposed nails / improperly sealed penetrations observed at HVAC platform. Recommend correcting.

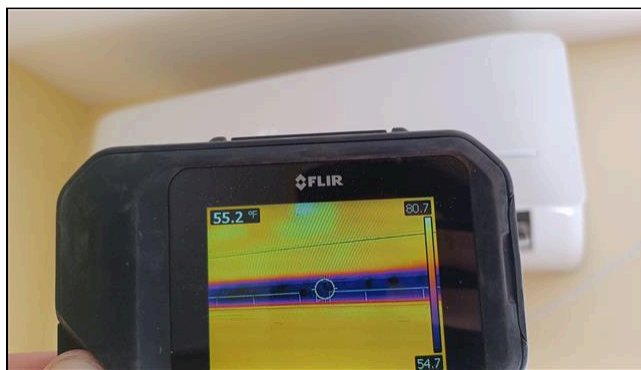
9.5 Item 6(Picture)

(6) The rear studio mini split responded to test in AC mode.

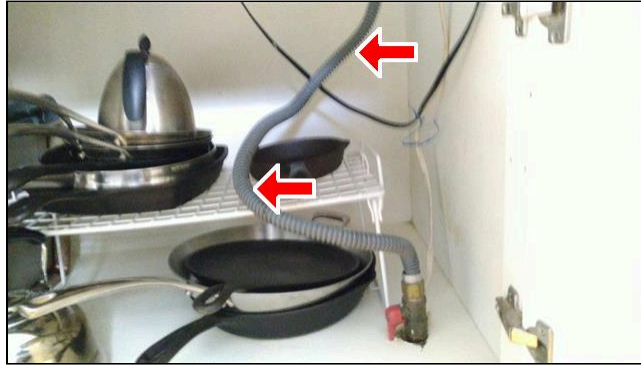
11.1 Item 1(Picture)

Gas line is exposed/vulnerable to damage at stovetop cabinet. Suggest correcting.

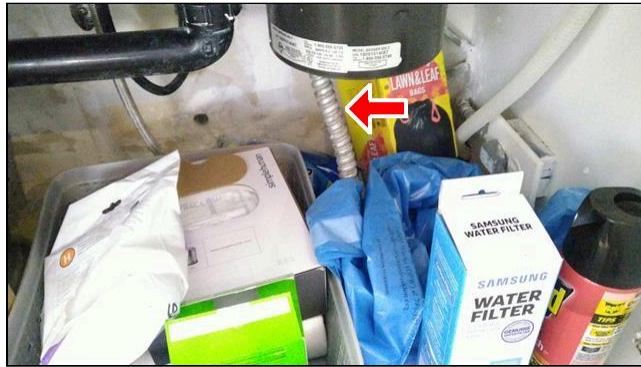
11.3 Item 1(Picture)

The garbage disposer is hard wired. Recommend installing a U.L. listed cord and outlet.

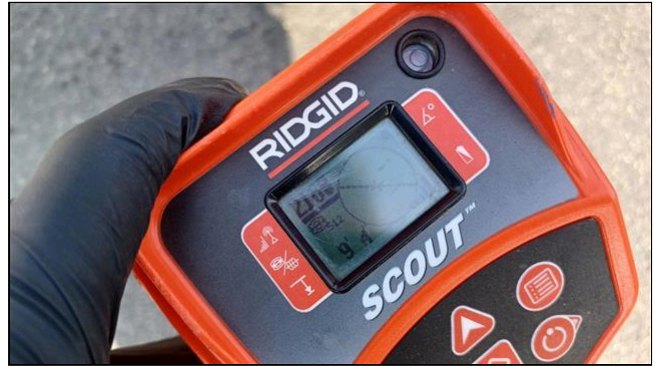
The sewer line from the left side clean-out access to the city sewer, measured at a length of 46.1 feet at a depth of 9.4 feet.

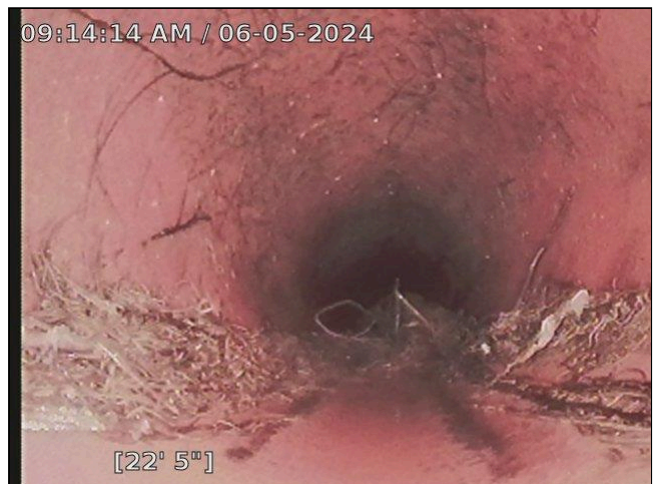
12.2 Item 2(Picture)

Root intrusion observed at joints of the sewer line. Roots are not causing blockage at the time of inspection, hydro jetting is not recommended, but will be required in the future. Root intrusion is an ongoing issue and continual maintenance will be required.
