# Titus Inspections

# **Inspection Report**

510 Harkness Ln Redondo Beach CA 90278

Property AddressDate of InspectionReport ID510 Harkness Ln7/3/2023230714-02

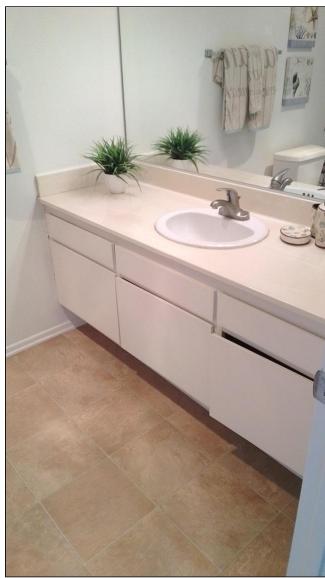
4.5 Item 2(Picture) 2nd floor primary bedroom bathroom base cabinets

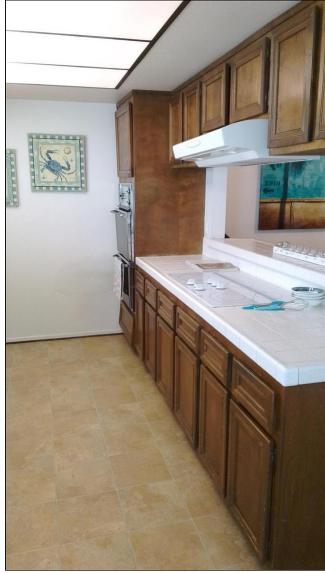
4.5 Item 3(Picture) Kitchen cabinets

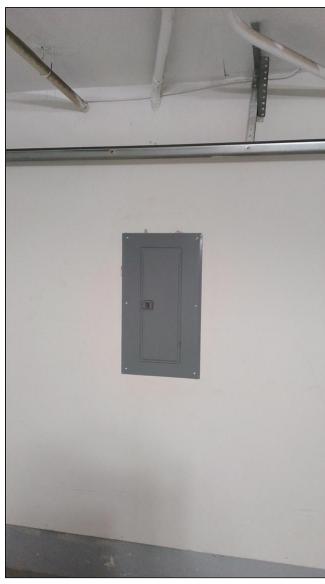
5.1 Item 2(Picture) Main distribution panel

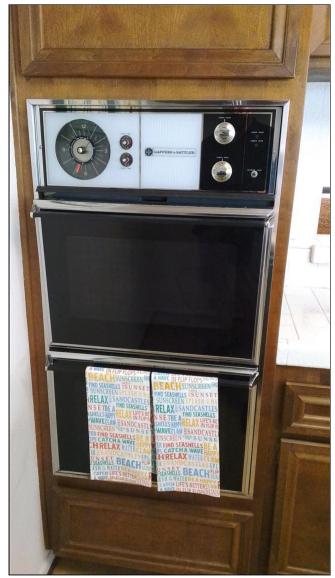
**7.1** Oven is dated but did operate at time of inspection.

7.1 Item 1(Picture) Oven

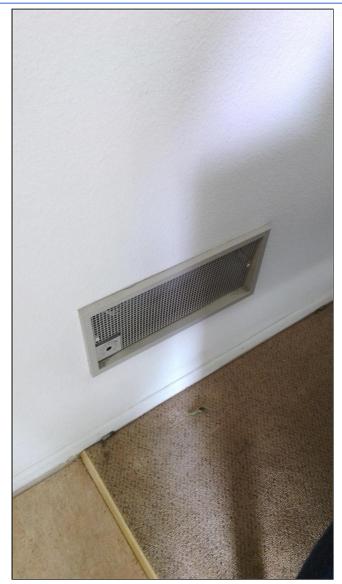
9.0 Item 5(Picture) Electric wall heater #5, living room

**9.1** (2) Electric wall heater #5 in living room did not have control knob and inspector was unable to confirm heater operation. Recommend a qualified person further inspect for repair recommendations.

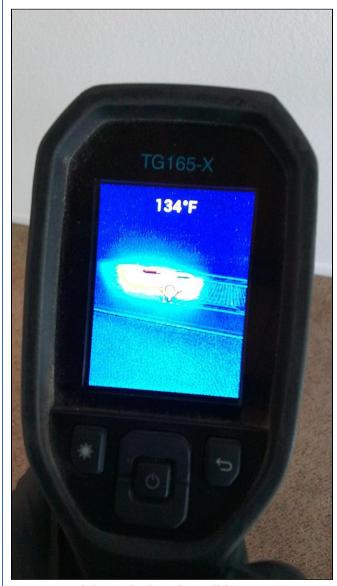
9.1 Item 1(Picture) Electric wall heater #1 temperature

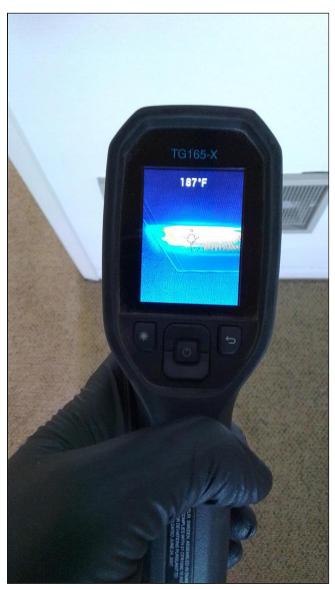
9.1 Item 2(Picture) Electric wall heater #2 temperature

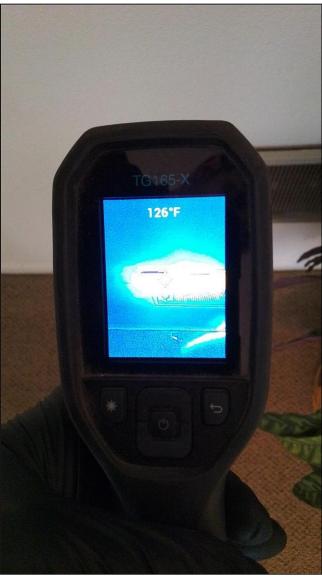
Electric wall heater #4 temperature at registers was 126 degrees at time of inspection.

9.1 Item 4(Picture) Electric wall heater #4 temperature

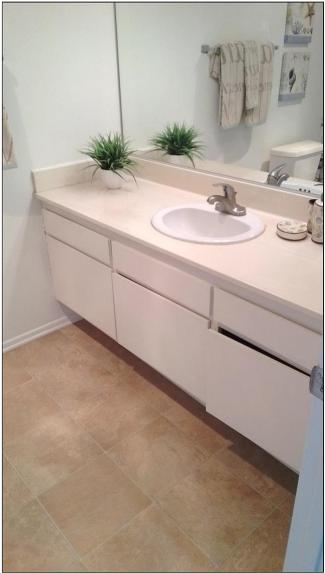
4.5 Item 2(Picture) 2nd floor primary bedroom bathroom base cabinets

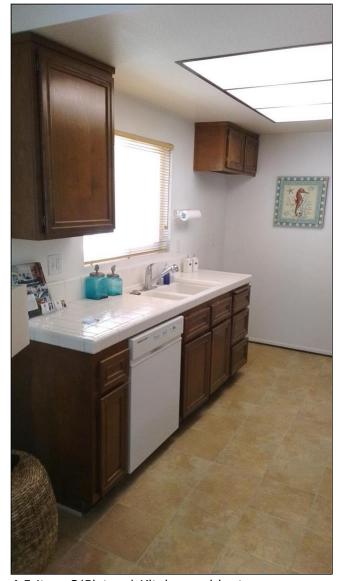
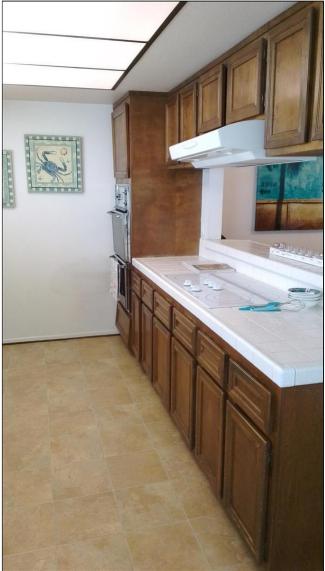
4.5 Item 3(Picture) Kitchen cabinets

4.5 Item 4(Picture) Kitchen cabinets
