Jun 8th, 2026

26284 Trails End, Long Barn, CA, 95335

Home Inspection Report

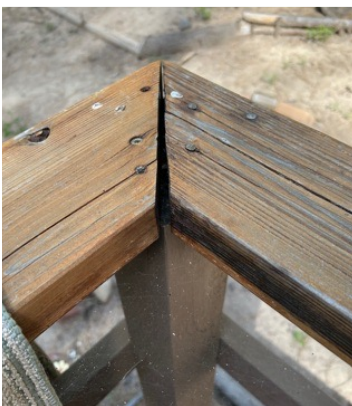
Gapping noted at deck wood members; this can allow moisture at adjacent wood members.

Marginal

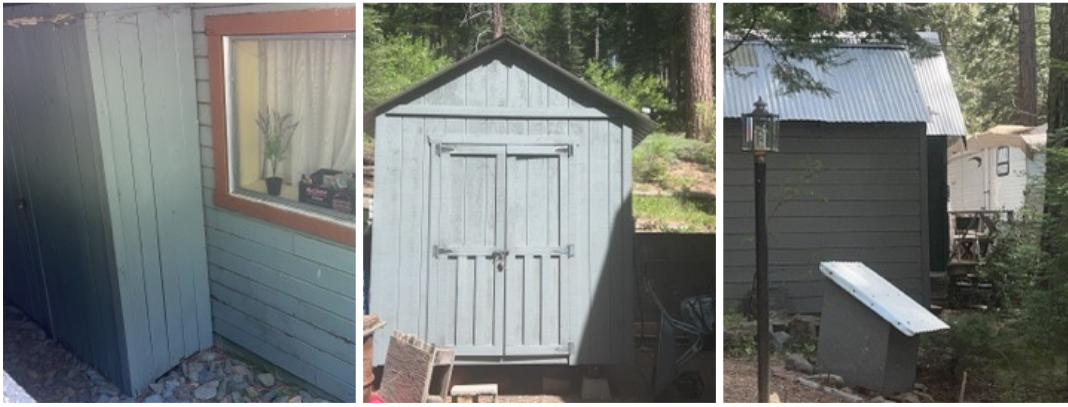
Not Inspected

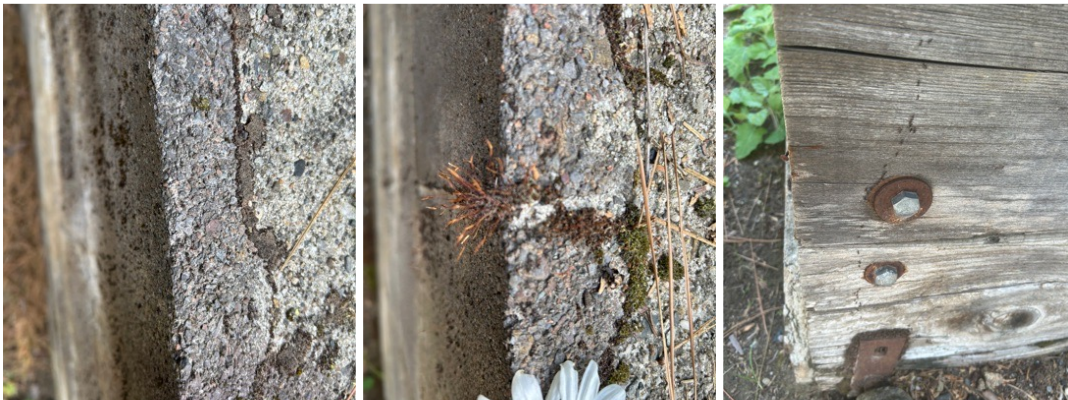
Evidence of an ant infestation was noted. No wood destroying organisms were noted so no recommendations are being given. If parties of interest desire, more information, they should contact a licensed branch 2 company.

Informational Item

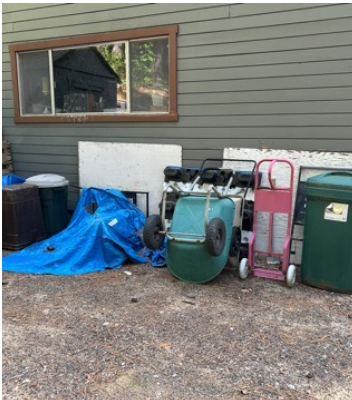
Wood deterioration is present at wood members.

Occupant belongings prevents full inspection of exterior siding.

[See Structural Pest Report](#)

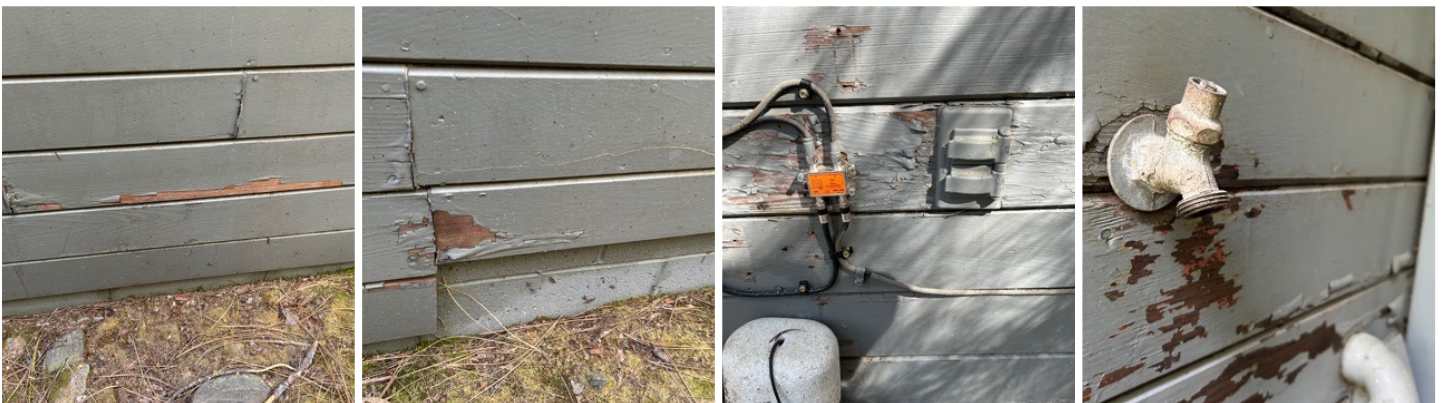
Paint peeling

Cosmetic Only

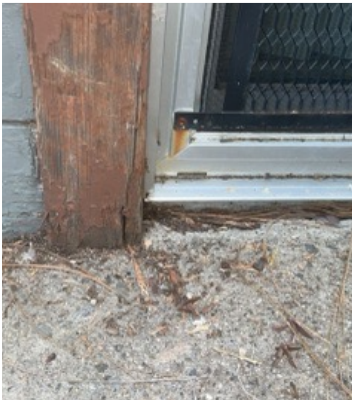
Cracks were noted at trim.

Marginal

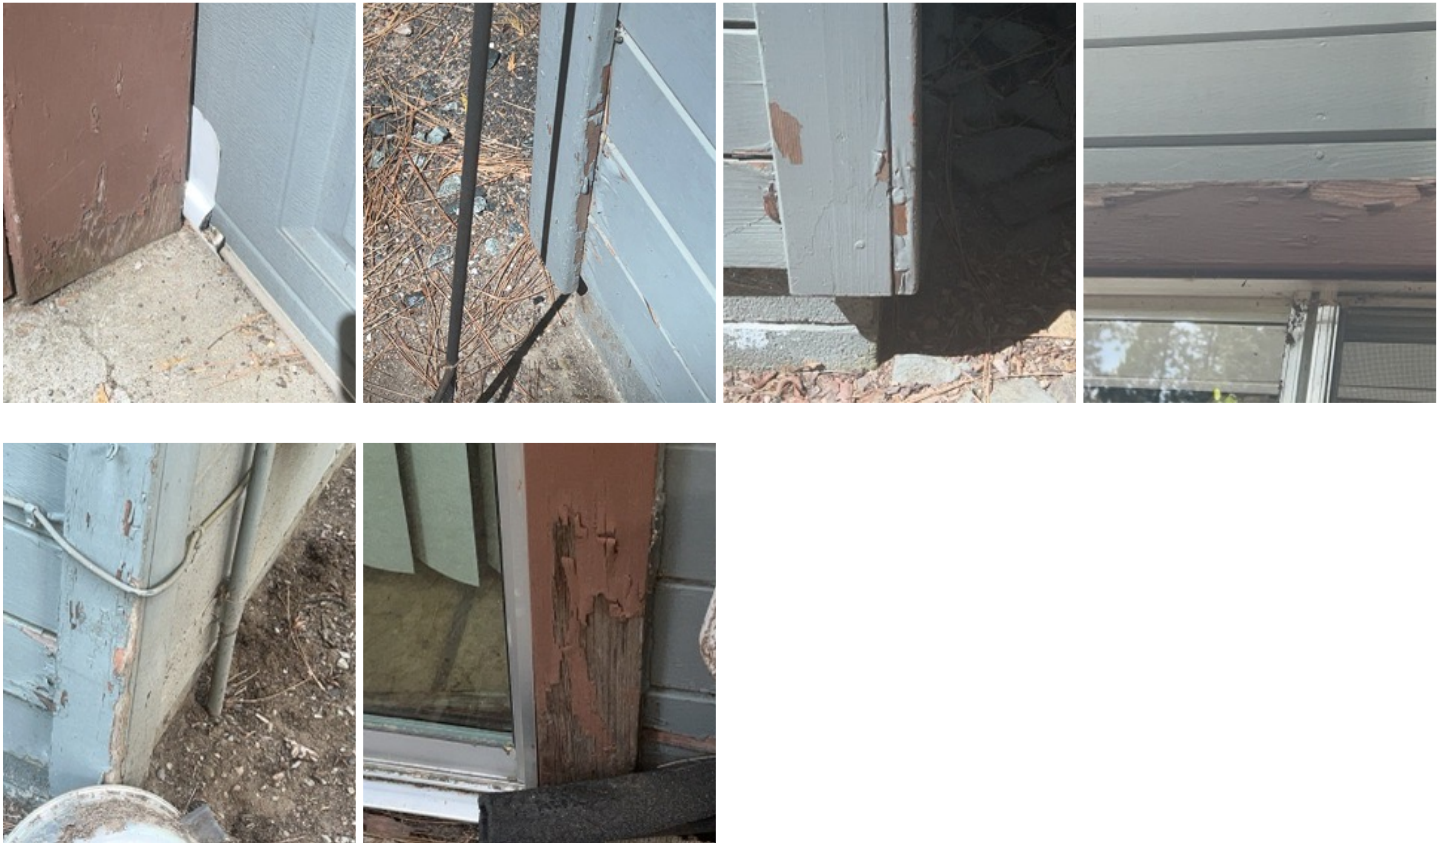
Paint peeling.

Cosmetic Only

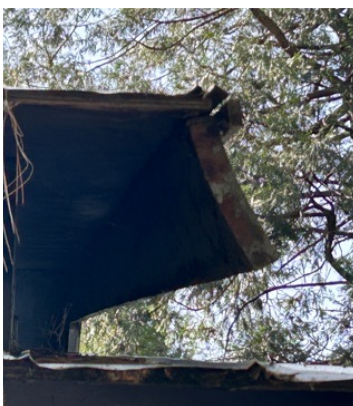
The fascia board was noted to be warped.

Marginal

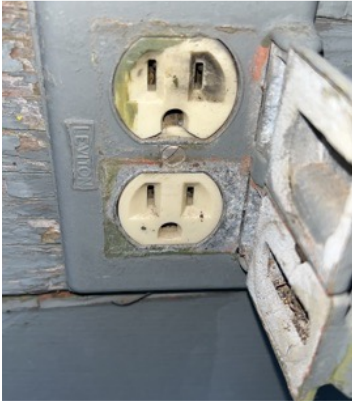
The ground portion of the three-pronged electrical outlet was noted to be broken; this will not affect functionality.

Marginal

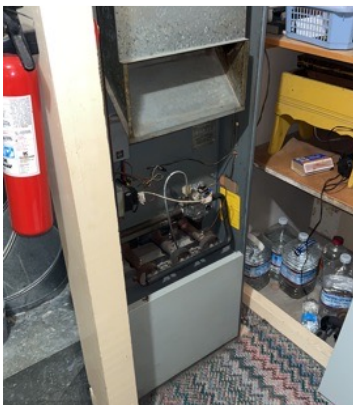
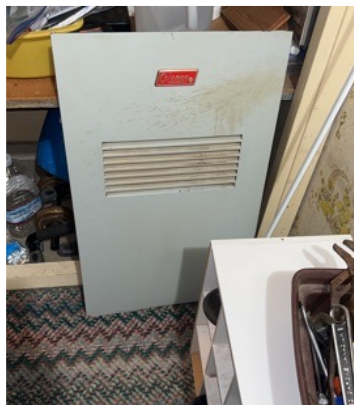
The cover plate was not secured at time of inspection.

Marginal

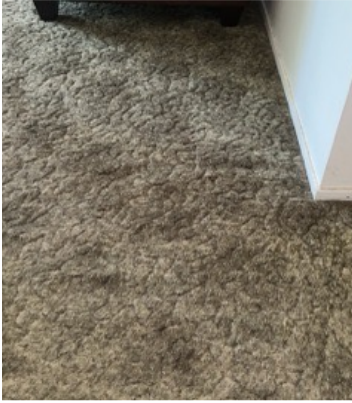
Carpet is in need of re-stretching.

Cosmetic Only

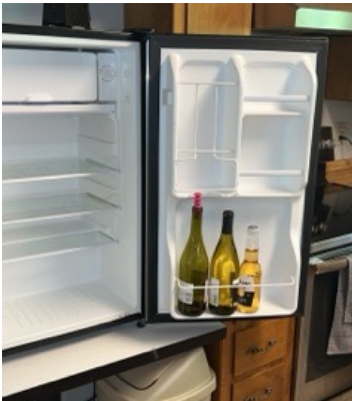
Disconnected from power and left open at time of inspection

Not Inspected

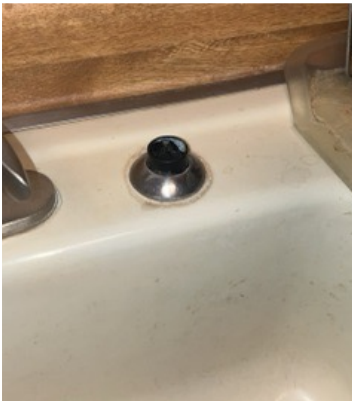
The sink spray nozzle was missing/not installed at time of inspection.

Defective

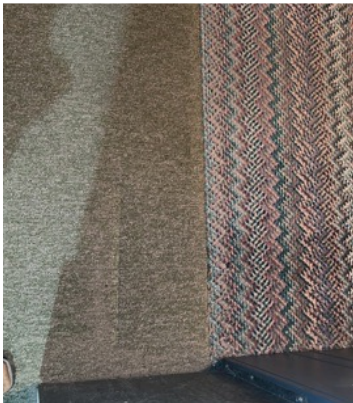
Carpet seams visible.

Cosmetic Only

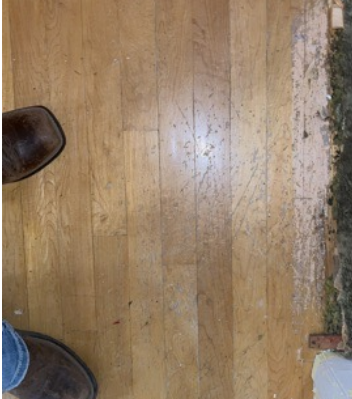
Minor damage noted at hardwood flooring.

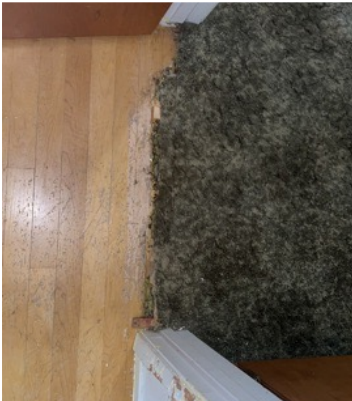
Transition strip between carpet and hard wood flooring has not been installed.

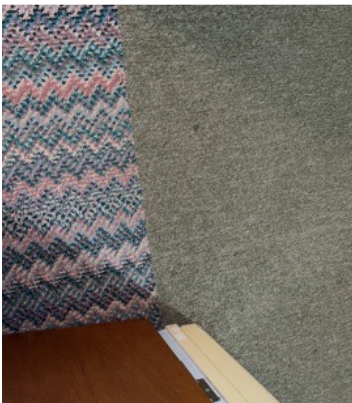
The transition strip between different types of carpet has not been installed.

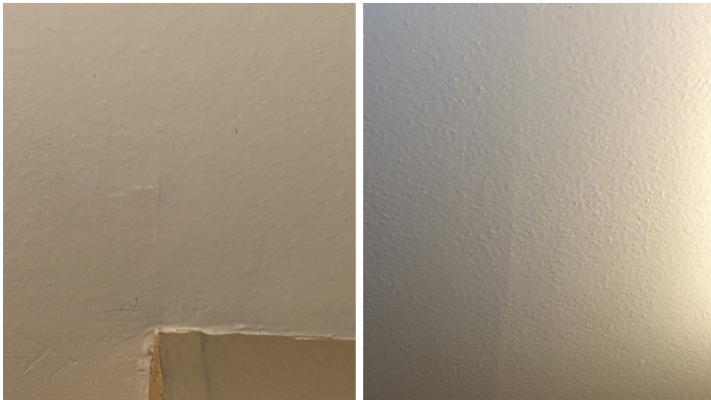
Visible tape joint.

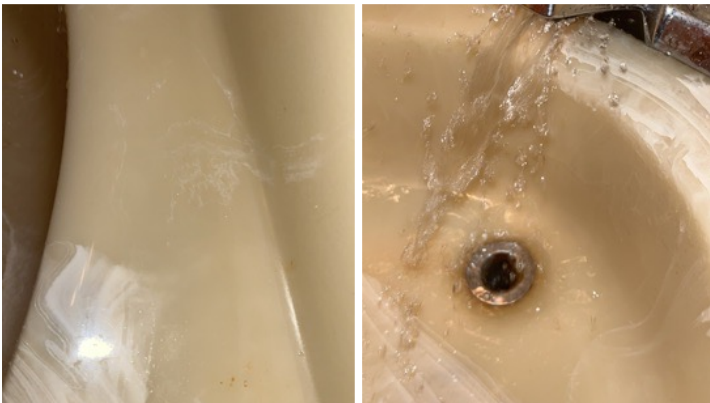
The sink faucet sprays erratically when turned on; water drains towards front of sink countertop.

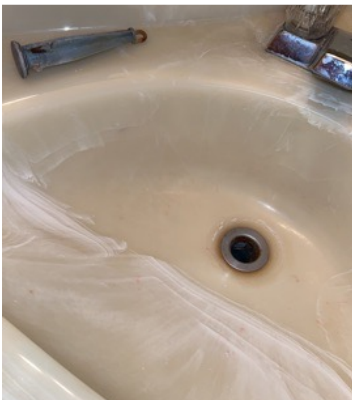
Drain stopper was not functioning as designed when inspected.

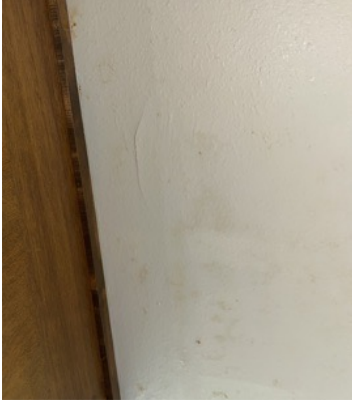
Cracks present at sheetrock.

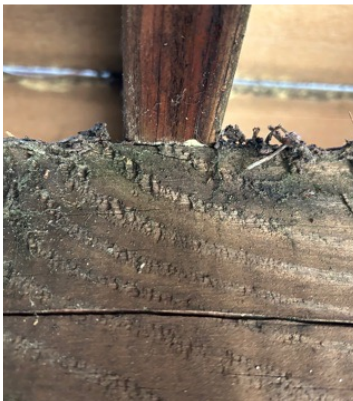
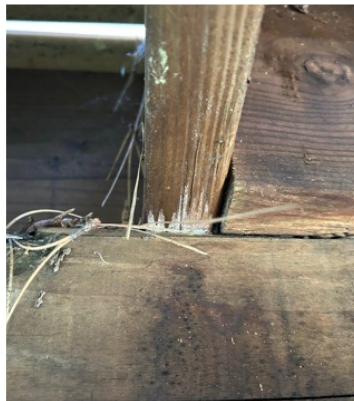
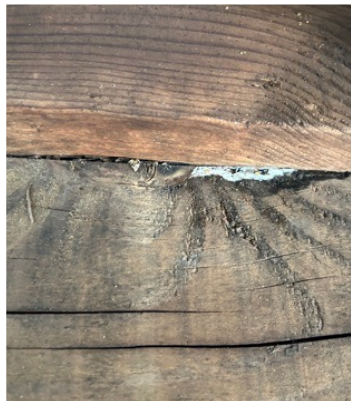
Surface fungus noted at underside of deck

See Structural Pest Report

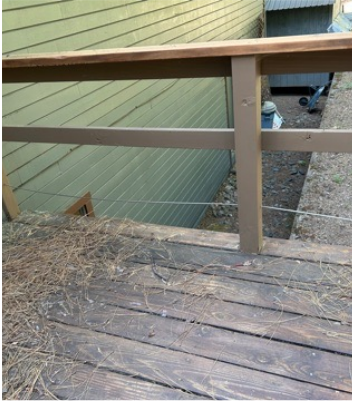
Large gaps are present at the baluster openings; this can be a fall hazard for small children.

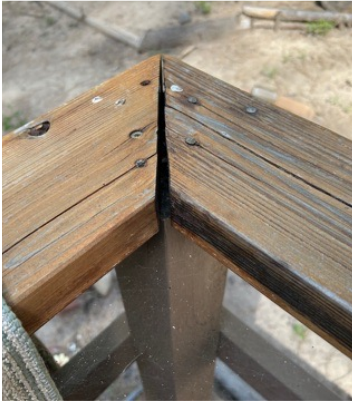
Gapping noted at deck wood members; this can allow moisture at adjacent wood members.

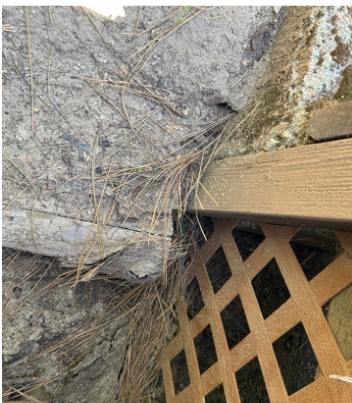
Drifting soil has caused earth to wood contacts.

See Structural Pest Report

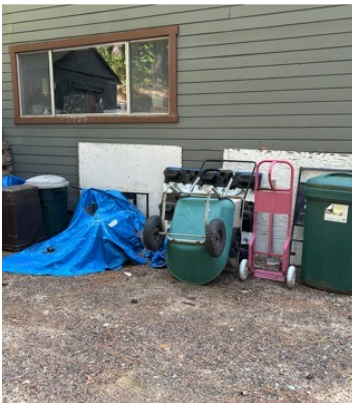
Occupant belongings prevents full inspection of exterior siding.

[See Structural Pest Report](#)

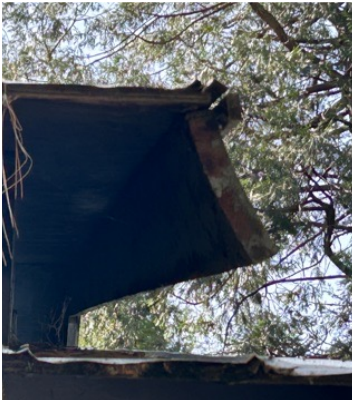
The fascia board was noted to be warped.

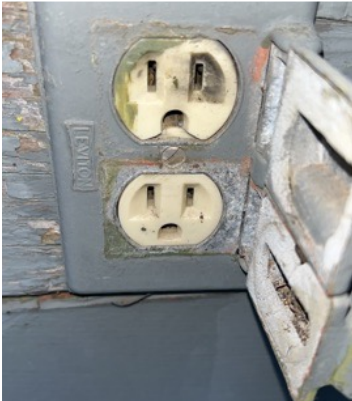
The ground portion of the three-pronged electrical outlet was noted to be broken; this will not affect functionality.

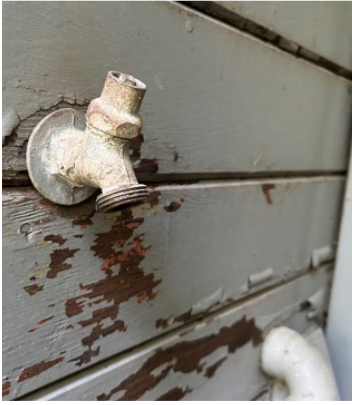
A continuous leak was noted at exterior hose bib spicket.

See Structural Pest Report

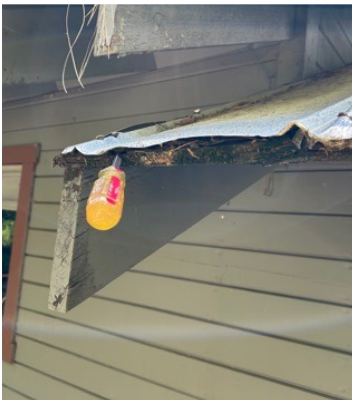
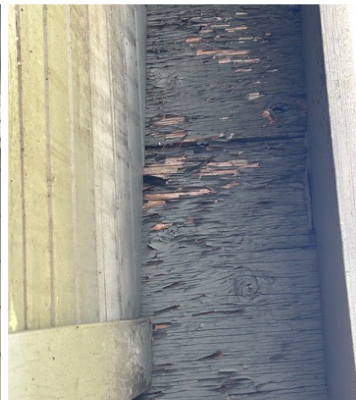
Wood deterioration was noted at roof sheathing in multiple locations.

See Structural Pest Report

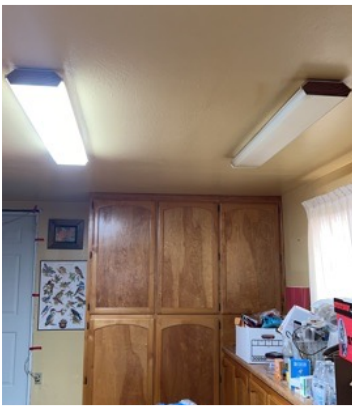
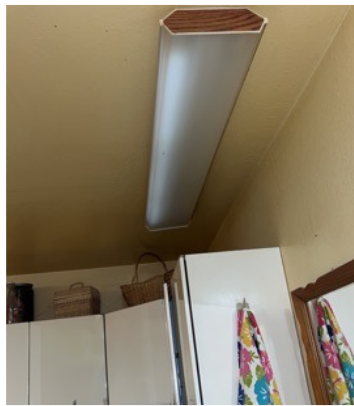
19.9 FIXTURES

The light fixture is missing the glass globe portion.

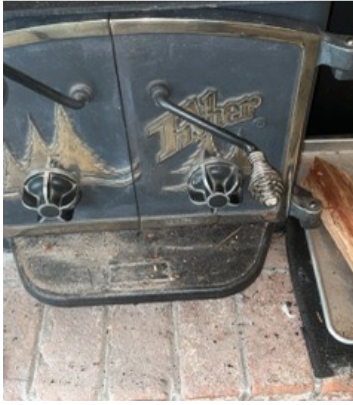
Missing corded rope seal.

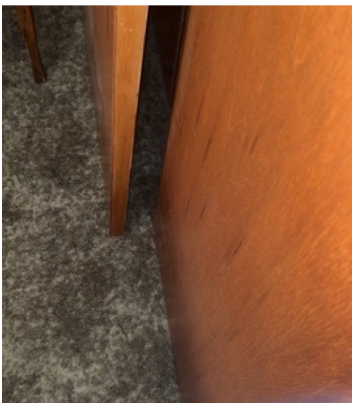
24.4 FLOOR

Floor squeaks noted, this is an indication that the subfloor fasteners are loose.

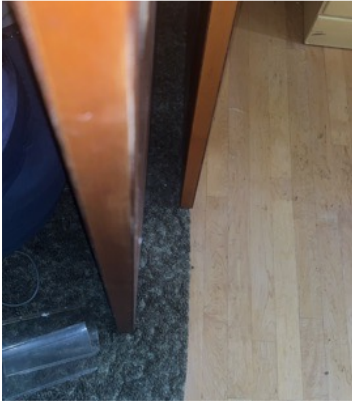
25.3 WALLS

Damage noted.
