REAL ESTATE INSPECTION SUMMARY

LOCATED AT:
403 S Paseo Laredo
Cathedral City, CA 92234

INSPECTED ON:
Monday, September 12, 2022 at 1:00 PM

Report# 11761

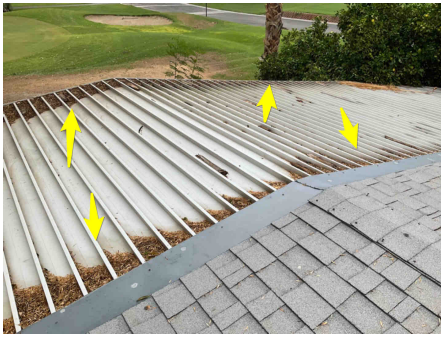
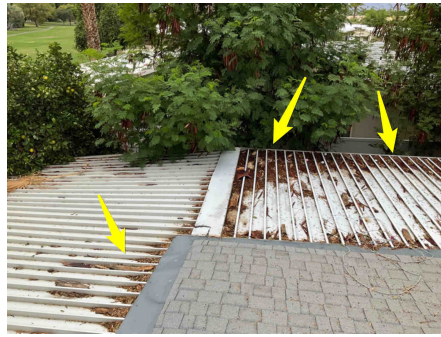
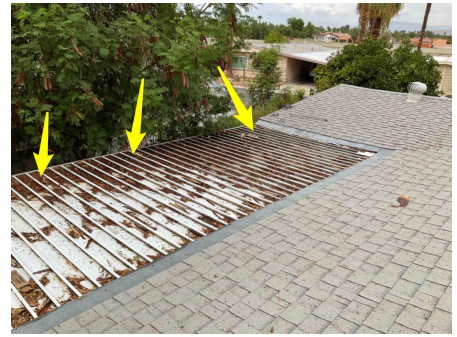
EXTERIOR AREAS PATIO/PORCH COVERS CONDITION

NR 1: Debris should be removed from patio roof.

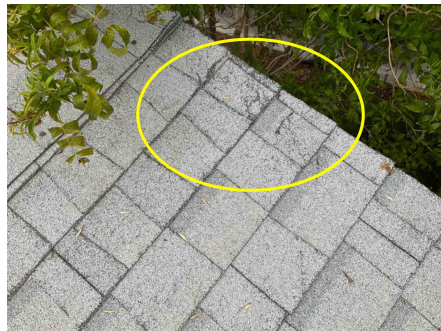
ROOF SYSTEM ROOF CONDITION

NR 3: Wear is noted to composition roof.

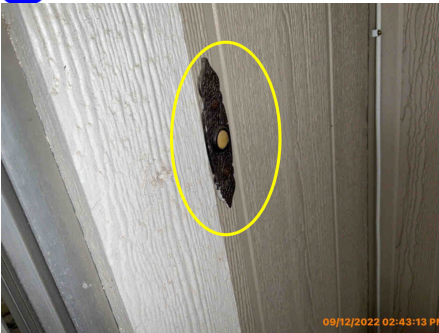
ELECTRICAL SYSTEMS DOOR BELL CONDITION

NR 5: Door bell did not work at time of inspection

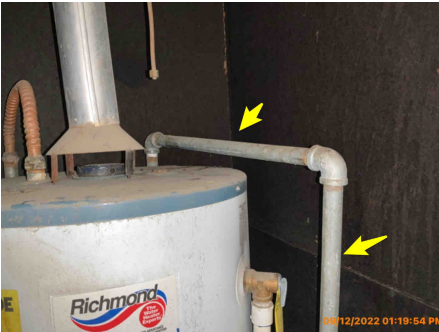
PLUMBING SYSTEMS WATER SUPPLY TYPE/CONDITION

NR 6: The home contained galvanized steel water distribution pipes. These pipes are outdated and subject to corrosion which will eventually result in restricted flow and leakage. We recommend the advice and services of a qualified Plumbing Contractor

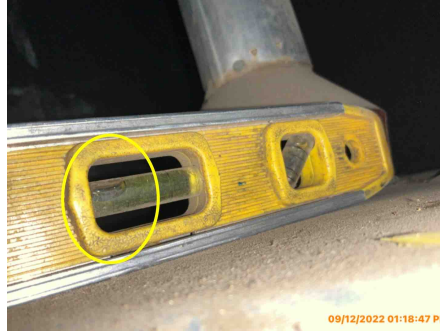
WATER HEATER WATER HEATER TANK

NR 7: Water heater appears to be leaning and not securely installed.

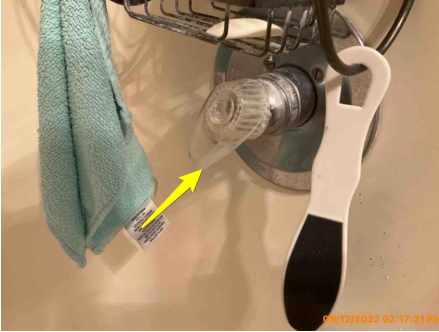
PRIMARY BATHROOM SHOWER PLUMBING FIXTURES CONDITION

NR 19: Handle loose at shower control

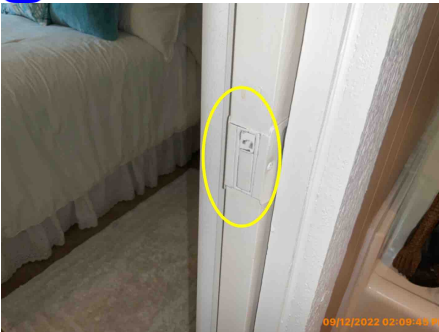
PRIMARY BATHROOM DOOR(S) CONDITION

NR 20: Pocket door pull handle is damaged and door is stuck in pocket

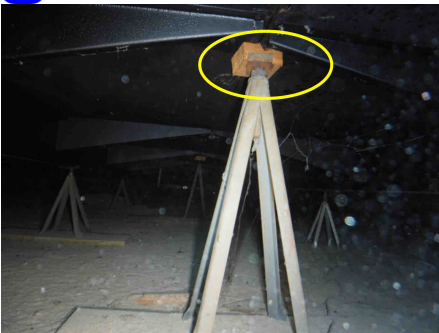
CRAWLSPACE MH SHIMS SECURE

NR 21: No, steel jacks are not secured to frame

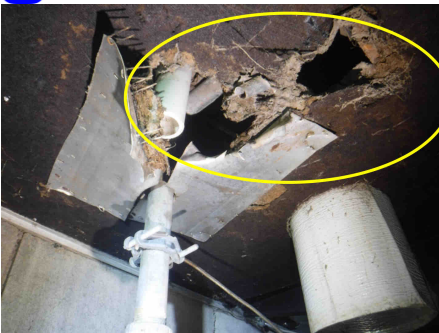
CRAWLSPACE MH UNDER FLOOR CONDITION

NR 22: Openings to the bladder under the home should be repaired.

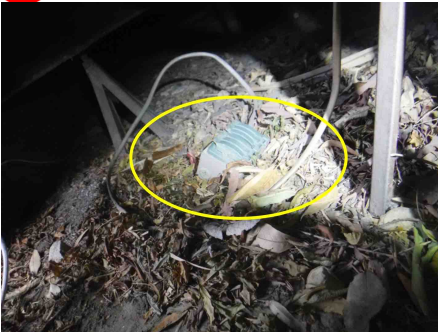
CRAWLSPACE MH ELECTRICAL WIRING

SC 34: Junction box not mounted to framing

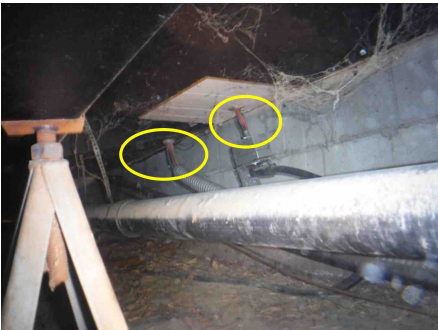
SC 35: Loose junction box and conduit with exposed wiring noted. Recommend further review and repair by qualified Electrical Contractor.

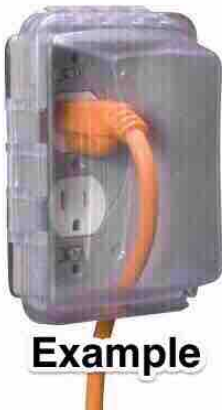
Example

RM 39: Recommend installation of listed outdoor cover for unattended cords to protected receptacles from moisture damage at exterior of house.

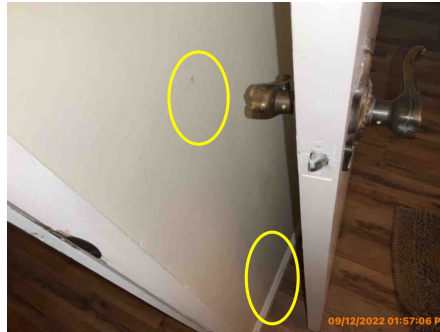
RM 49: Door stop is missing. Install a door stop to prevent damage to wall

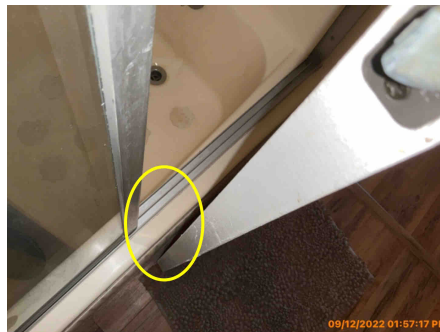
RM 50: Door stop is missing, recommend installation of door stop to prevent damage to bathtub
