## **Confidential Inspection Report**

**475-169 MIDWAY DRIVE**

**Escondido, CA 92027**

**December 10, 2025**

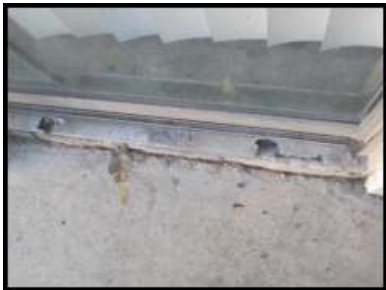
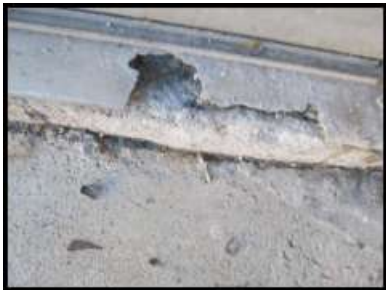
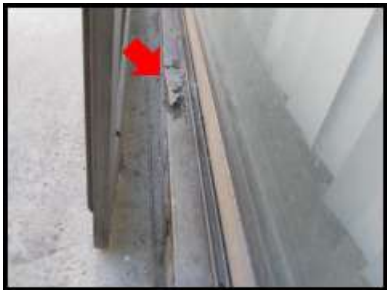
The threshold is severely deteriorated and needs replacement.  
Screen door needs to be installed.

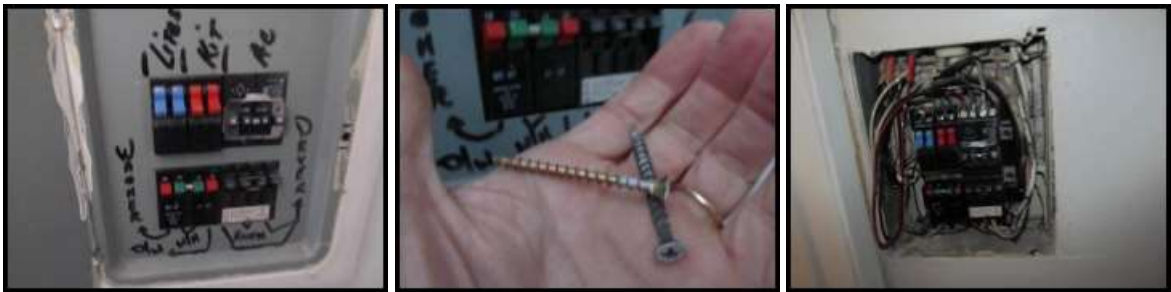
Potential for fire or shock hazards to occur.

Electrician is needed to further evaluate conditions..

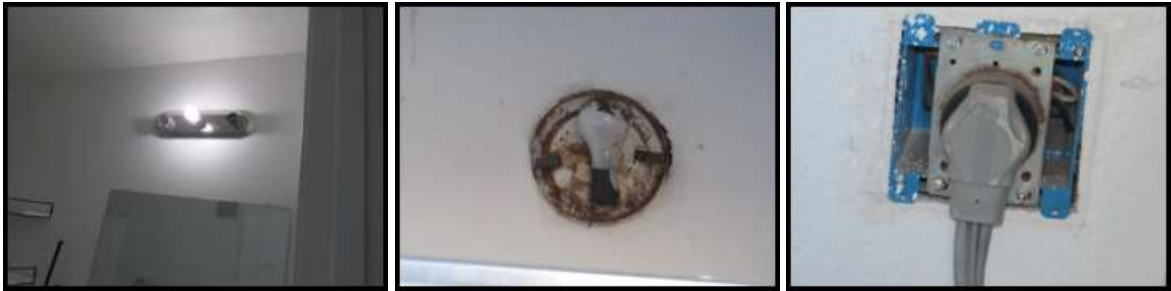
| General: | <input type="checkbox"/> | <input checked="" type="checkbox"/> | <input type="checkbox"/> | Laundry Light fixture is damaged and needs replacement.<br>The services of a licensed electrician are recommended for further evaluation and corrections. |

Missing Fixture bulbs.

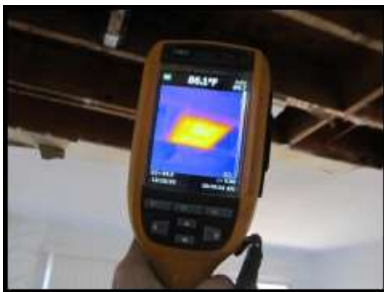
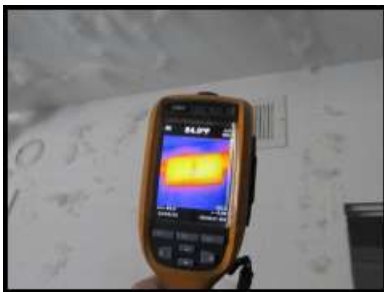
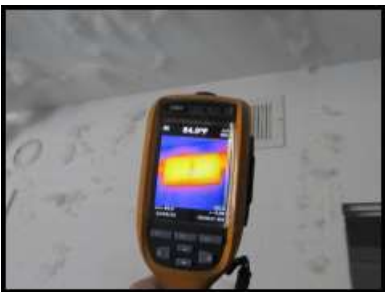
Roof HVAC unit.

Brand: ☒ ☐ ☐ Rheem brand.  
Fuel Source: Electric.  
General Operation & Cabinet: ☐ ☒ ☐ Original Equipment same age as home  
Equipment is an older unit that has a very limited service life.

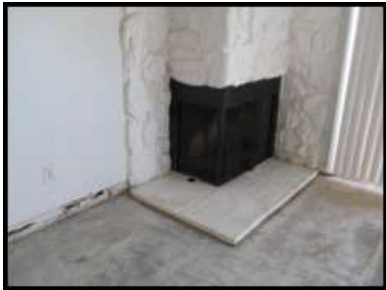
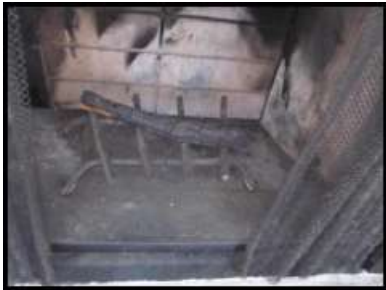
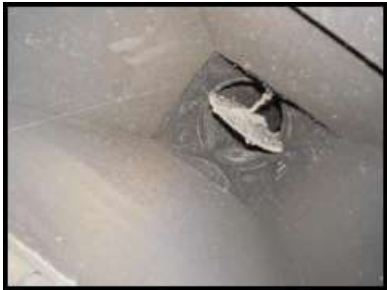
Defects noted at time of inspection.  
Further Evaluation is recommended for your safety.  
Creosote buildup is noted.  
Cleaning and a full inspection is recommended.

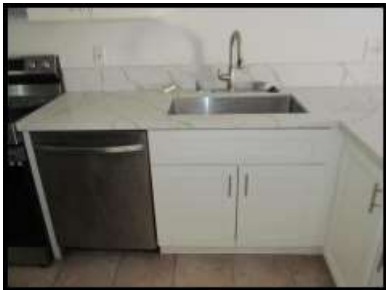
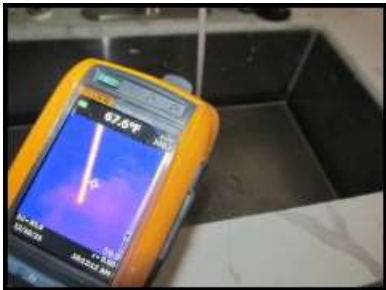
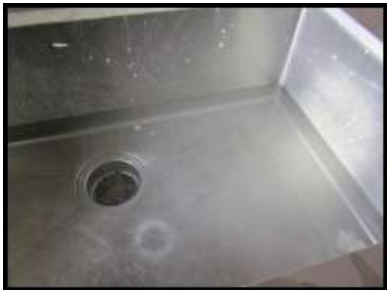
**Plugged Drain**

☐ ☒ ☐ General condition appears serviceable.  
The fixtures are fully functional and operate as intended.  
Minor calcification and corrosion type cosmetics are common and not reported.  
No leakage noted.

Plugged Drain Noted.

Repair as needed.

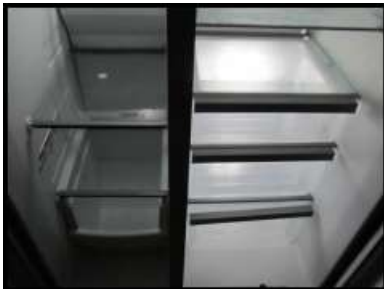
| | | | Dents noted. |

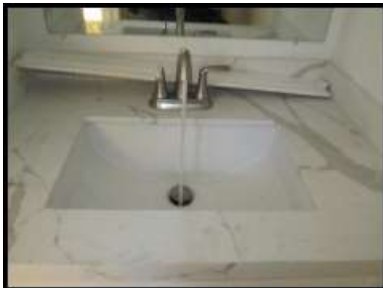
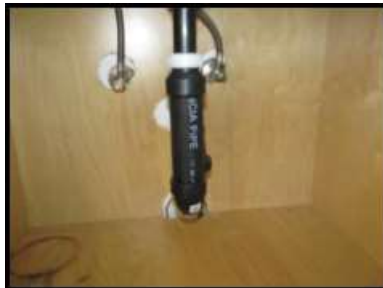
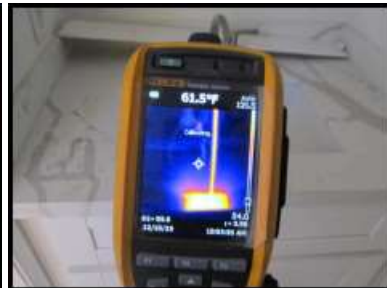
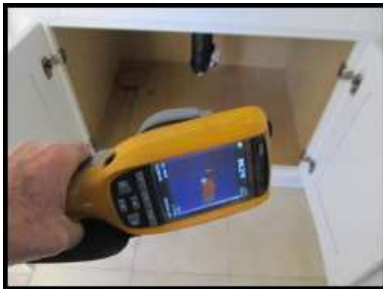
The fixtures are fully functional.  
Minor corrosion is typical.

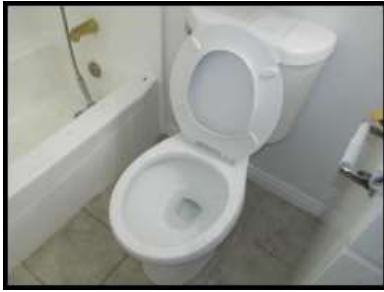
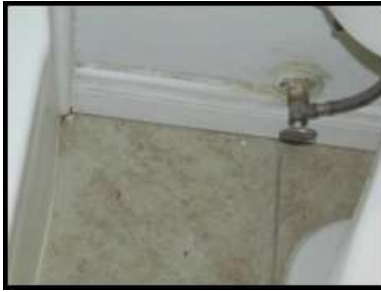
Flow Rates are not determined.

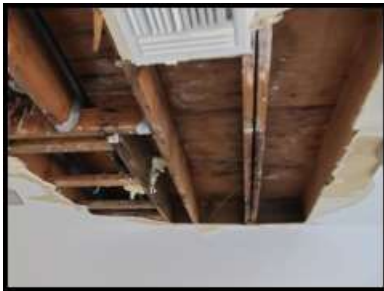
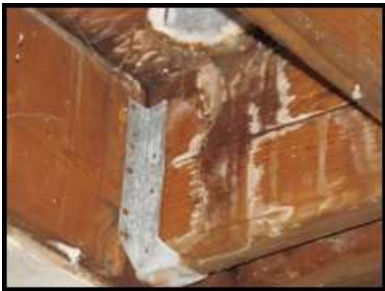
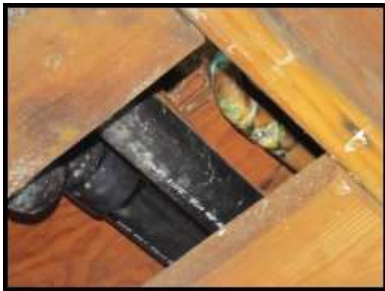
Mold appears to be growing on the walls and ceilings.  
Upstairs bedrooms.

Open hole in ceiling on first floor.

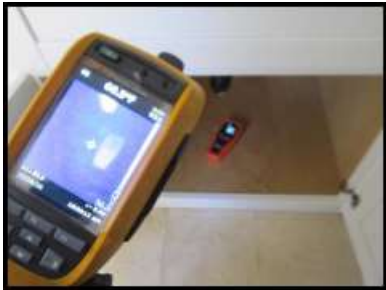
No Viewable previous Damage, stains or moisture intrusion noted.  
Only readily accessible, viewable surfaces are checked.
