USA Home Inspectors

Home Inspection Report

3254 S Bonita St

Inspected On: Wed, Jul 23 2025 at 8:00AM

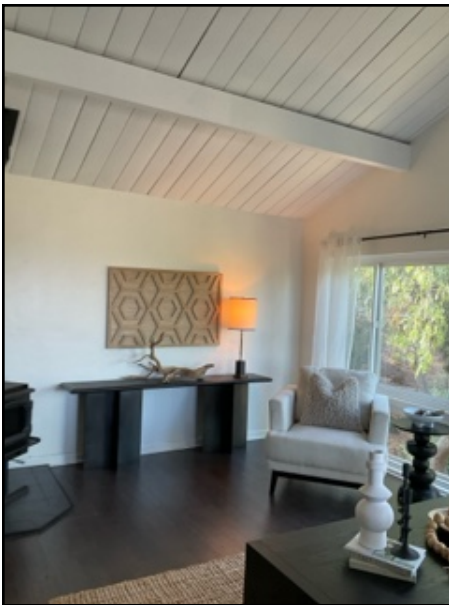
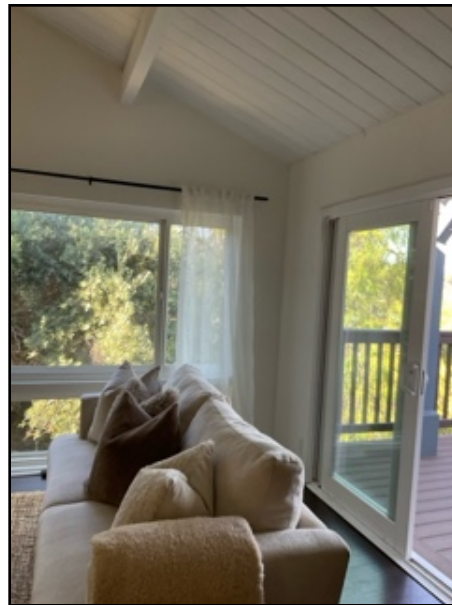
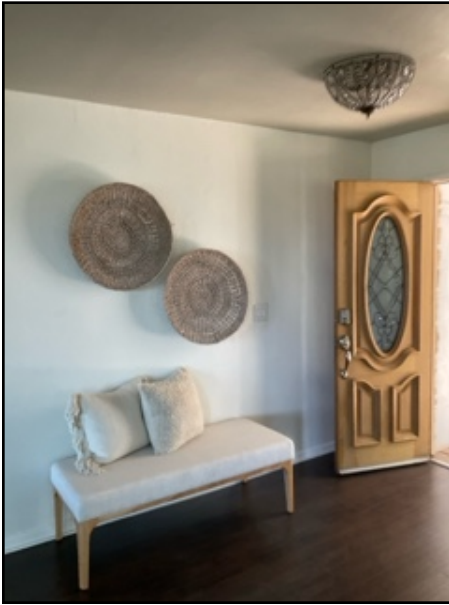
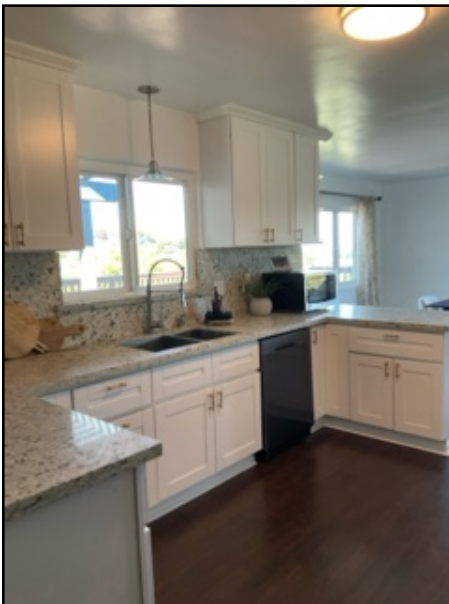
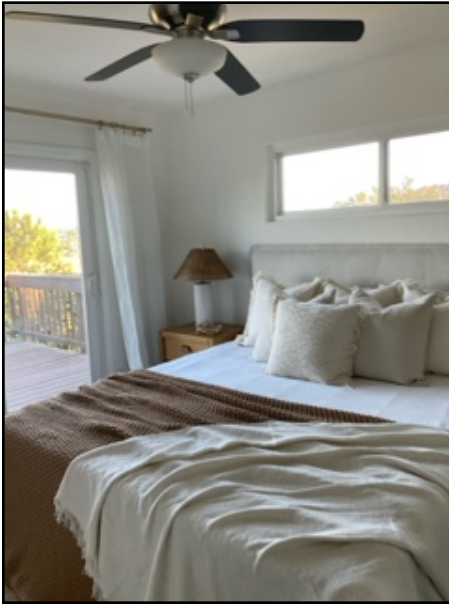
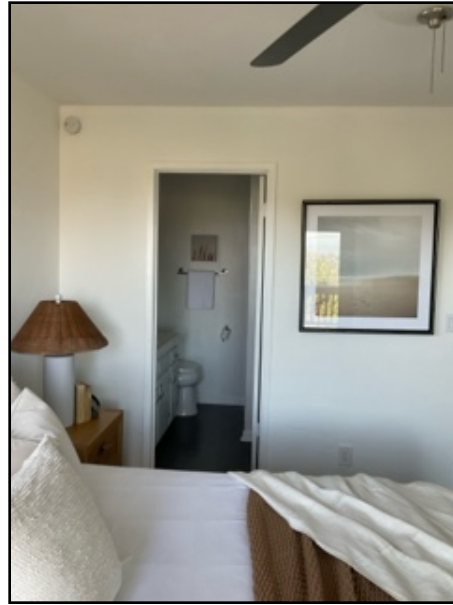
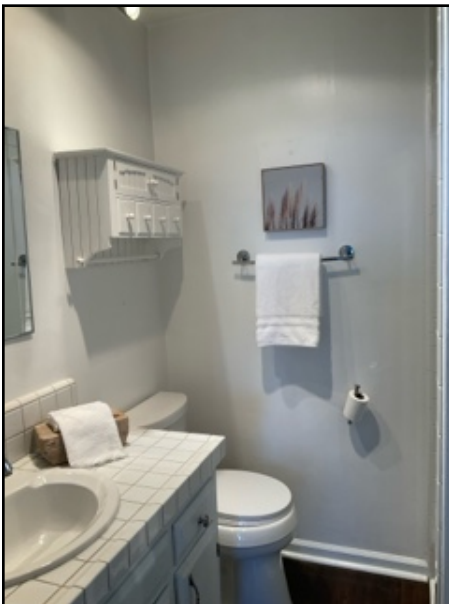
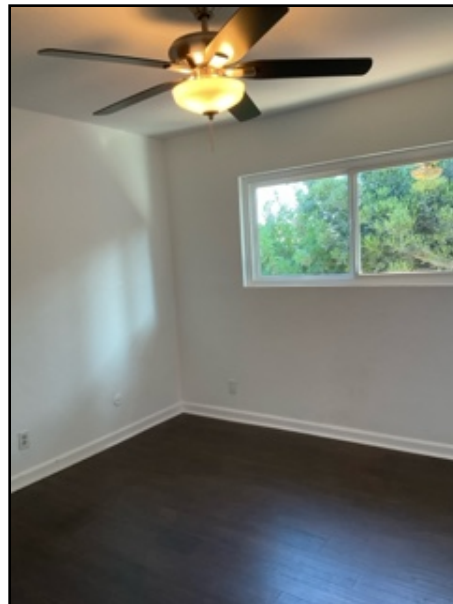
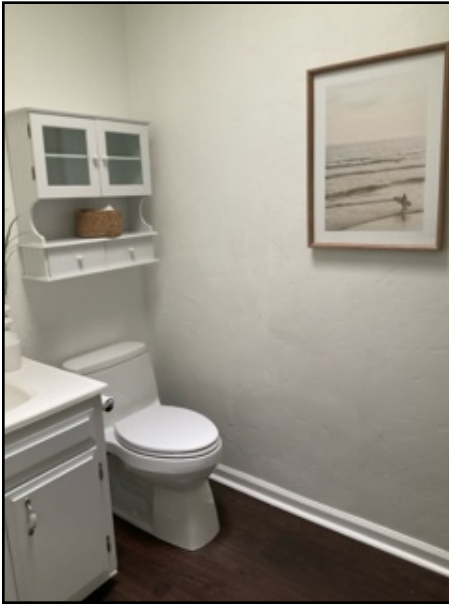
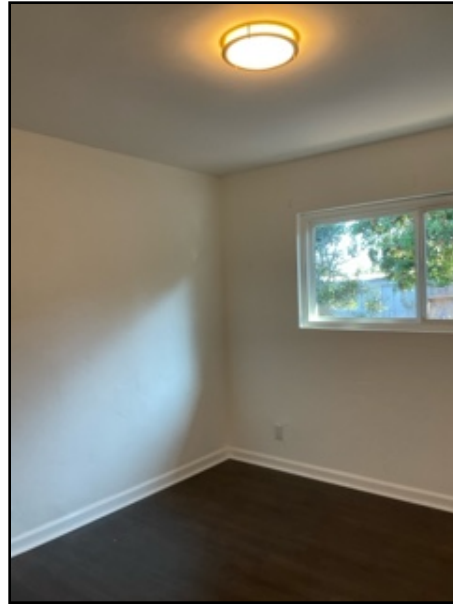
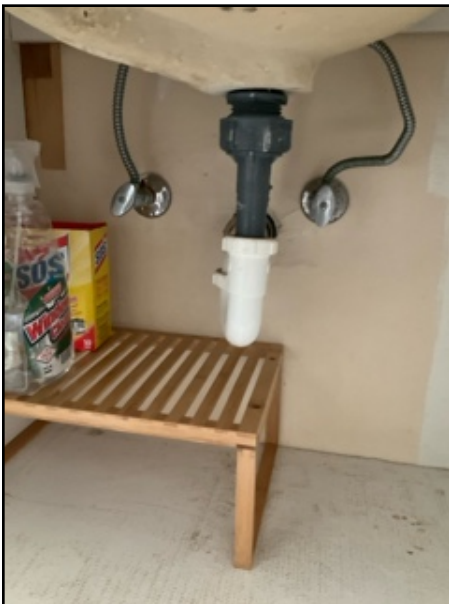
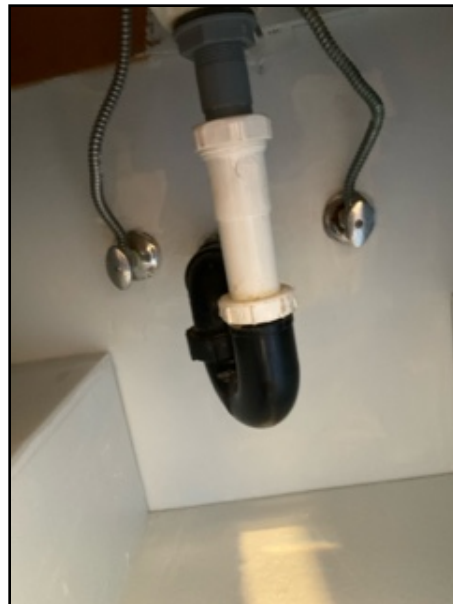
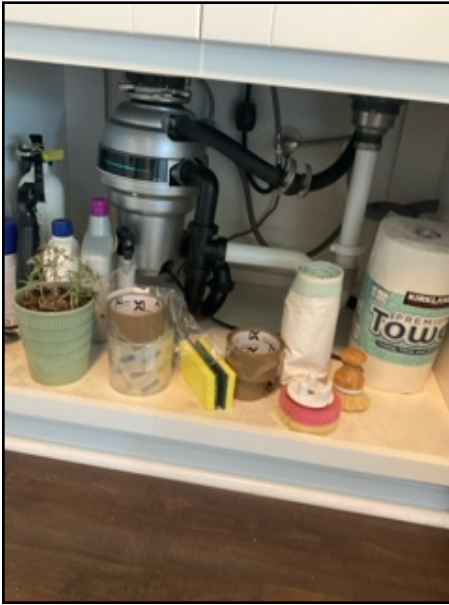
Personal property present at time of inspection, some areas and systems are not fully visible due to current occupants personal items.

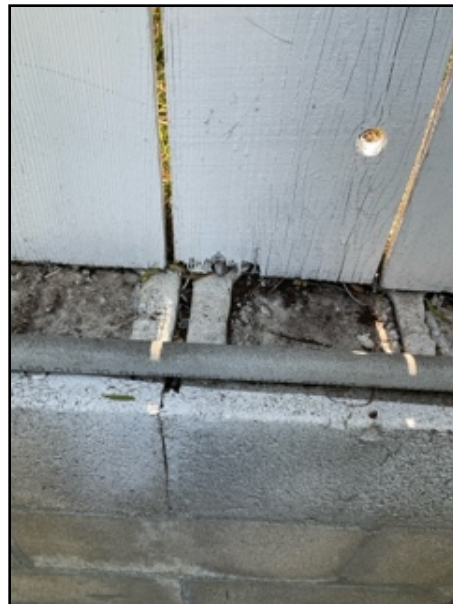
Figure 11-6

REPAIR OR REPLACE: Sunburn, peeling paint, damaged wood, wood-to-soil contact, and evidence of possible wood destroying organisms noted at various locations throughout fence.

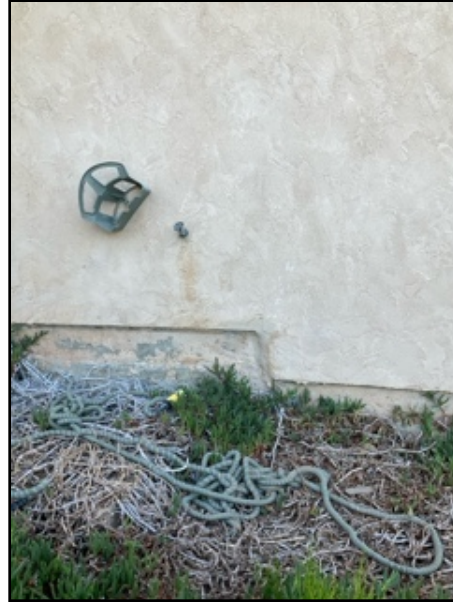
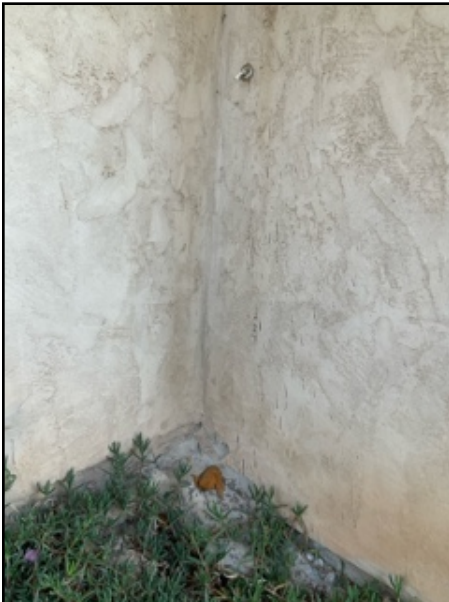
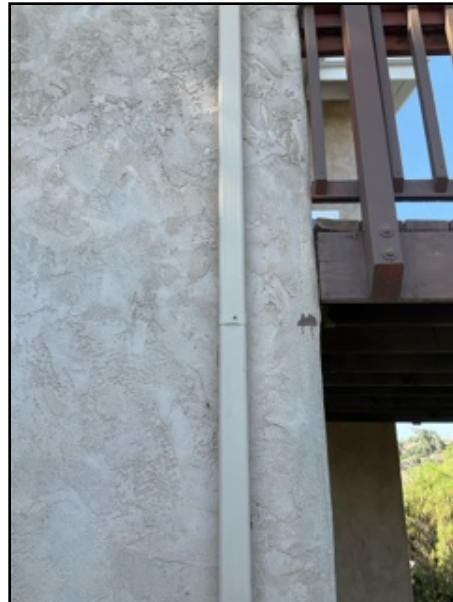
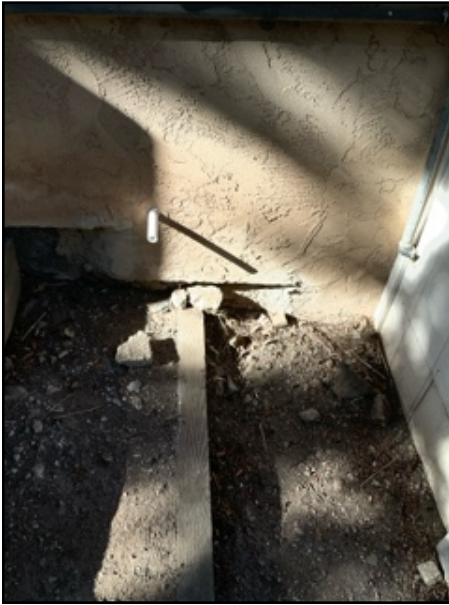
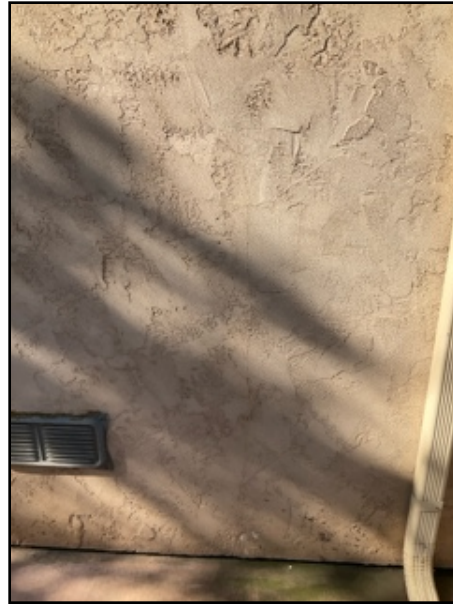
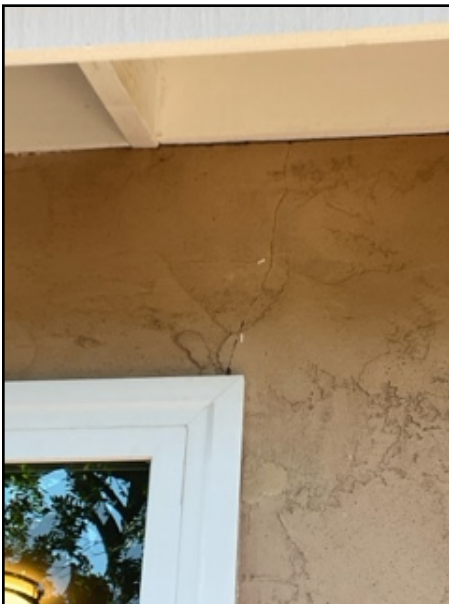
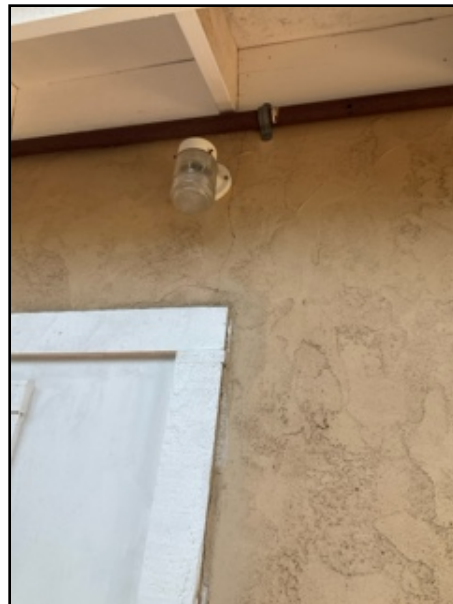
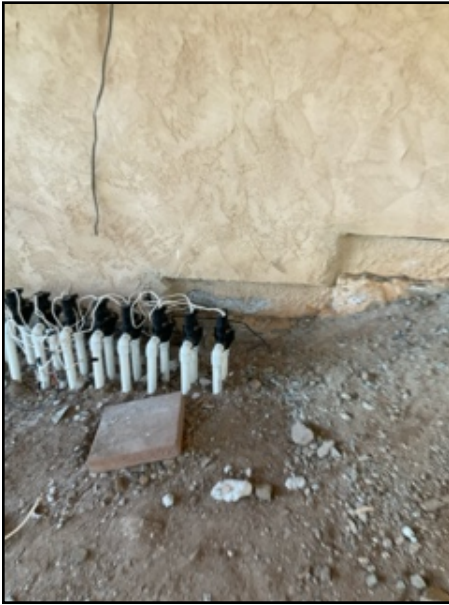
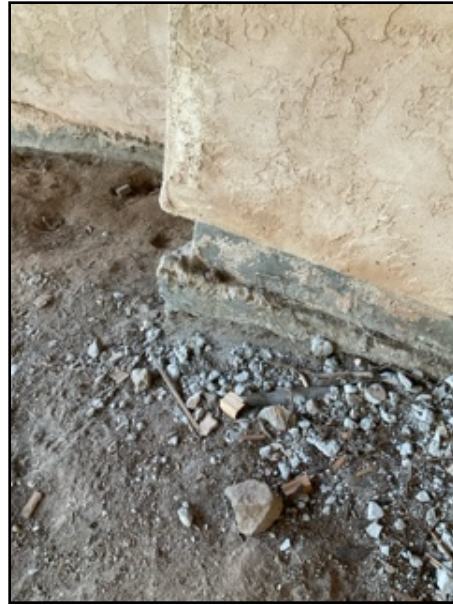
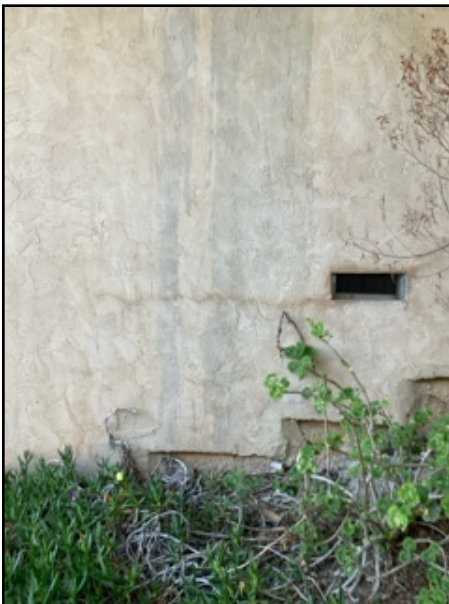
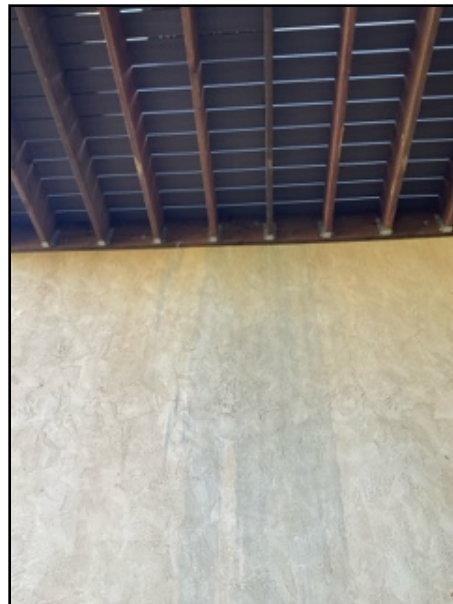
**Comment 14:**
Defects such as peeling, holes, cracks, and patches noted at various places throughout exterior.

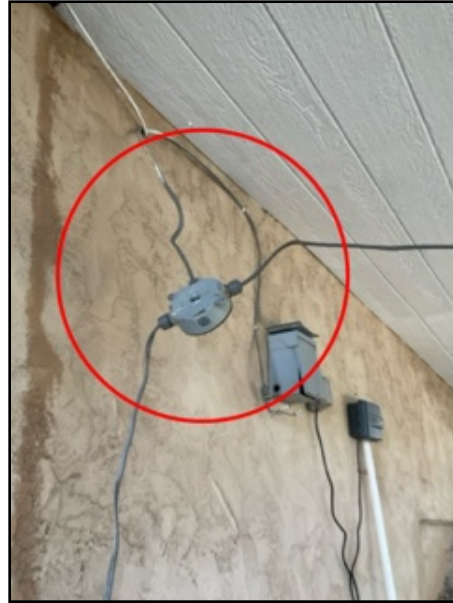
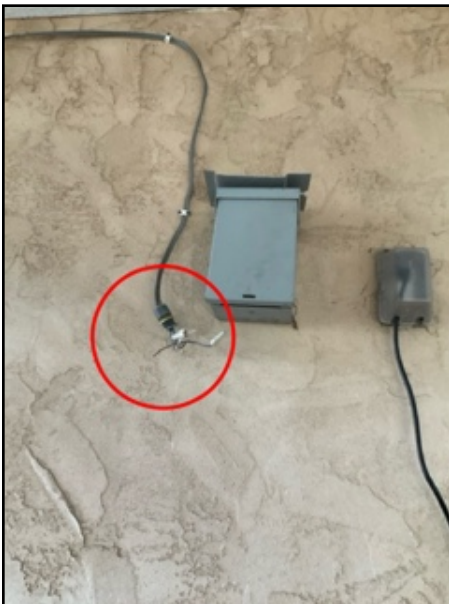
REPAIR OR REPLACE: Exposed non-hot wires noted on exterior.

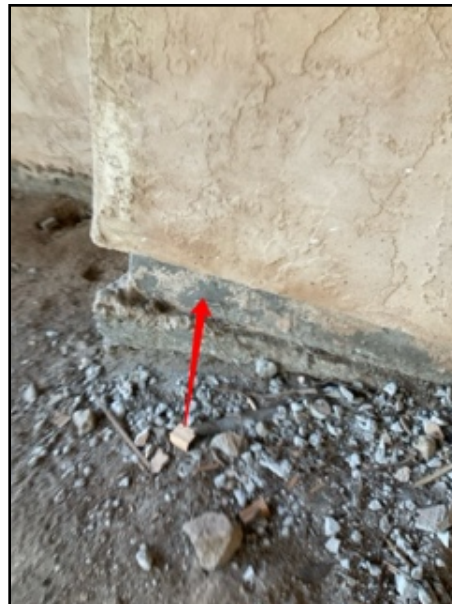
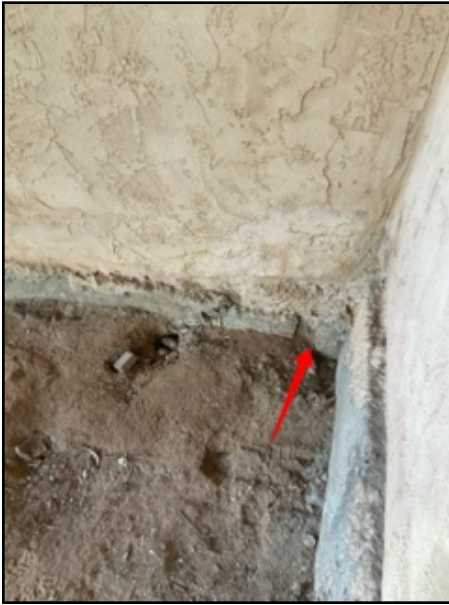
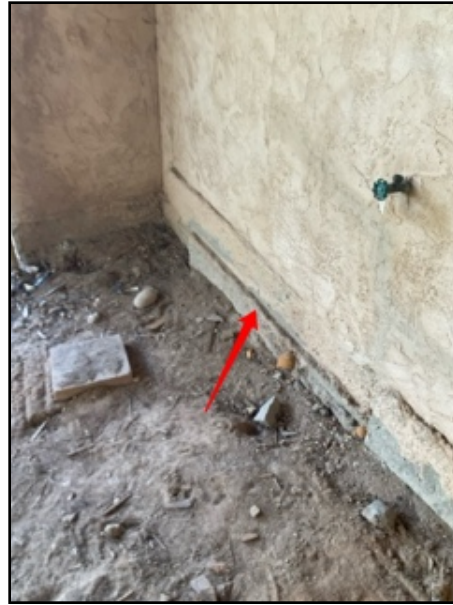
FURTHER EVALUATION REQUIRED: Exposed foundation noted in rear and side of home. So erosion noted.

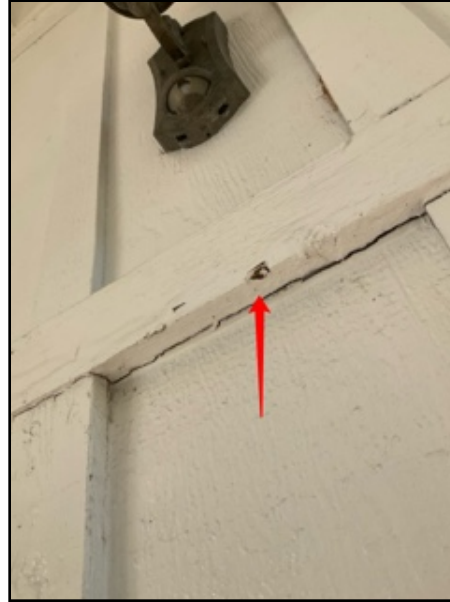
Figure 19-2

**Comment 19:**
FURTHER EVALUATION REQUIRED: Evidence of possible wood, destroying organisms/dry rot noted on wood siding near front door.

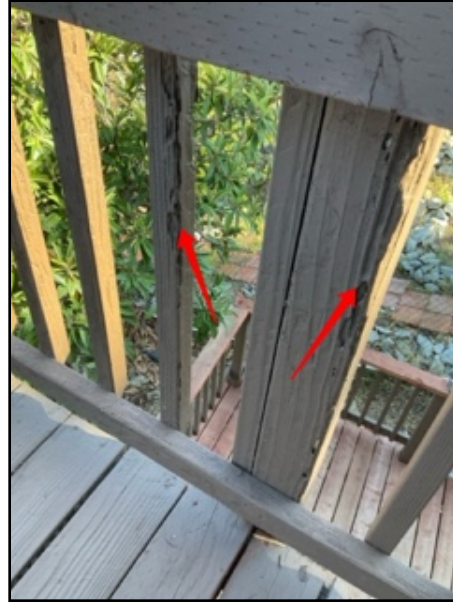
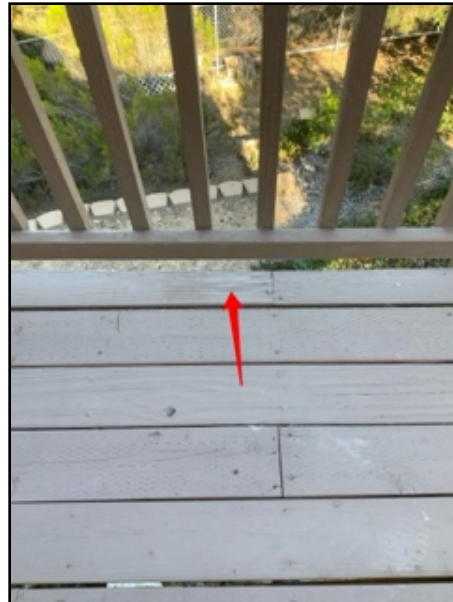
**Comment 21:**
FURTHER EVALUATION REQUIRED: Evidence of possible wooddestroying organisms/dry rot noted on wood balcony off master bedroom.

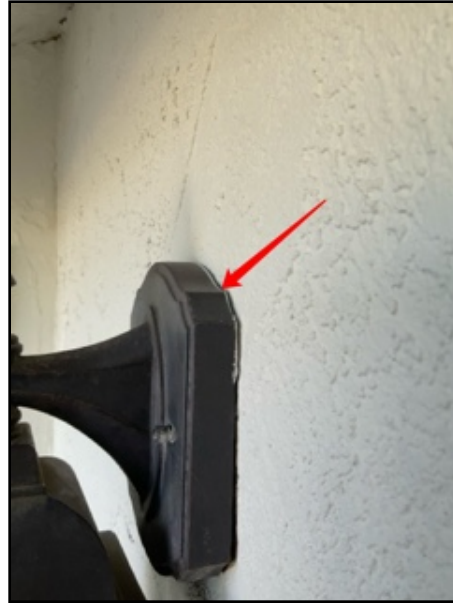
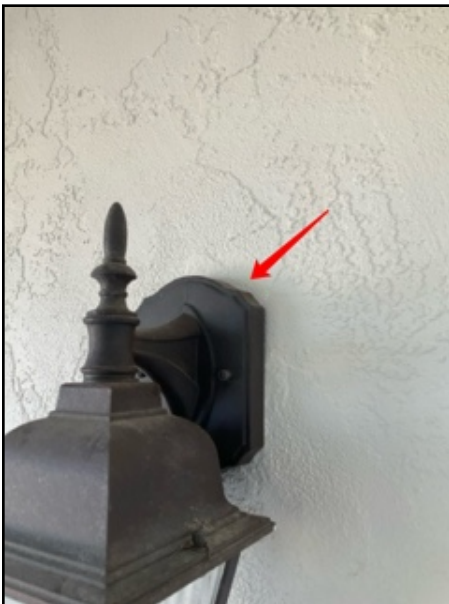
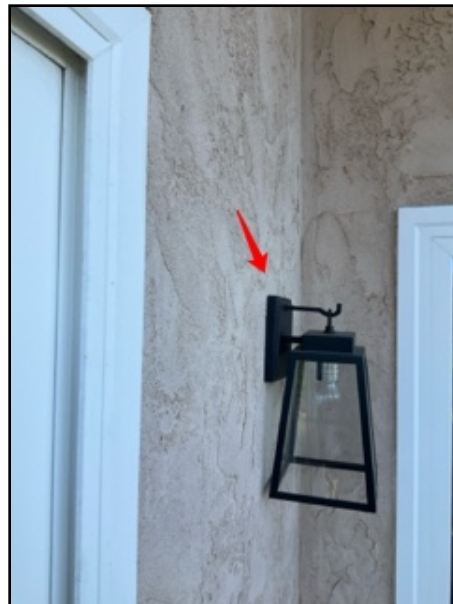
**Comment 22:**
REPAIR OR REPLACE: Exterior lights noted as loose and not sealed.

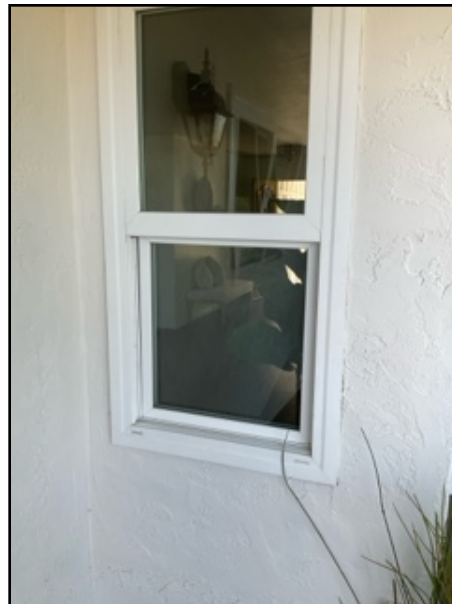
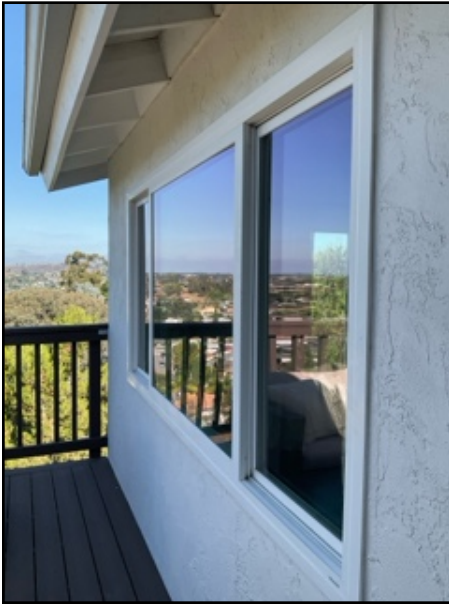
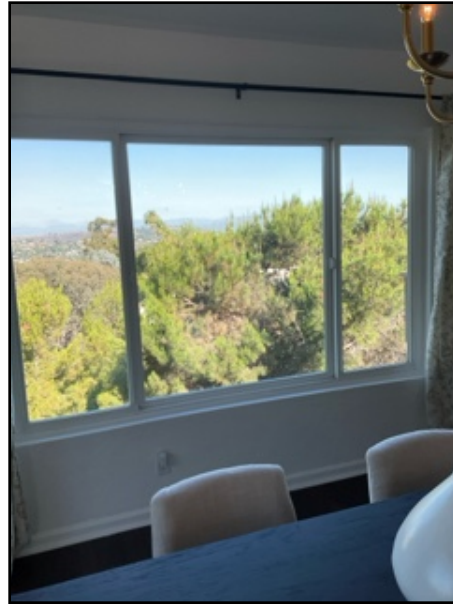
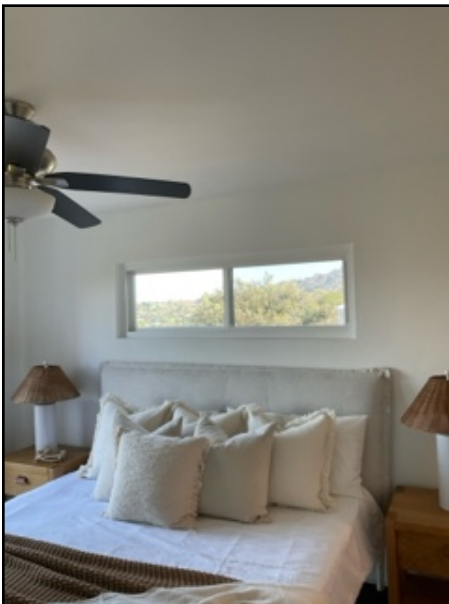
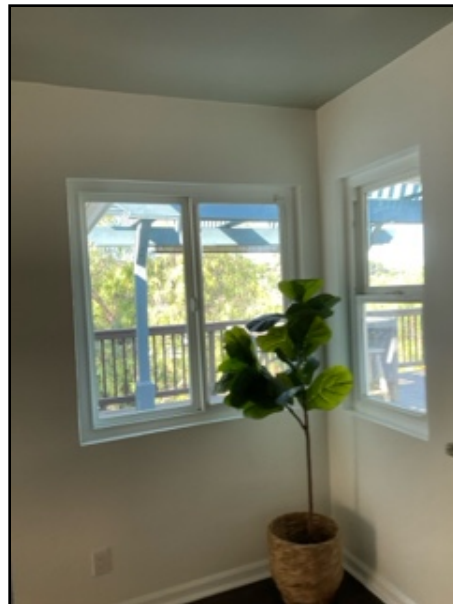
REPAIR OR REPLACE: Window screens noted as not installed on any windows.

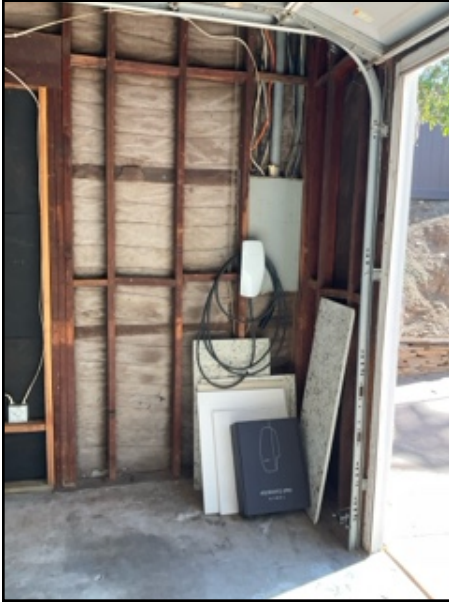
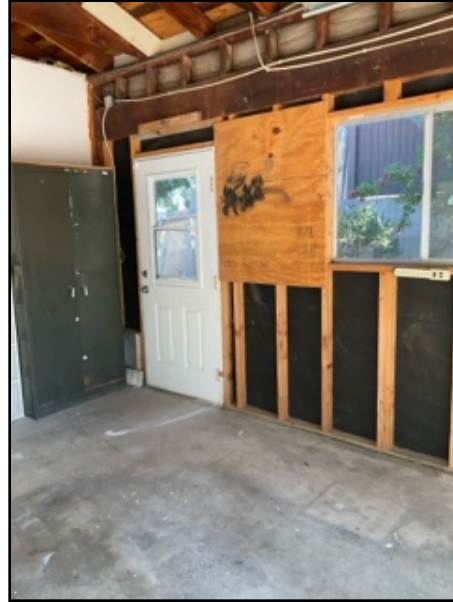
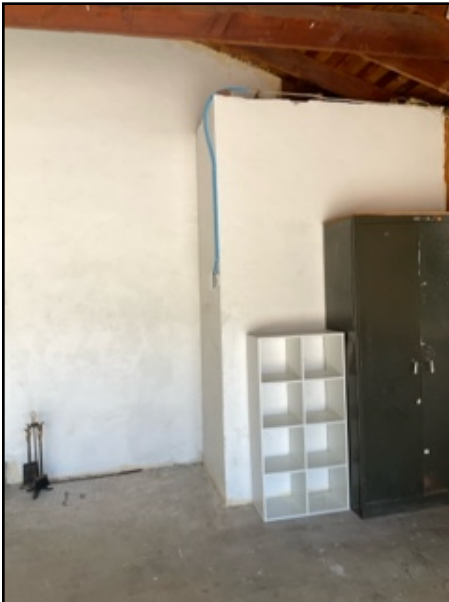
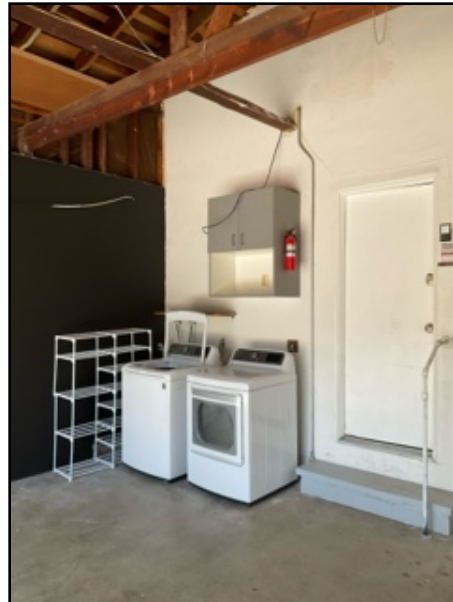
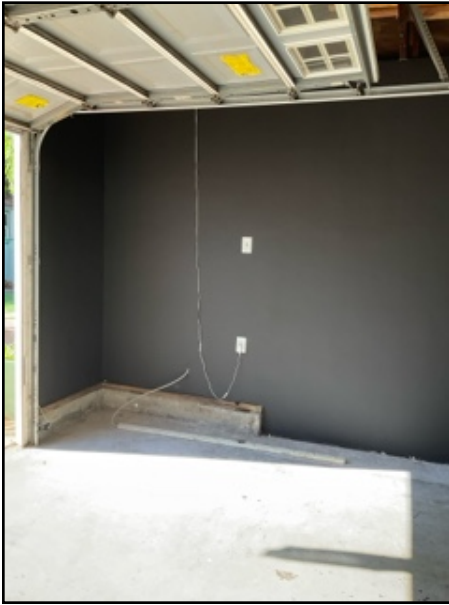
Personal belongings stored in garage prevented inspection of some aspects of the garage.

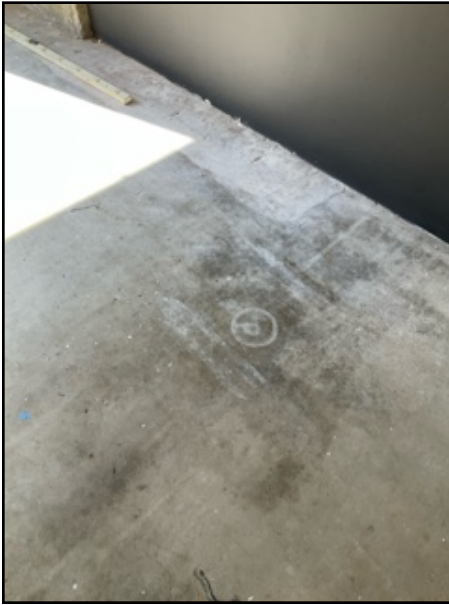
Figure 26-3

Comment 26:
Cracks and stains noted at garage floor.

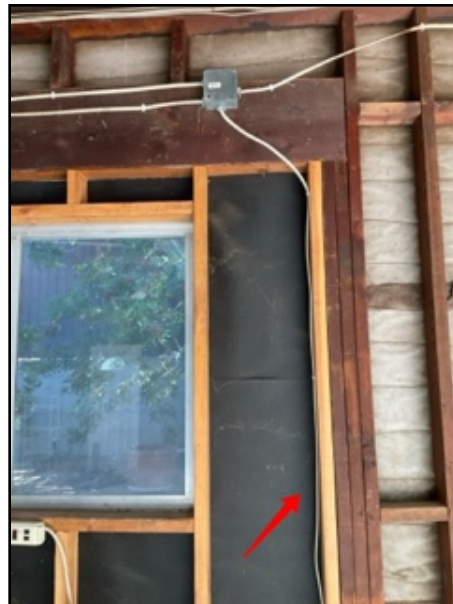
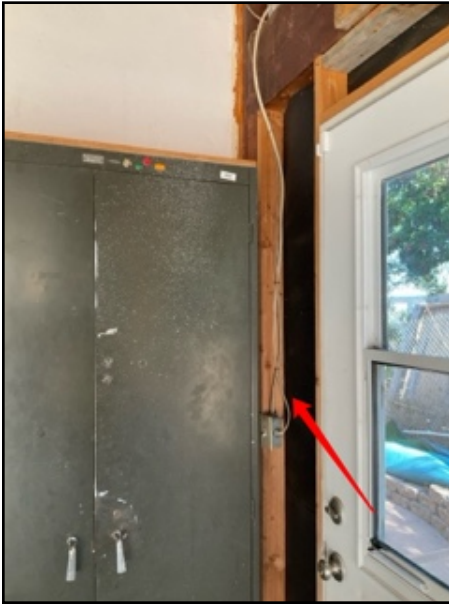
REPAIR OR REPLACE: Exposed electrical wires under 7 feet in garage.

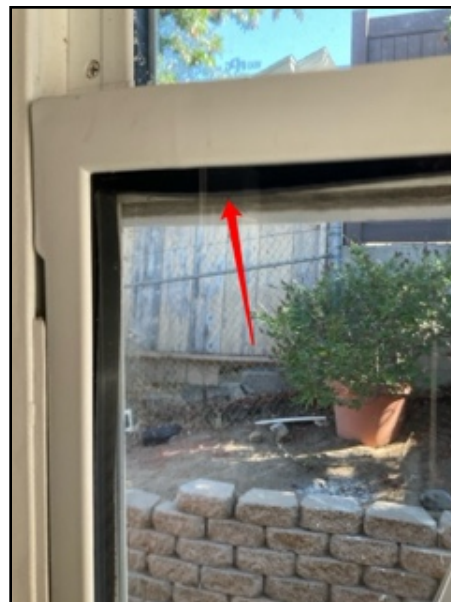
Figure 34-2

REPAIR OR REPLACE: Trim around garage window off side door noted as broken and seal is moving.

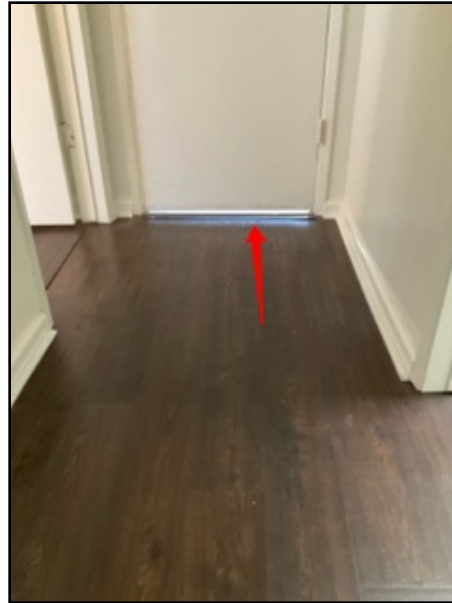
Figure 35-2

REPAIR OR REPLACE: No weatherstripping noted as installed around garage entry door. Daylight noted as coming through bottom of door. This is a possible rodent entry point.

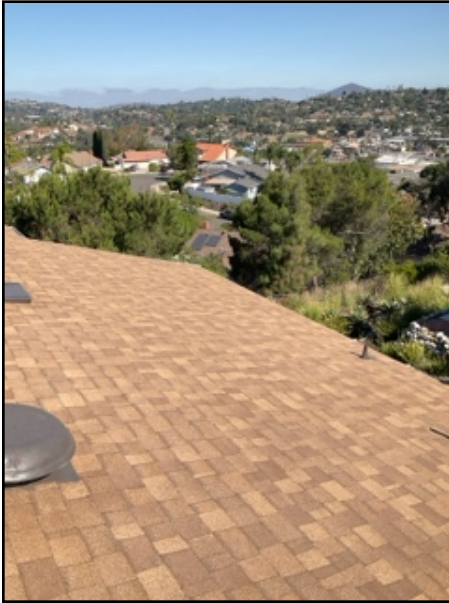
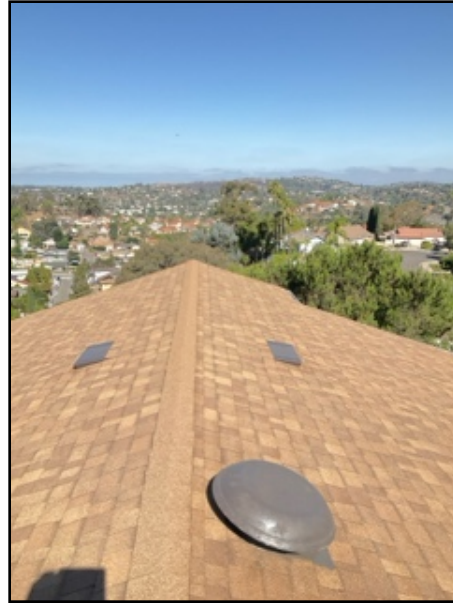
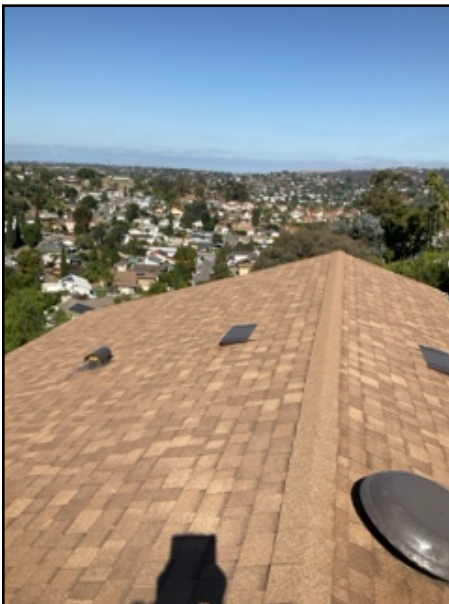
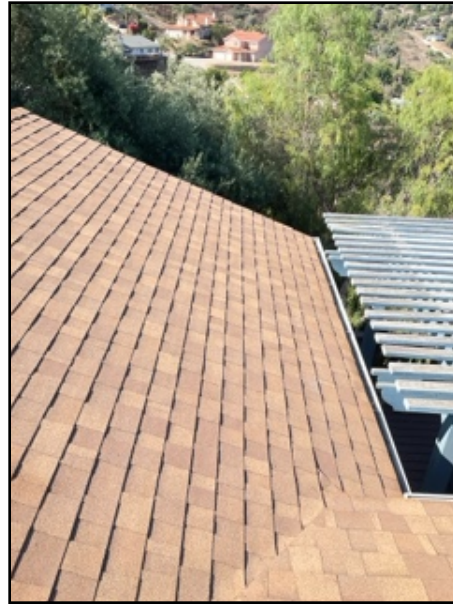
Comment 37:
Roof inspection pictures.

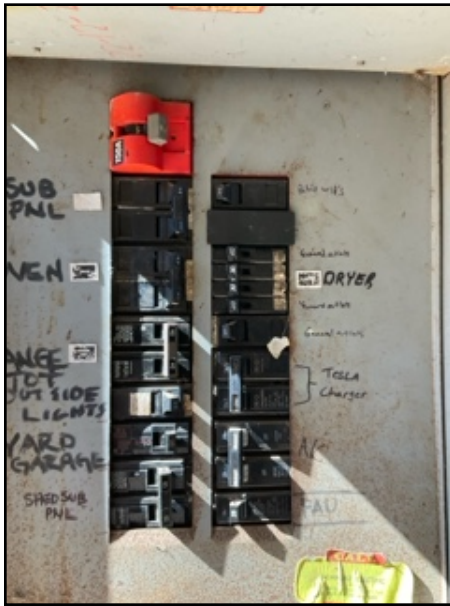
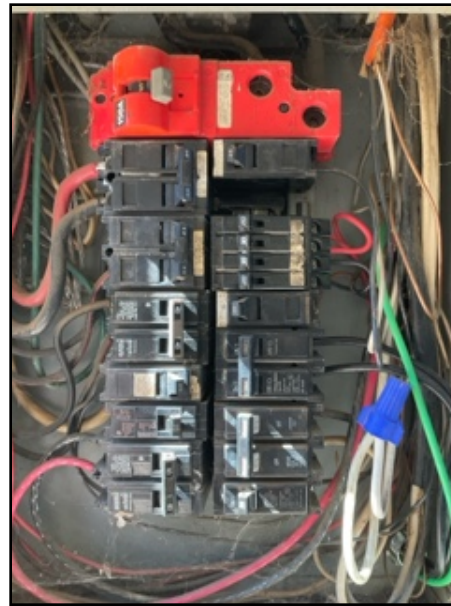
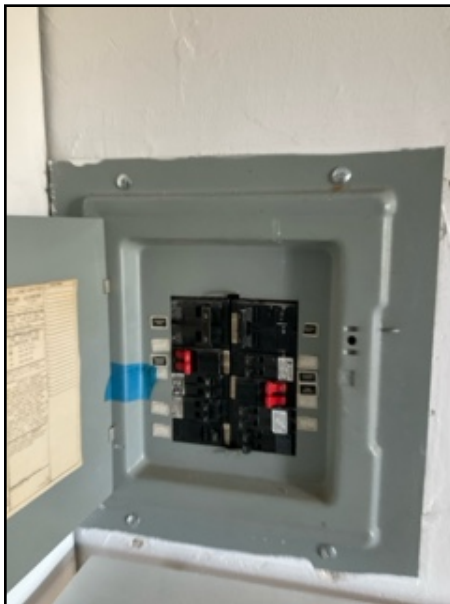
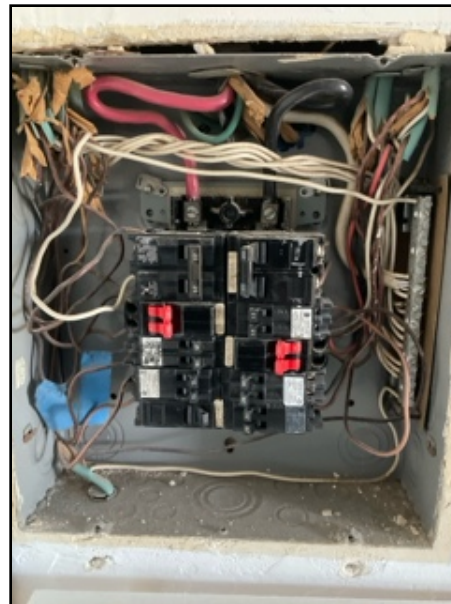
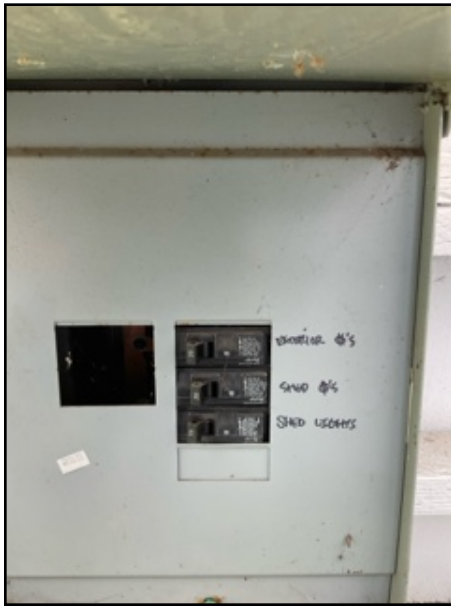
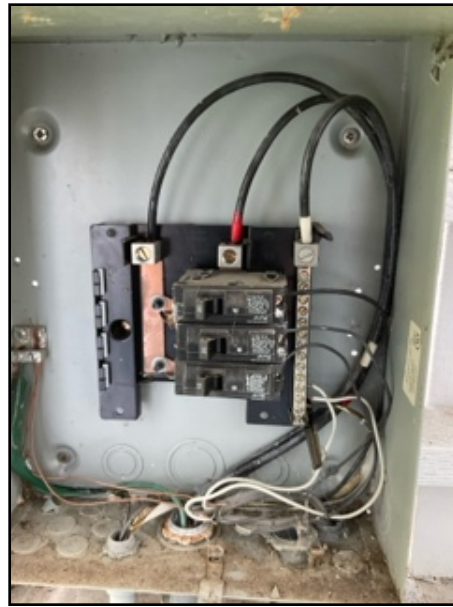
Service panel inspection pictures. A thermal scan was conducted and no significant hot spots were noted.

Several electric components appear to be the original configuration. Several advances in safety have been made since the original design was installed. The service panel appears to be functioning as designed.

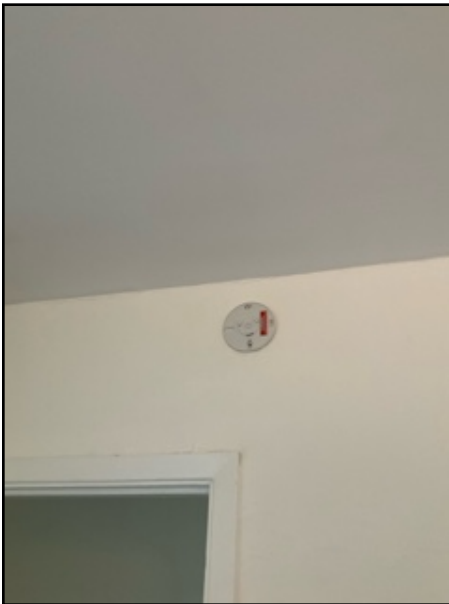
Figure 41-1

**Comment 41:**
REPAIR OR REPLACE: Smoke detectors noted as not installed in two small bedrooms.

Per Section 72 of the National Fire Protection Association (NFPA) National Fire Alarm Signaling Code, smoke alarms must be installed on each habitable level, in every sleep room, and outside each sleeping area.

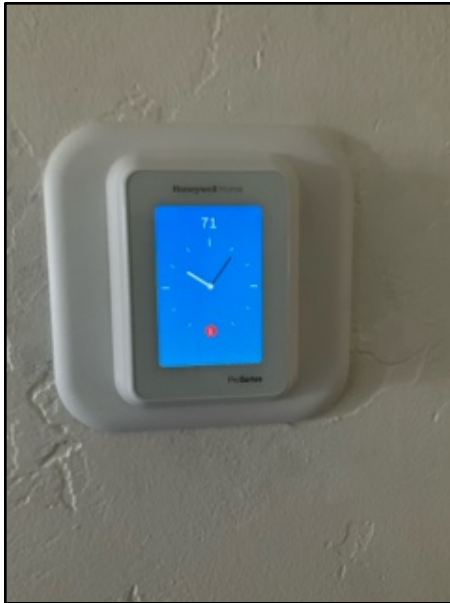
Figure 45-1

Inspector notes smart thermostat present at the home. Throughout this report, smart devices will be noted as 'FURTHER EVALUATION REQUIRED' due to the accompaniment of usernames and passwords often associated with these types of devices.

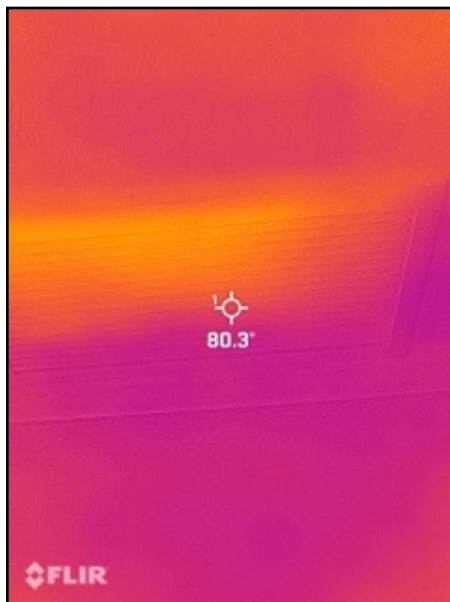
Comment 50:
AC supply and outputs.

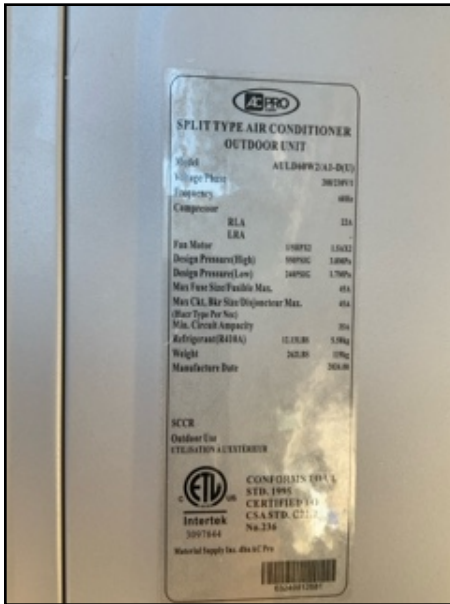
Figure 51-1

Condenser Data Plate Picture:.

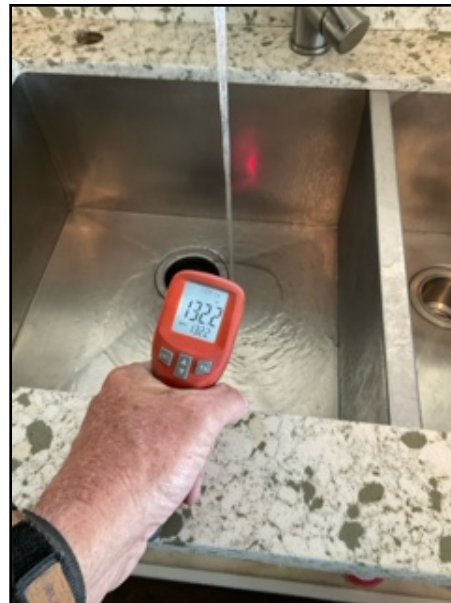
Figure 54-2

Water temperature was 132°F. Most appliance manufacturers recommend a temperature of around 120°F. Generally temperatures above 130°F are considered unsafe.

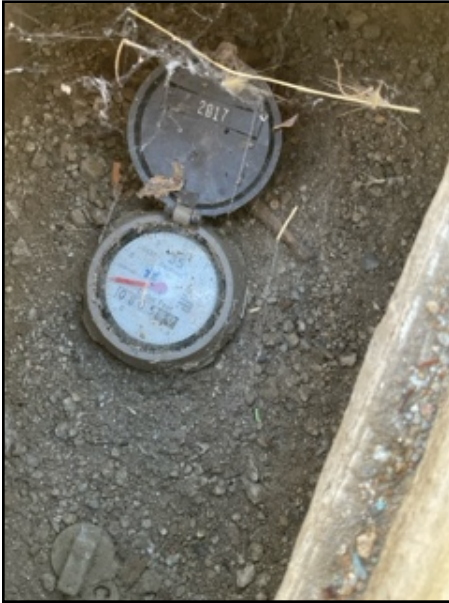
Figure 55-1

Comment 55:
Main water meter with leak detector.

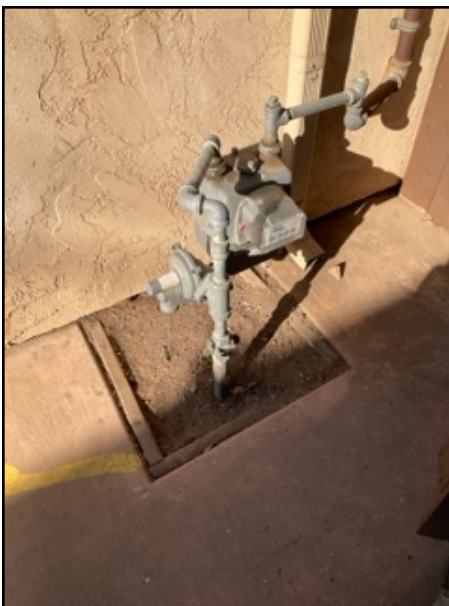
Figure 56-1

Comment 56:
Main gas shut off.

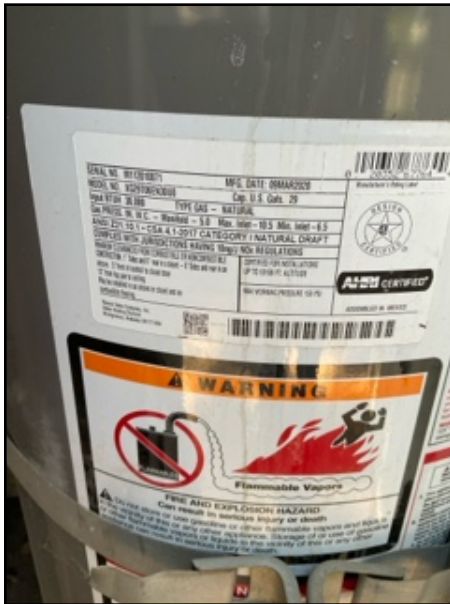
Figure 59-1

Comment 59: Water Heater Data Plate Pictures:.

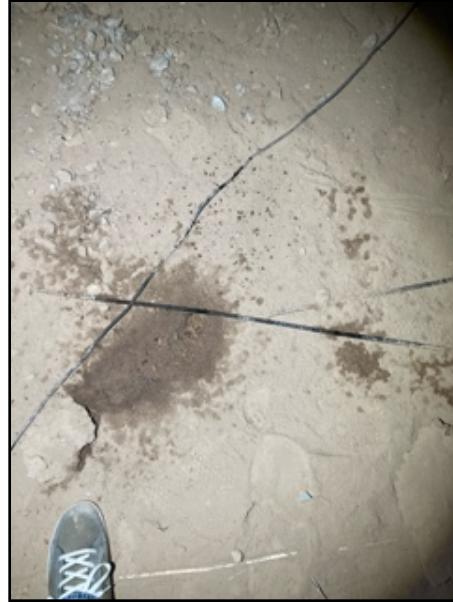
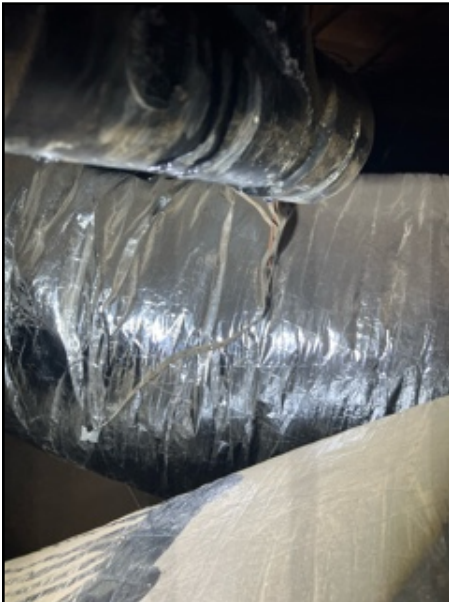
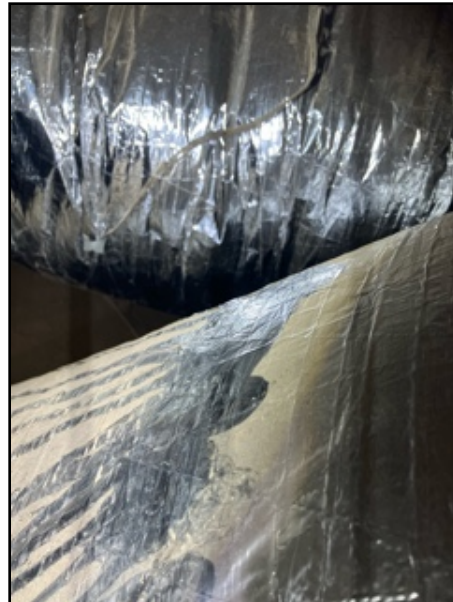
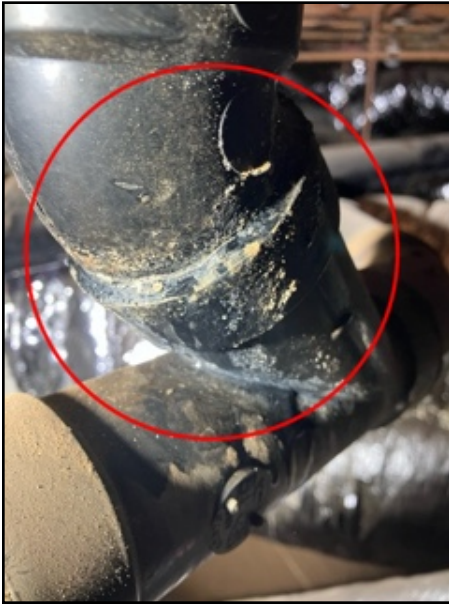
REPAIR OR REPLACE: Two leaks on drainage lines underneath primary bathroom. Have a more qualified professional to evaluate and repair.

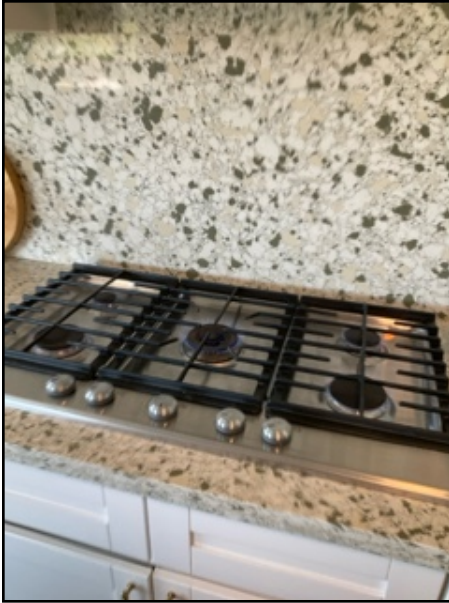
Figure 71-1

Comment 71:
Cooktop working.

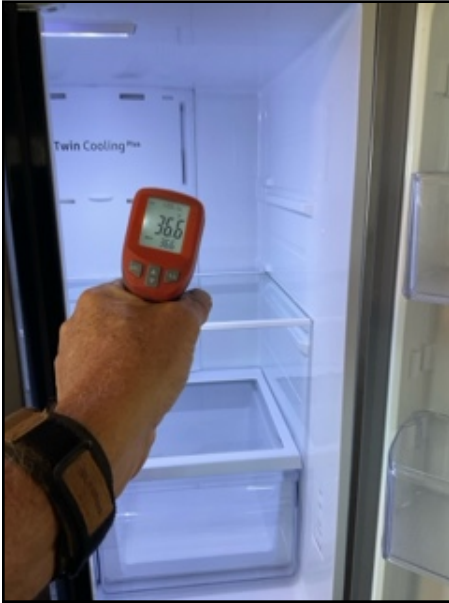
Figure 72-1

Comment 72:
Refrigerator working.

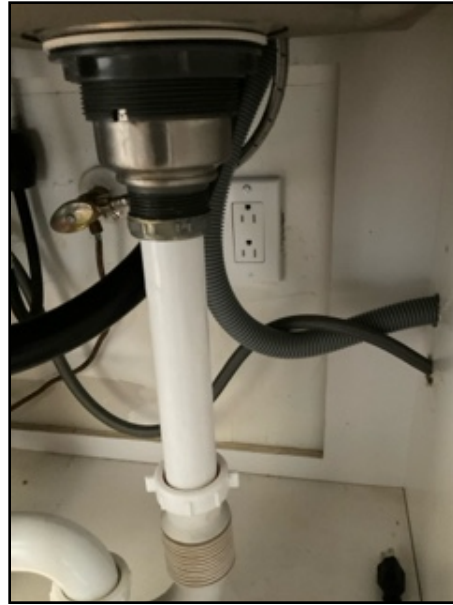
Figure 73-2

Comment 73:
REPAIR OR REPLACE: Garbage disposal noted as not plugged in at time of inspection. Inspector plugged in unit to both top and bottom outlet and it would continuously run. The outlet is not connected to the switch on right side of sink. Have a more qualified professional to evaluate and repair.

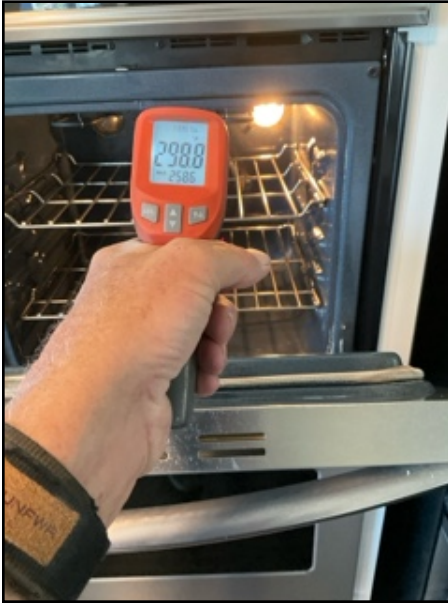
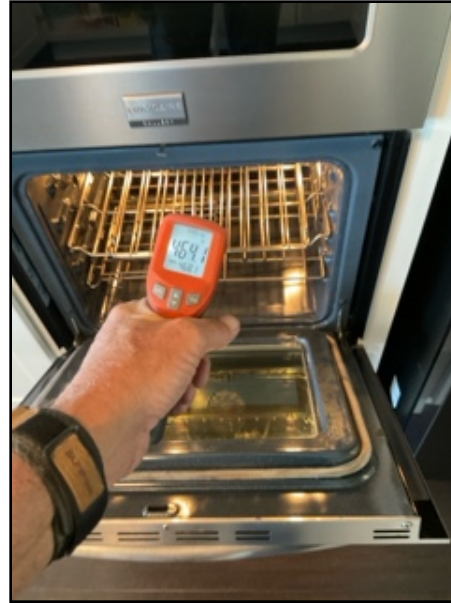
Comment 74:
Double ovens working.

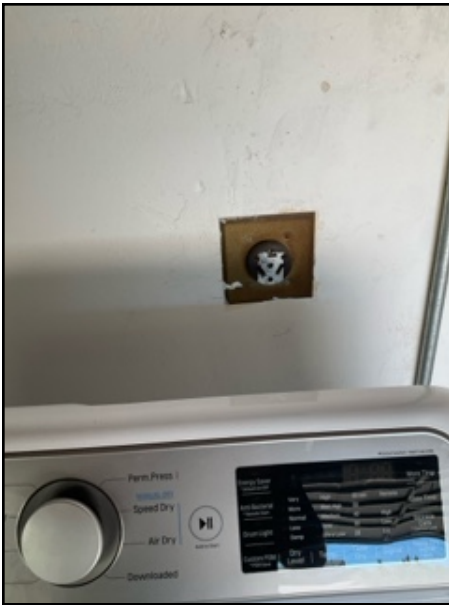
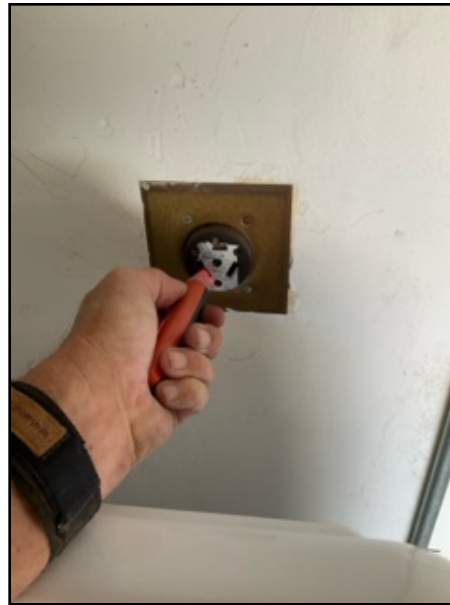
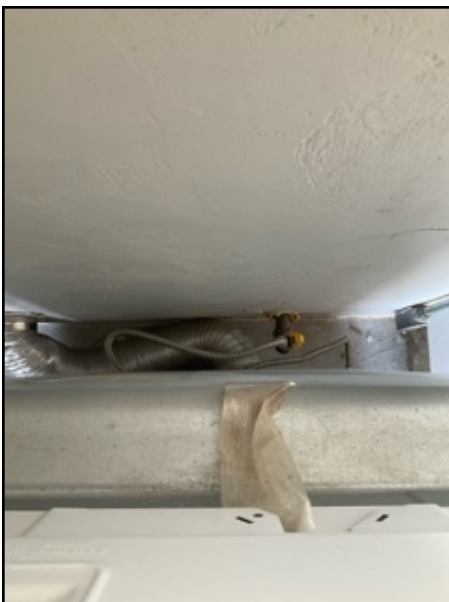
Comment 75:
Laundry is set up for 220 V or gas for dryer.
