USA Home Inspectors

Home Inspection Report

3254 S Bonita St

Inspected On: Wed, Jul 23 2025 at 8:00AM

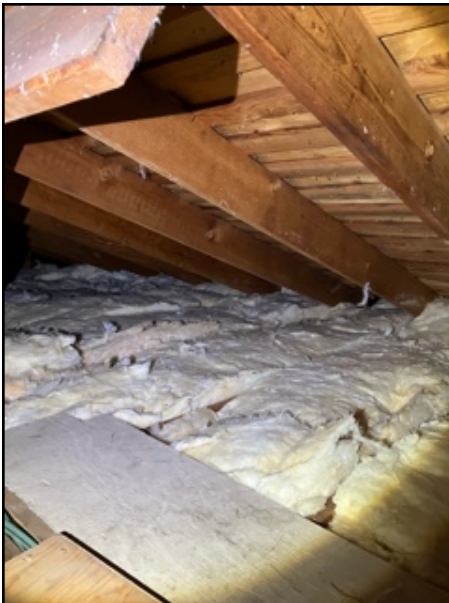
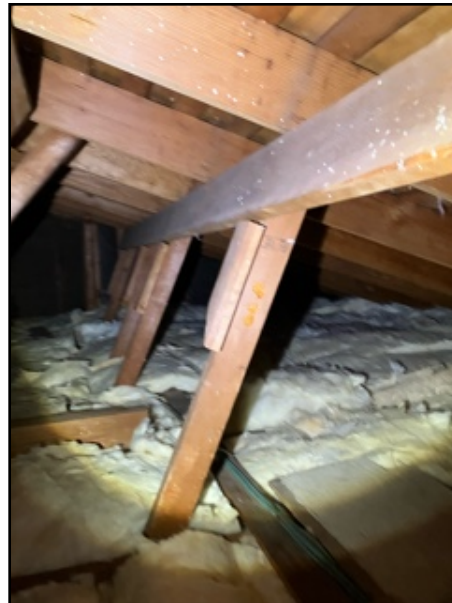
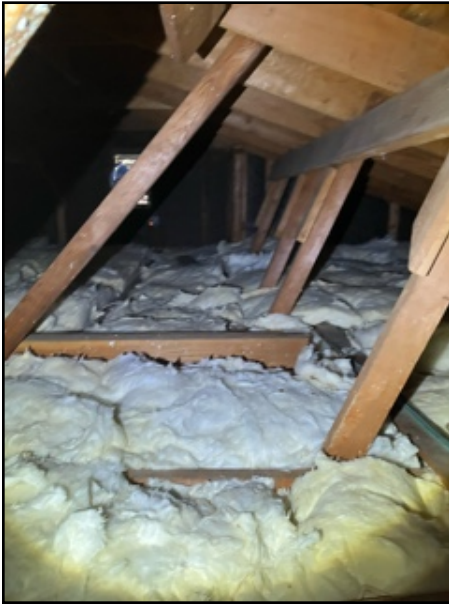
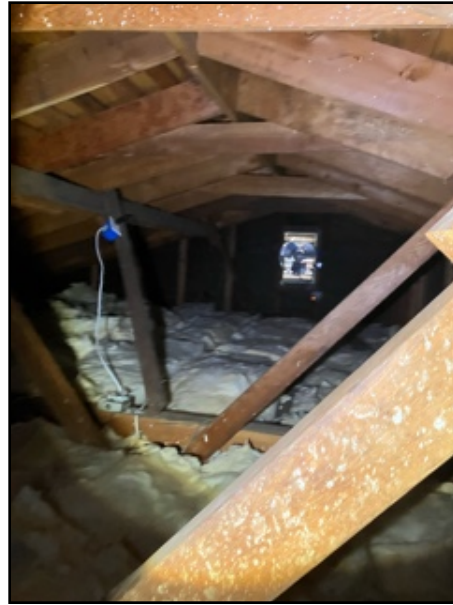
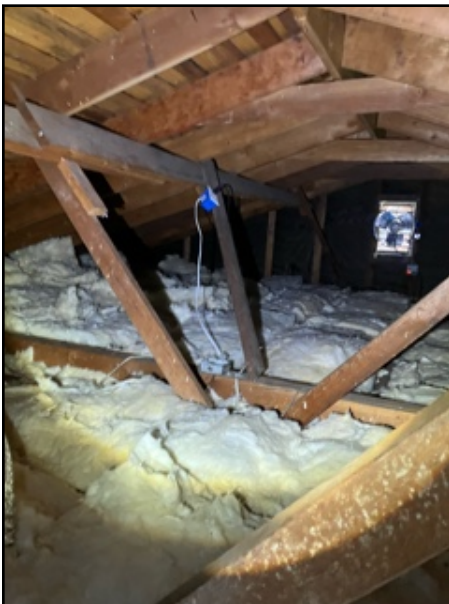
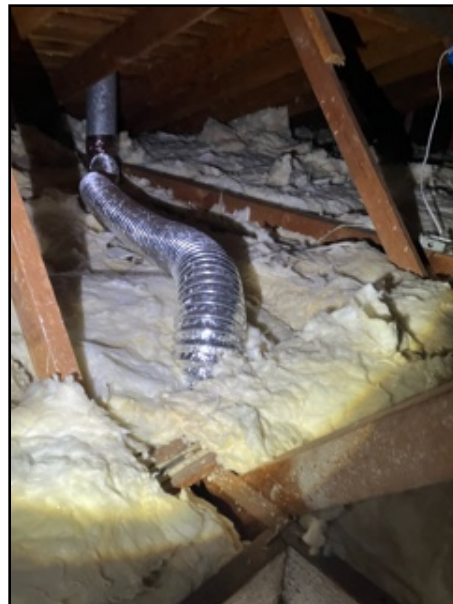
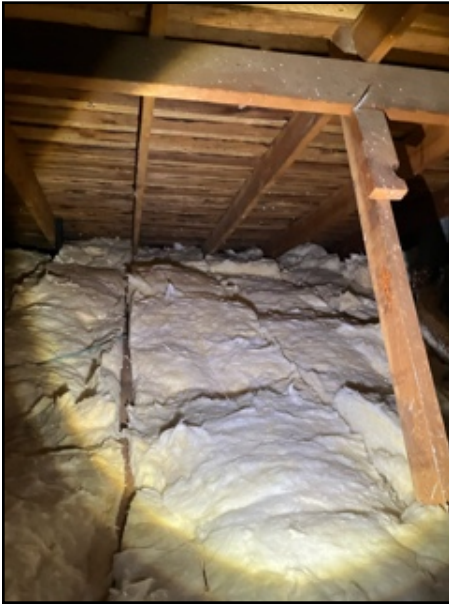
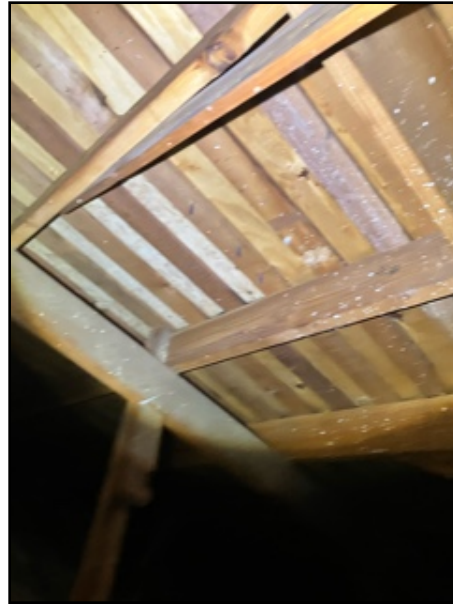
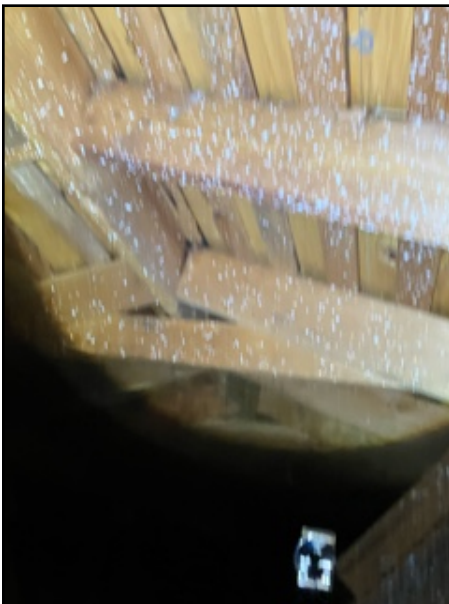
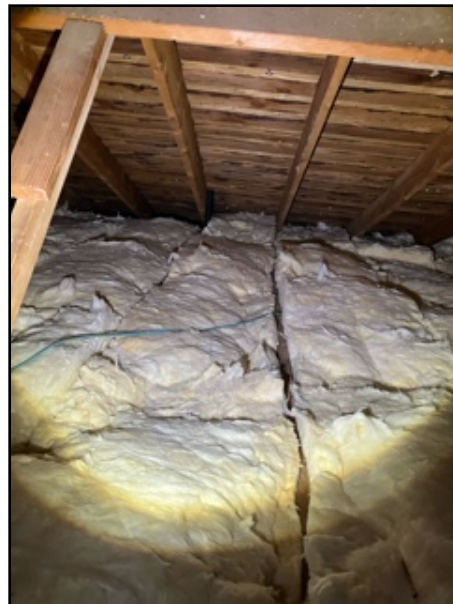
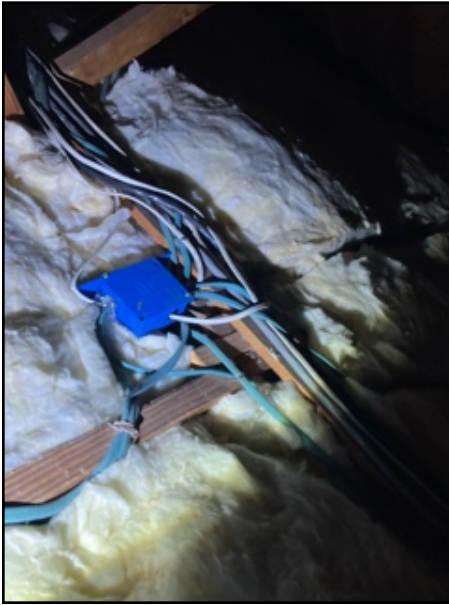
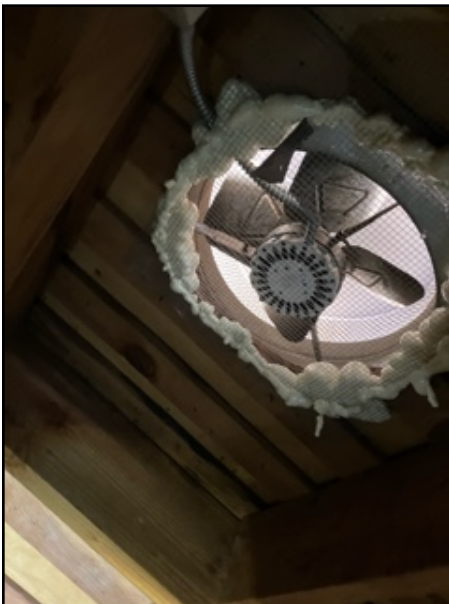
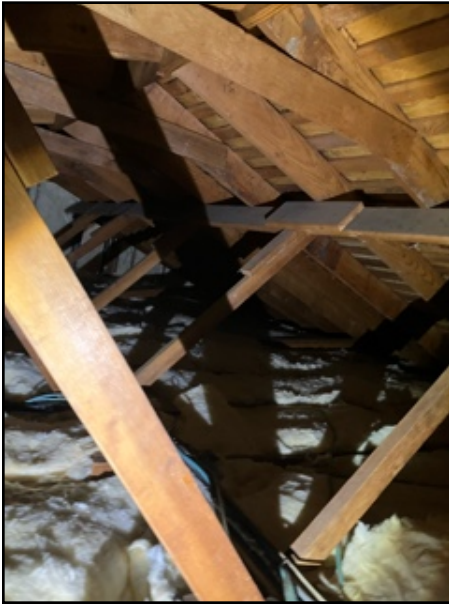
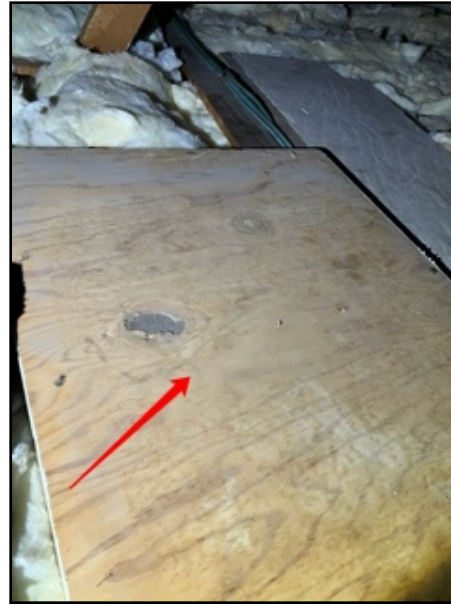
Some areas of the attic were not inspected due to limited access.

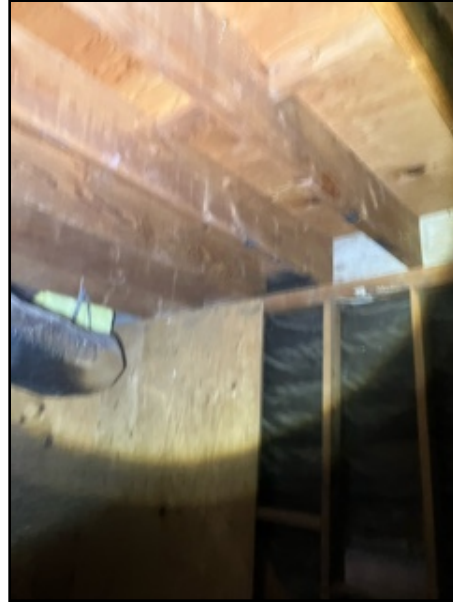
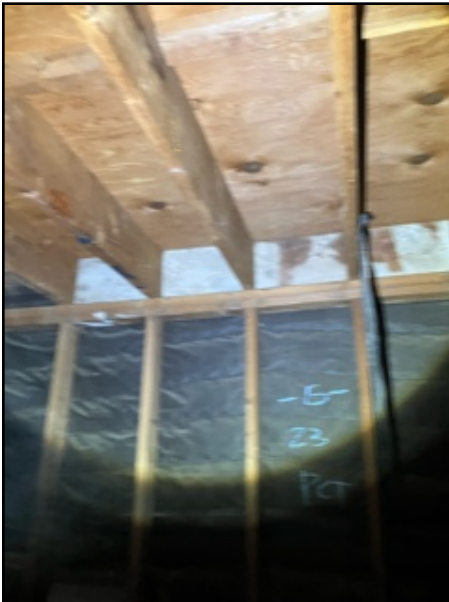
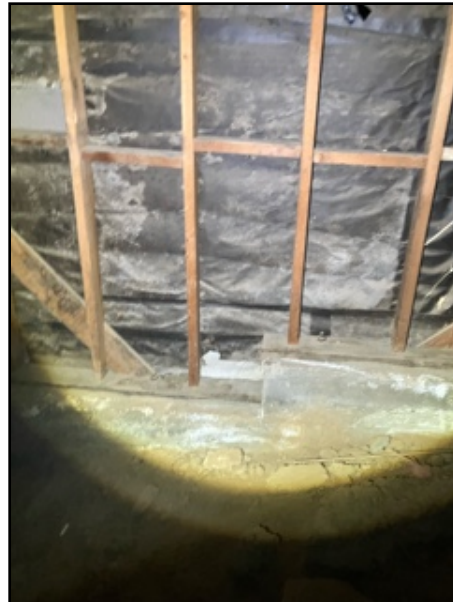
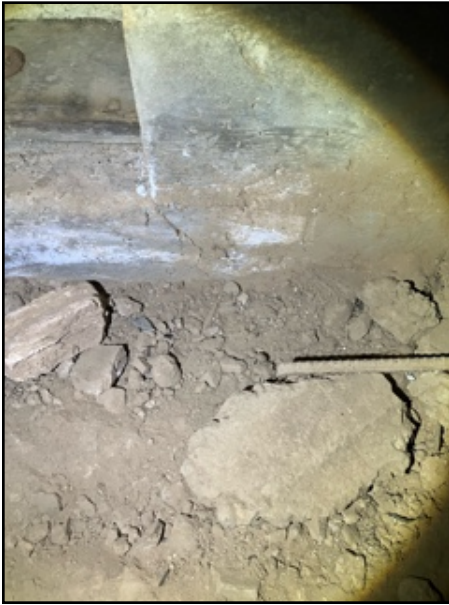
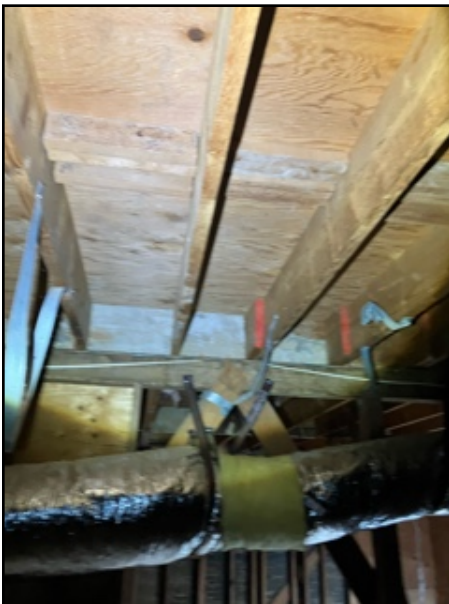
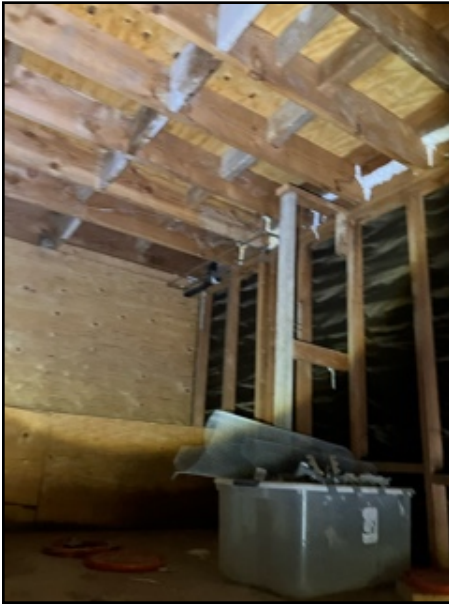
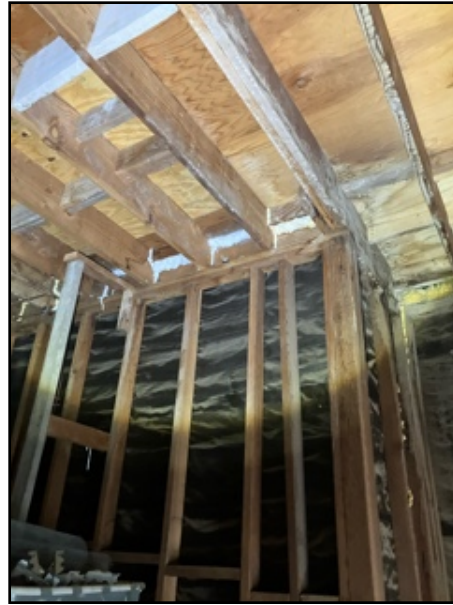
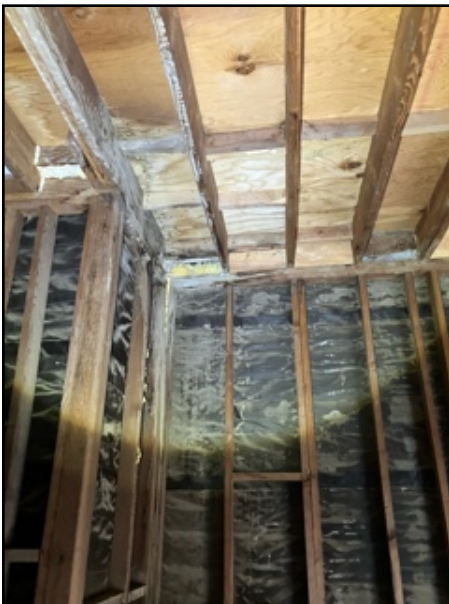
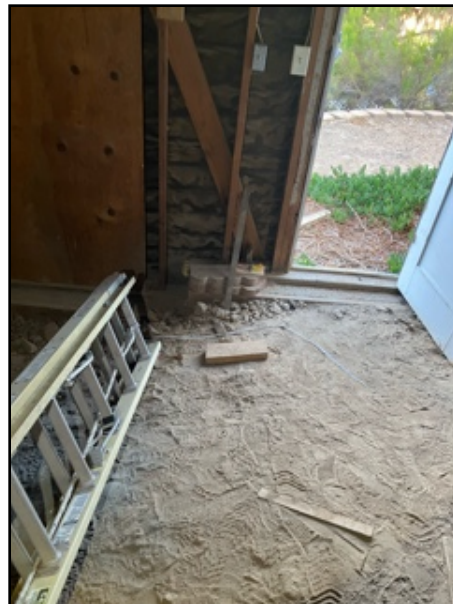
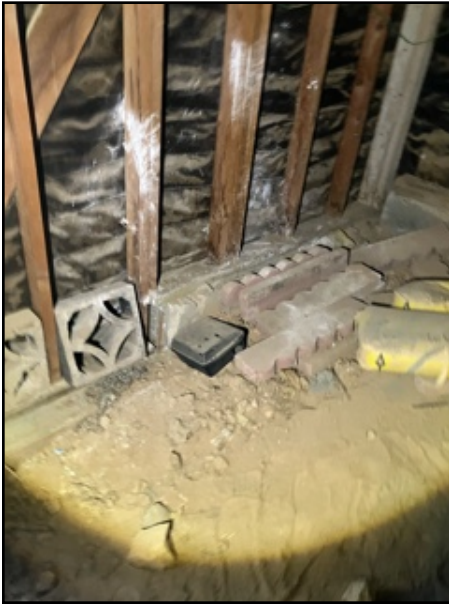
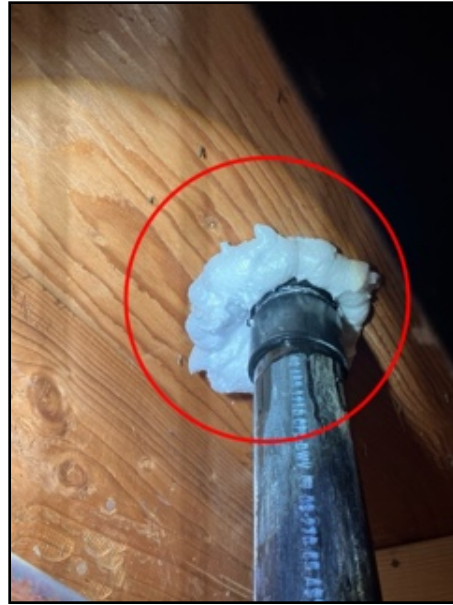
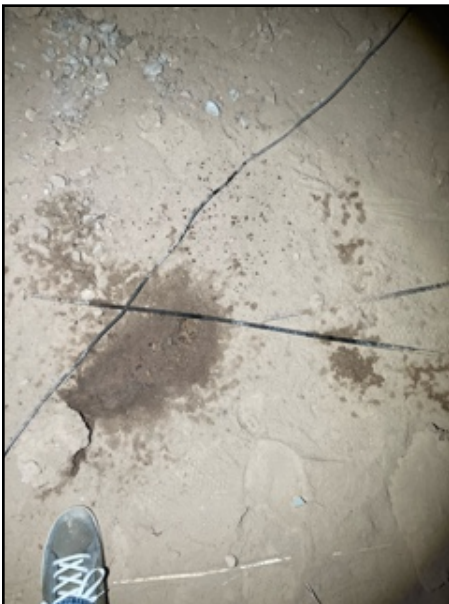
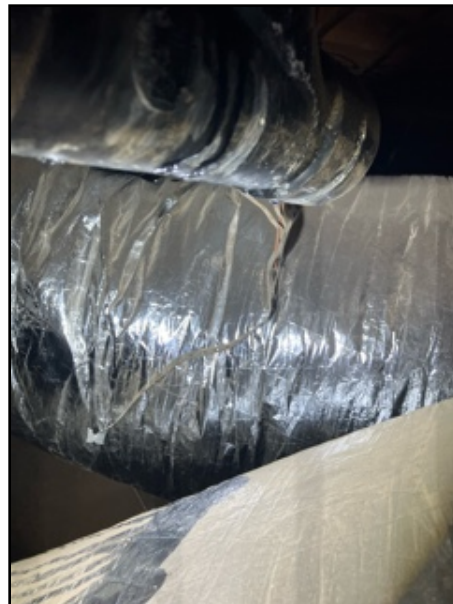
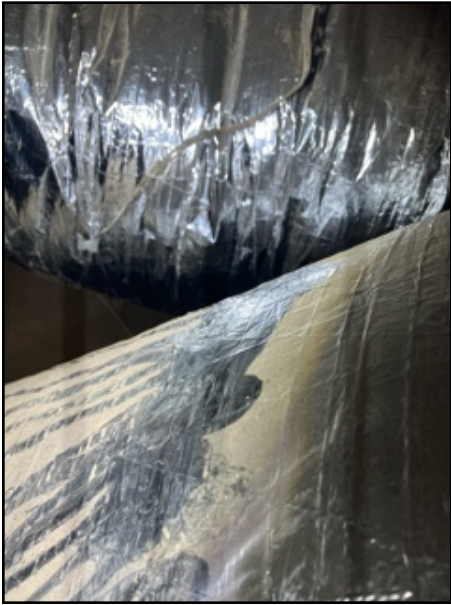
**Comment 77:**
REPAIR OR REPLACE: Two leaks noted on drain lines underneath primary bathroom. Evidence of rodents noted in crawlspace.

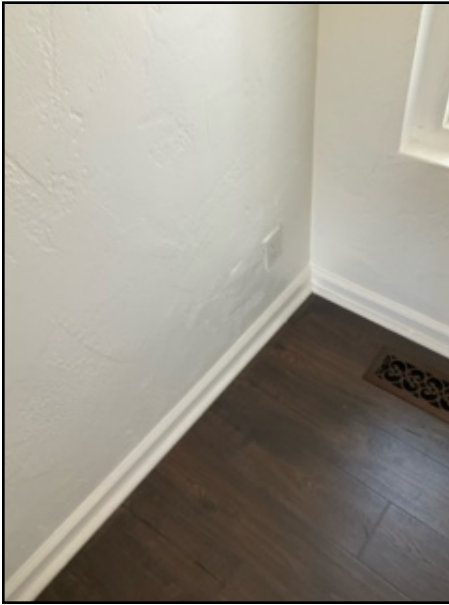
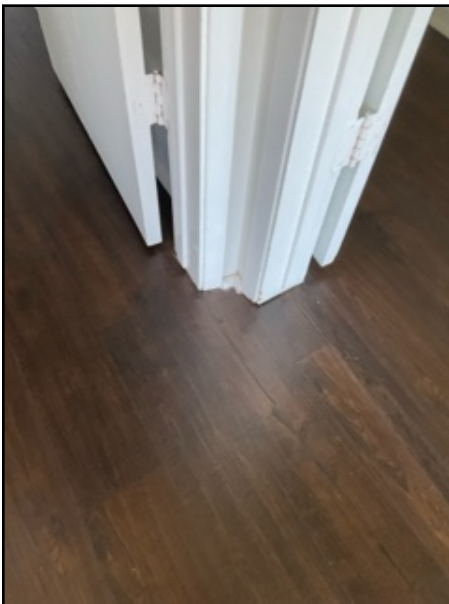
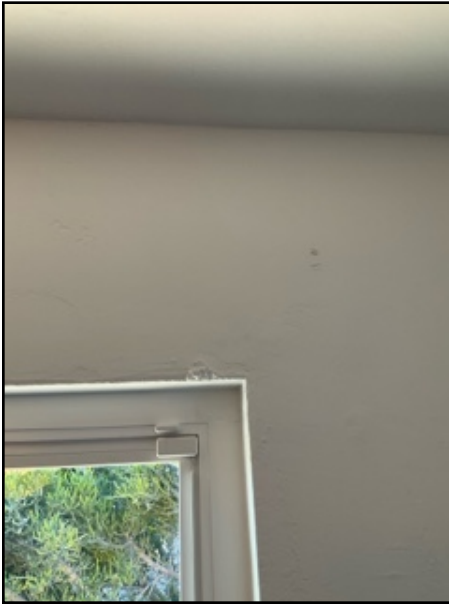
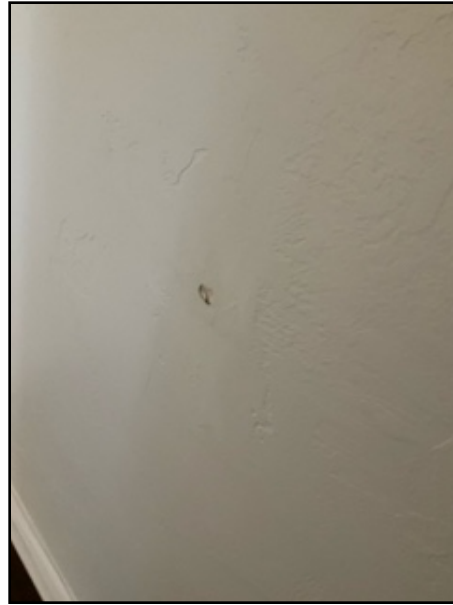
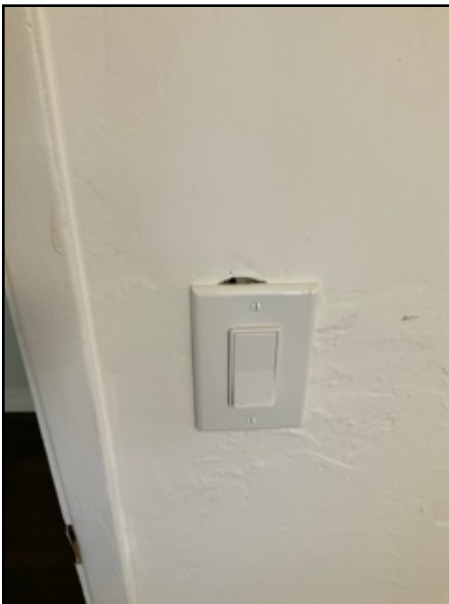
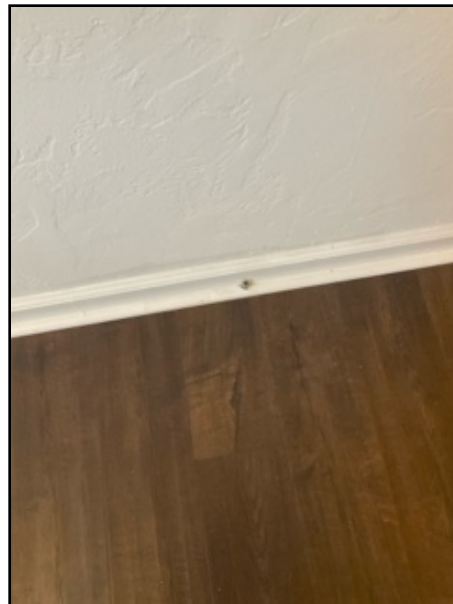
Minor paint, drywall damage, burned out bulbs, broken/missing covers and other minor cosmetic defects noted at various locations throughout the home.

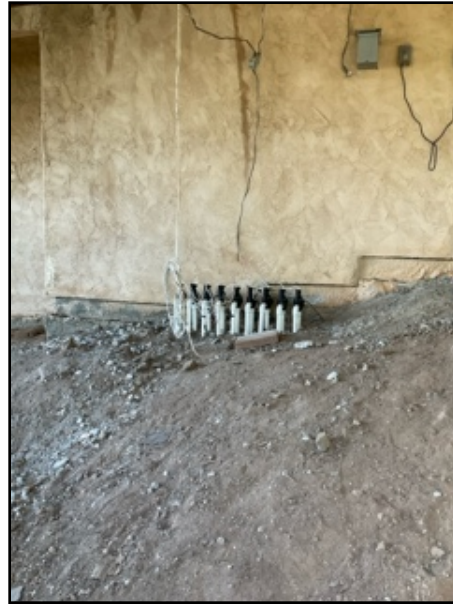
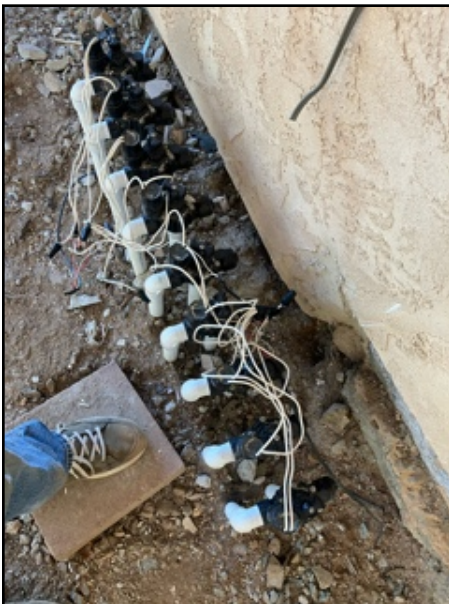
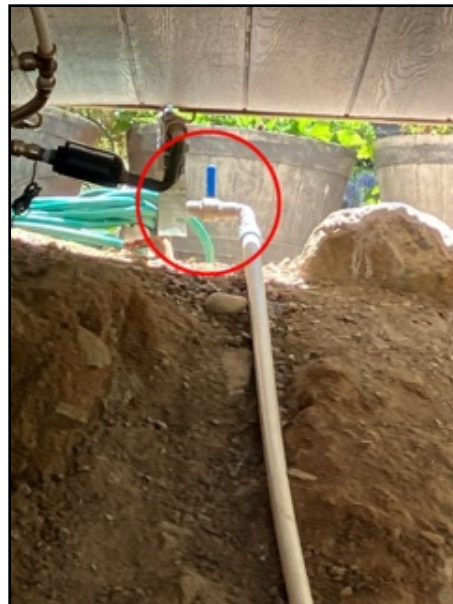
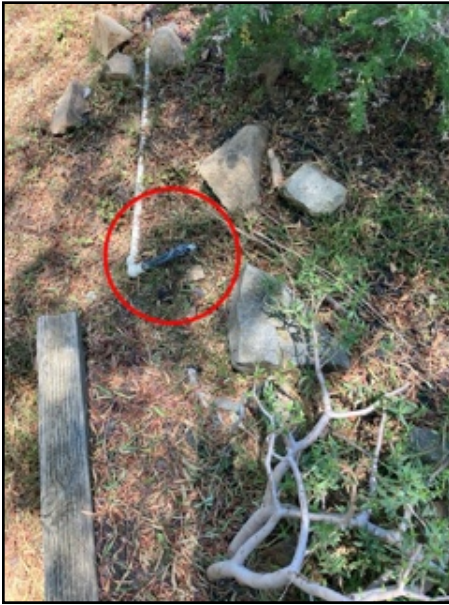
FURTHER EVALUATION REQUIRED: Water noted as turned off to sprinkler system at time of inspection. Some drip head sprinklers were not connected.
