Confidential Inspection Report

LOCATED AT:
337 S. Rodeo Dr
Beverly Hills, California

INSPECTED ON:
Wednesday, January 15, 2025

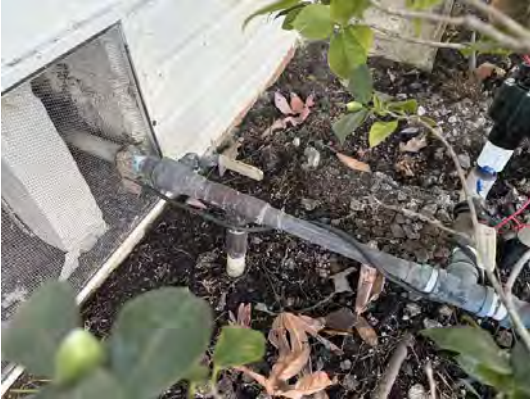
MAIN WATER SHUT OFF LOCATION

In the front of the building.

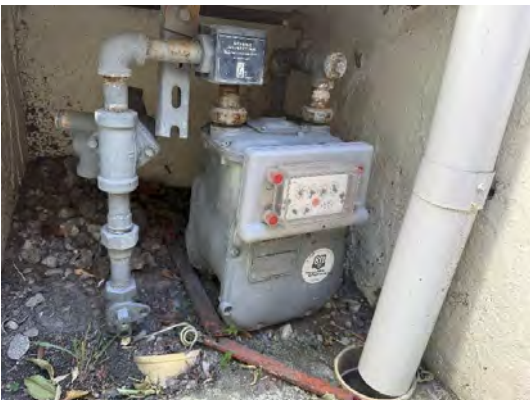
GAS METER LOCATION

The gas meter is located at the back of the building.

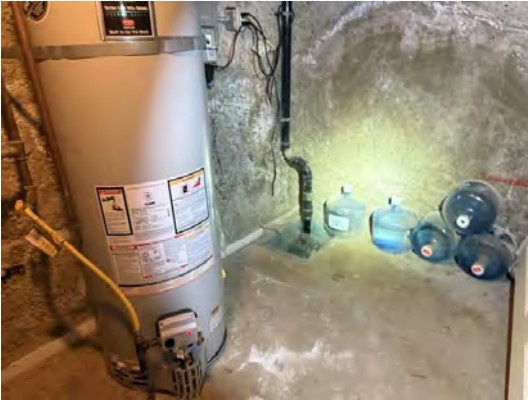
LOCATION

The water heater is located in the basement.

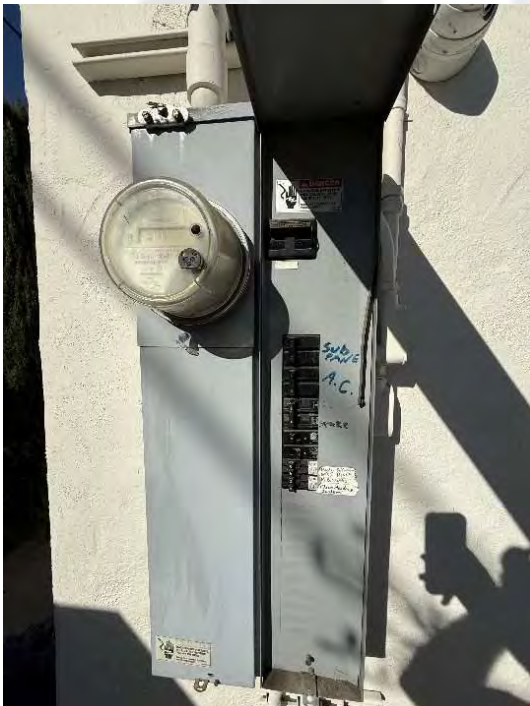
MAIN PANEL LOCATION

On the left exterior side of the building.

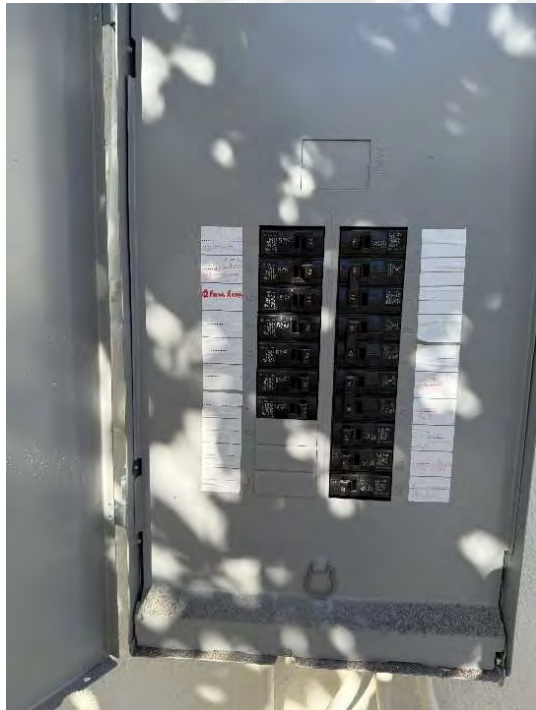
On the exterior of the building on the left

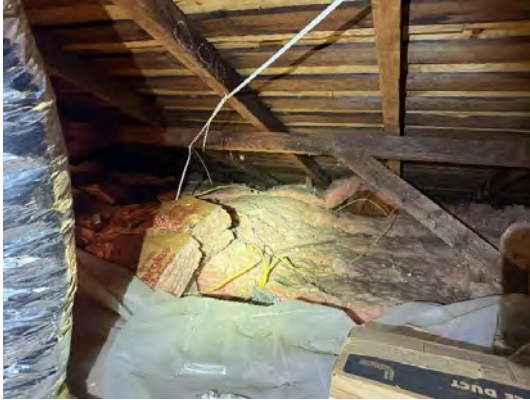
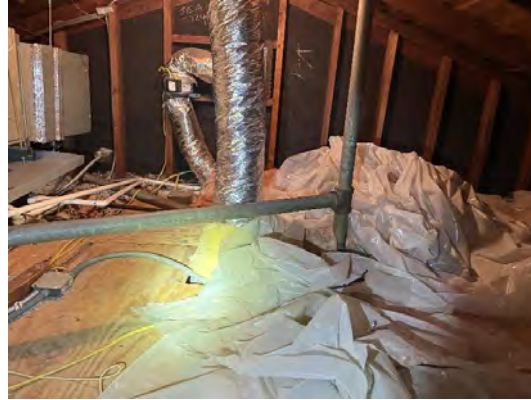
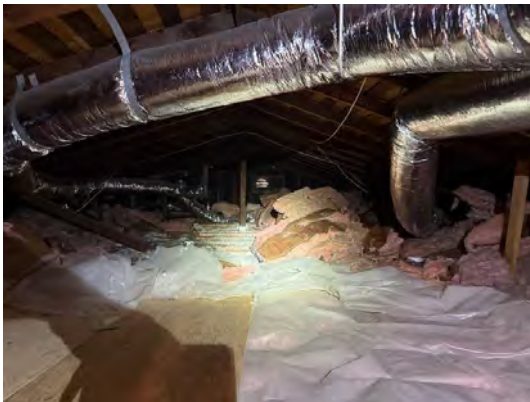
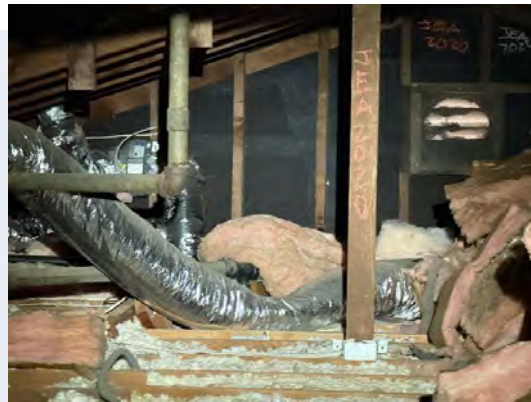
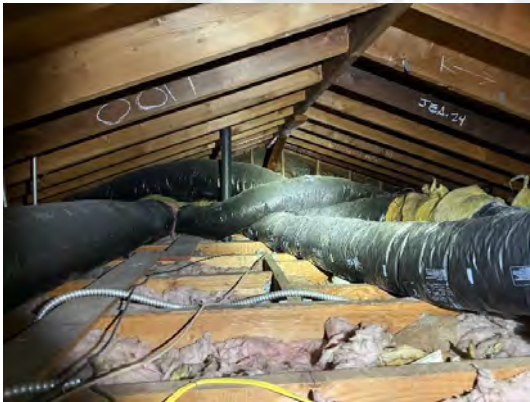
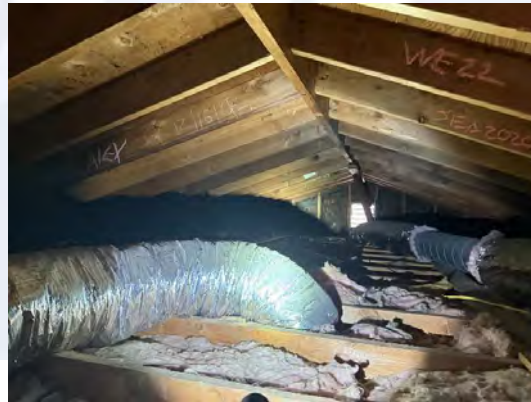
ACPT Acceptable where visible.

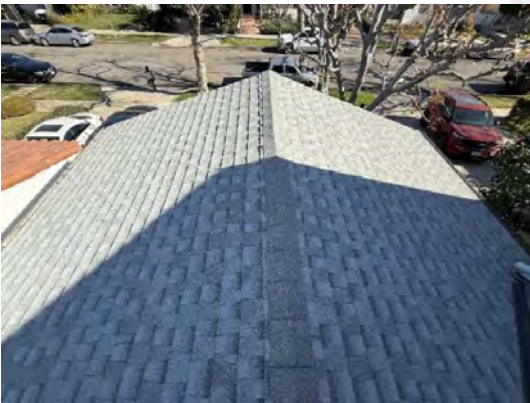
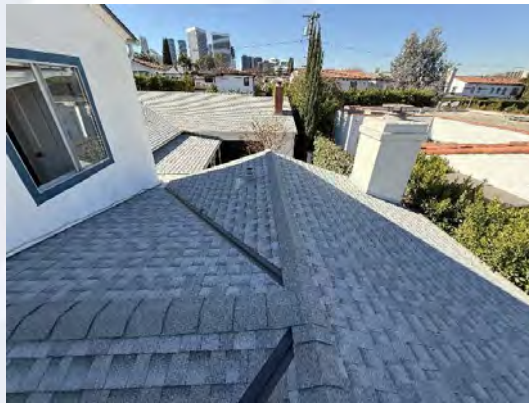
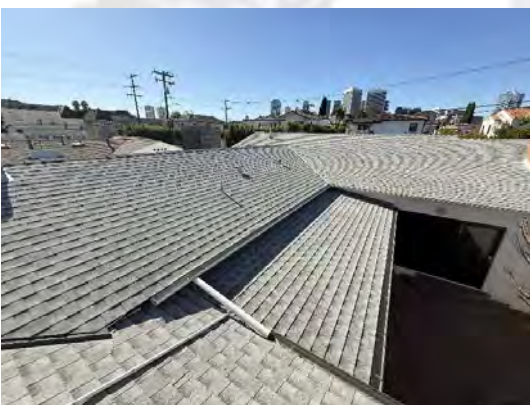
NDSA The mastic is cracked in areas and is not reliable to ensure a watertight seal. This was noted at the right rear of the roof

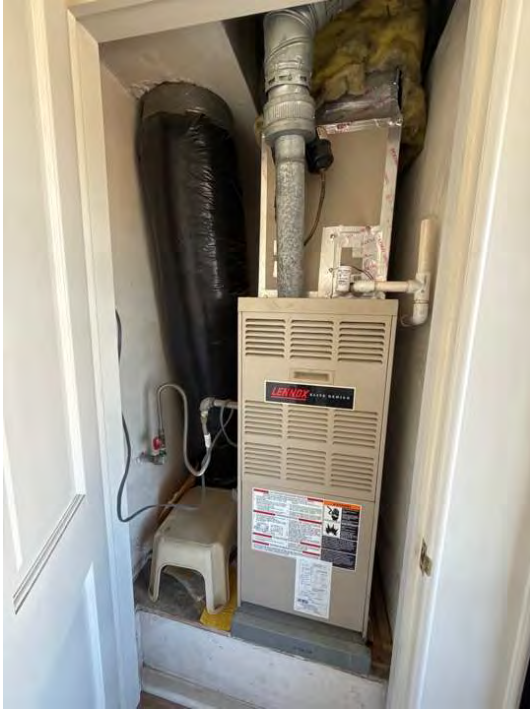
This unit is located in the primary bathroom closet

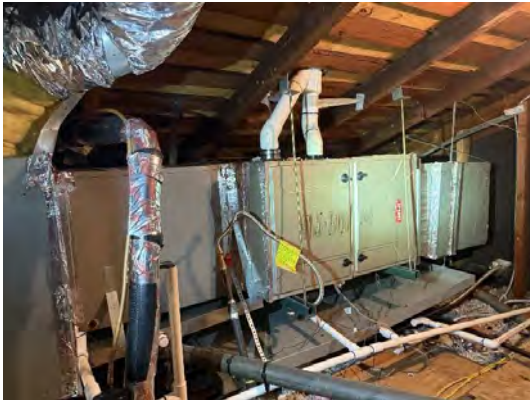
In the attic

The furnace is a gas-fired forced air system.

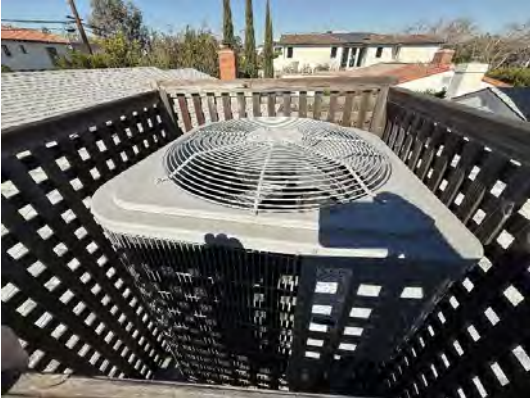
The condenser for the air conditioning is located on the roof.
