REAL ESTATE INSPECTION REPORT

Property Address:
686 S Camino Real
Palm Springs, CA 92264

Report # 10777

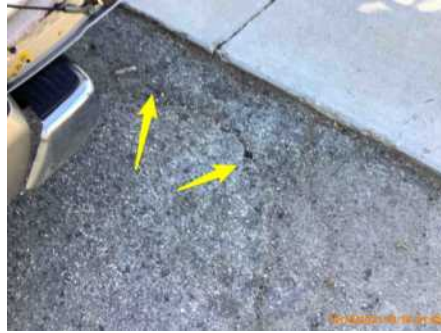
RM Cracks noted to driveway, We recommend further review and repairs by a qualified specialist in the appropriate trade.

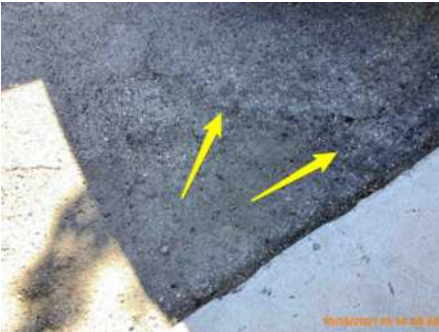
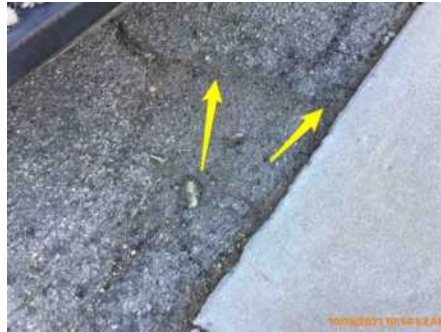
SC Tripping hazards noted at driveway. We recommend further review and repairs by a qualified specialist in the appropriate trade.

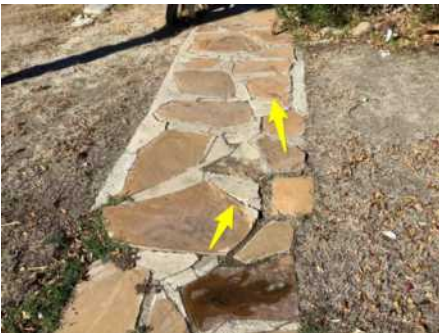
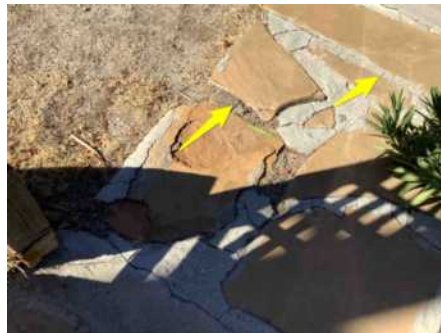
SC Walkway surface is raised/settled, this has created a TRIP - HAZARD at front. We recommend further review and repairs by a qualified specialist in the appropriate trade.

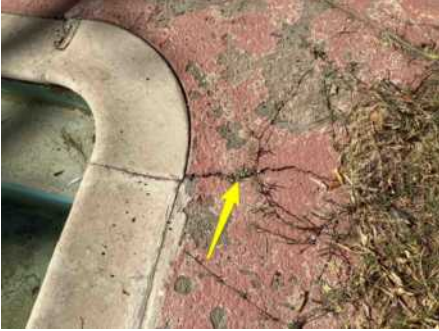
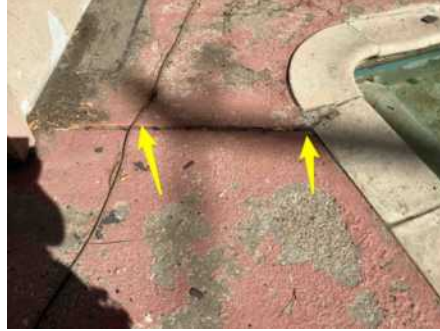
SC Patio surface raised/settled, this has created a TRIP - HAZARD at rear decking near pool. We recommend further review and repairs by a qualified specialist in the appropriate trade.

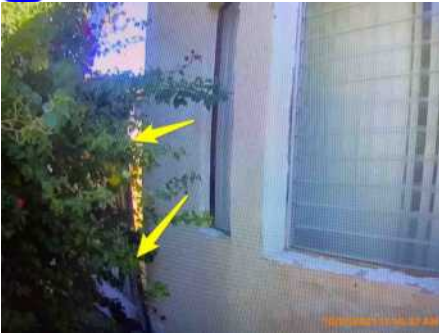
NR Loose posts noted at left side of house

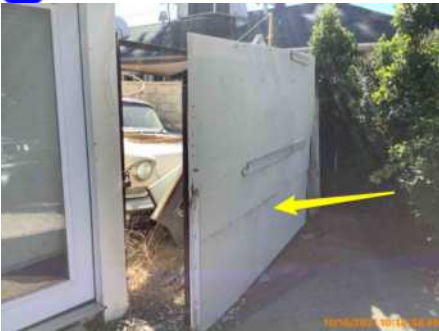
NR Gate needs repair at right side

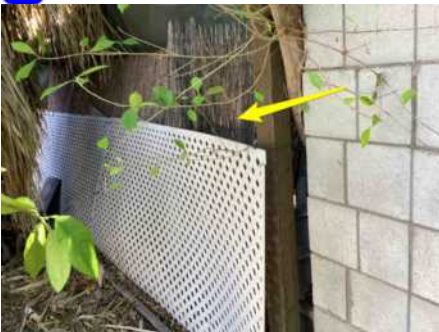
NR Repair needed to fencing

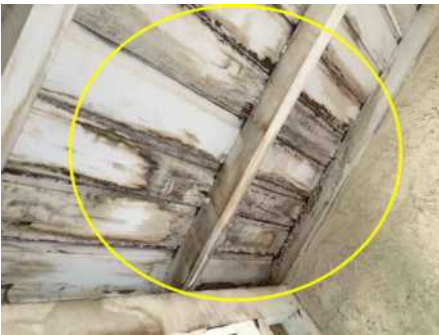
NR Moisture damage noted to front porch roof sheathing, Recommend further evaluation by a qualified Termite Company

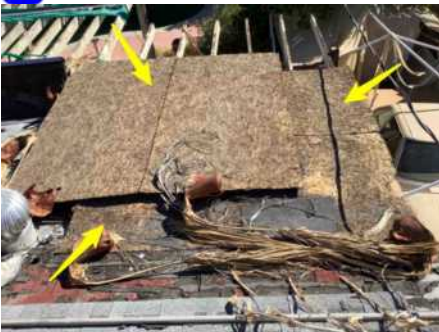
NR Roofing material missing on patio roof

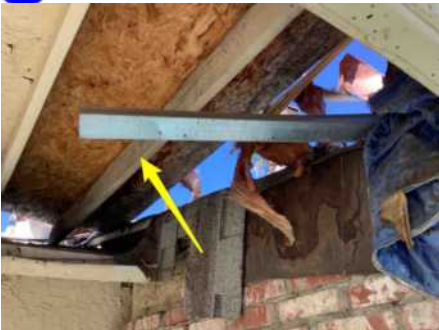
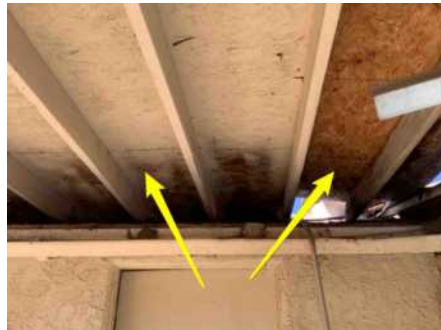
NR Improper installation at patio roof.

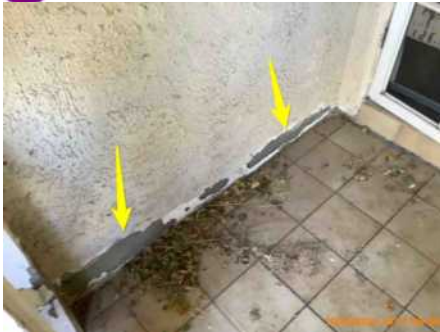
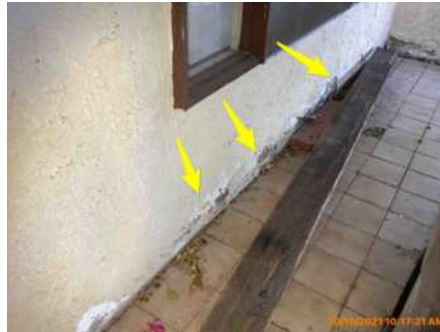
RM Damaged stucco noted at front

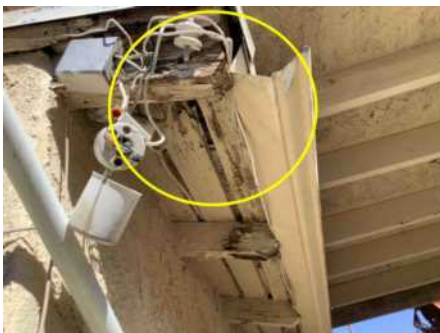
NR Damage noted at roof rafter(s). We recommend further review and repairs by a qualified specialist in the appropriate trade.

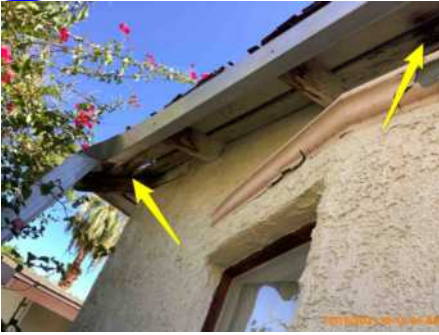
Staining noted at eaves, We recommend further review and repairs by a qualified specialist in the appropriate trade.

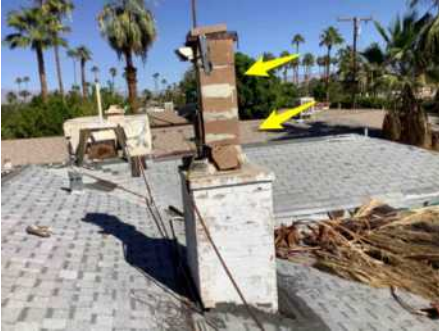
NR Appears to have been improperly altered. Recommend chimney specialist to evaluate and repair as needed.

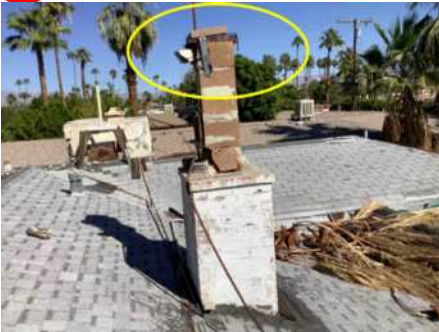
SC Improper cover and spark arrestor noted at chimney. Recommend further evaluation by a chimney specialist.

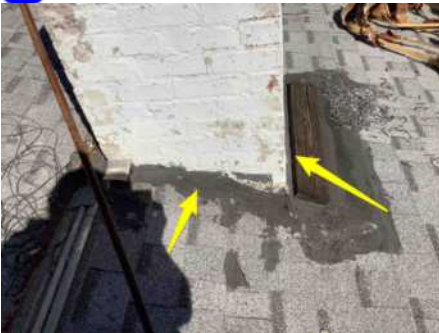
NR Counter flashing missing at chimney.

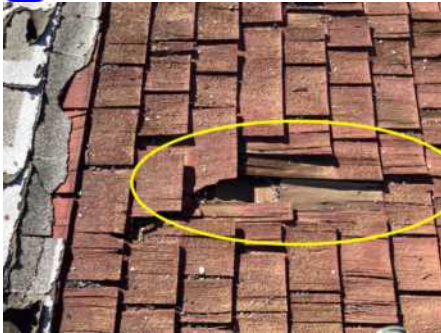
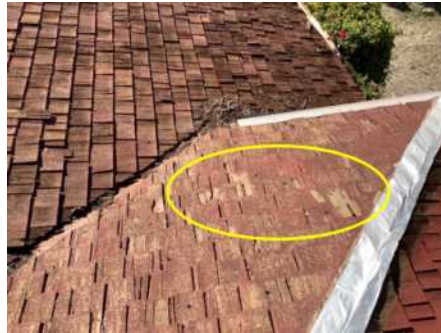
NR Damaged or missing Shingles noted. Repair/Replacement needed.

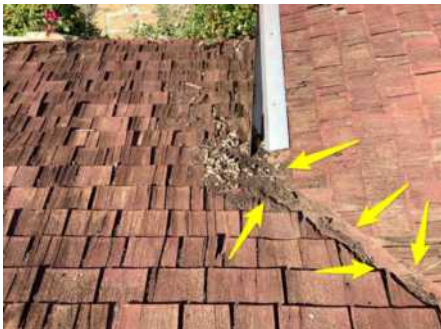
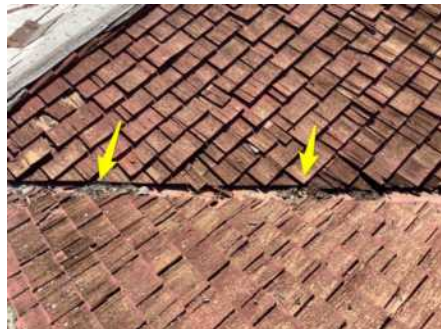
RM Clean debris from valley flashing to allow for proper drainage so roof does not leak when it rains. We recommend further review and repairs by a qualified specialist in the appropriate trade.

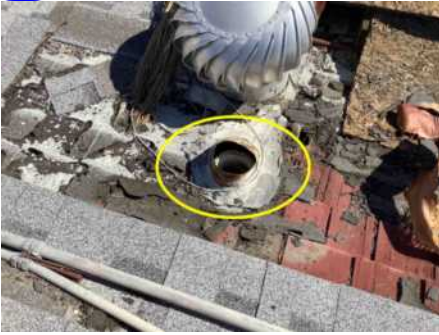
NR Cap missing on roof vent for water heater .

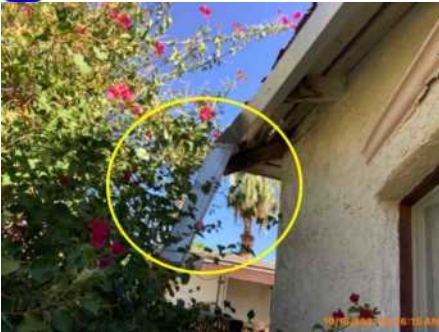
NR Damage gutters viewed

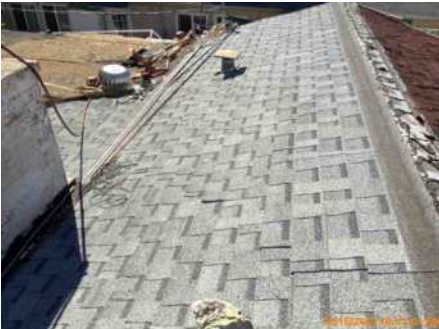
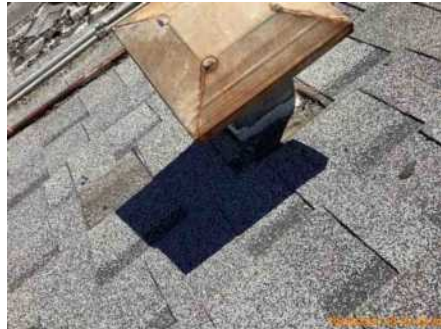
NR The only way to determine whether a roof is absolutely water tight is to observe it during a prolonged rainfall. Many times, this situation is not present during the inspection. Recommend roof be evaluated and certified by a qualified Roofing Contractor due to its age.

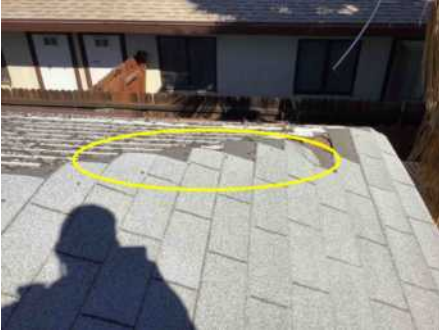
NR Nails/Fasteners are protruding from the roof surface. Recommend the entire roof be evaluated and repaired by a qualified Roofing Contractor

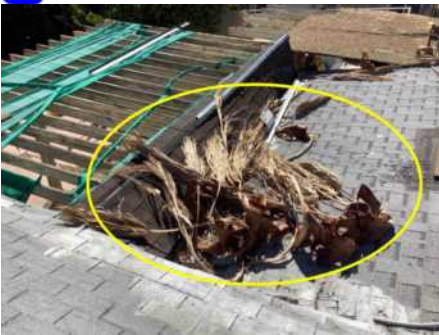
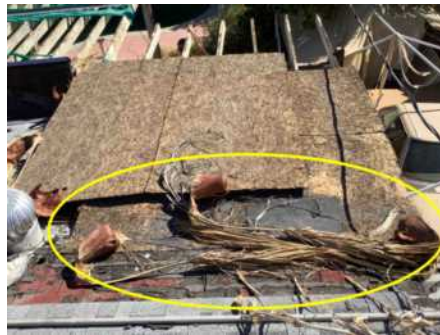
NR Debris should be removed from roof, Recommend further review and repair by a qualified Roofing Contractor

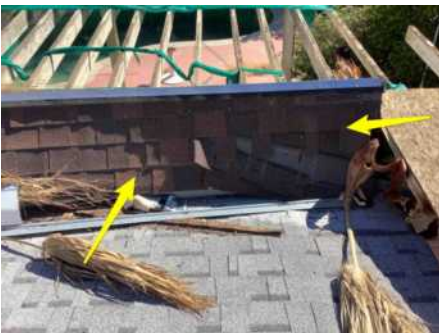
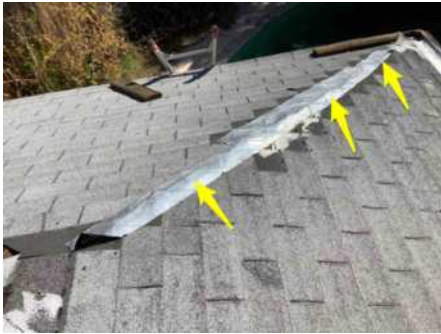
NR Improper installation is found, Recommend the entire roof be evaluated and repaired by a qualified Roofing Contractor

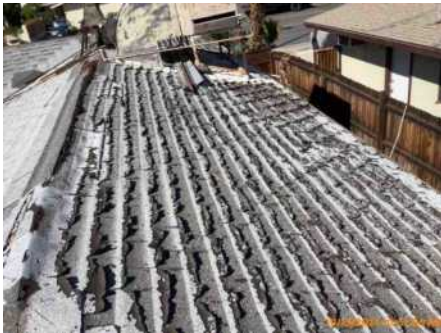
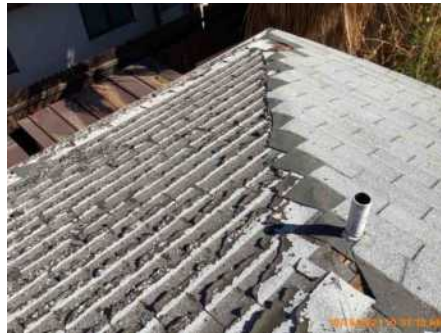
NR Heavy Wear noted to composition roof, composition roof appears to be at its end of its service life. Recommend the entire roof be evaluated and repaired by a qualified Roofing Contractor.

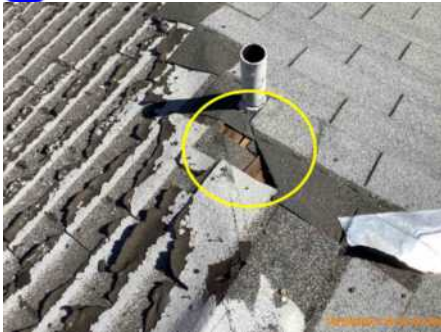
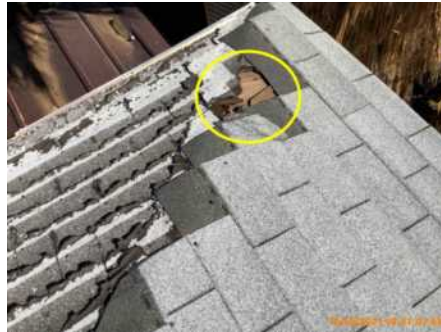
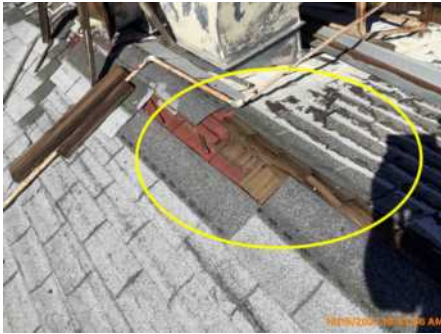
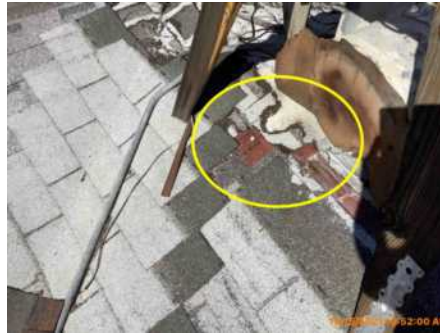
NR Missing composition shingles in several areas

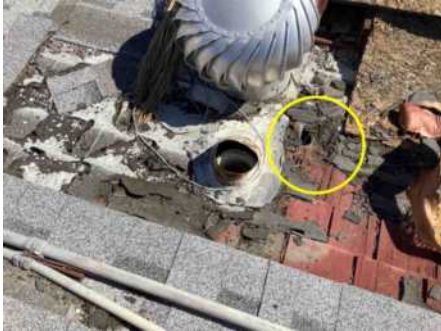
NR Damage noted to roof sheathing

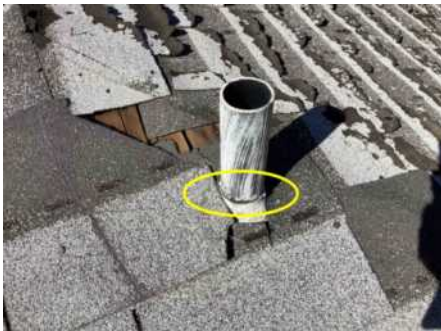
NR All flashing junctions should be re sealed to prevent leaks, We recommend the advice and services of a qualified Roofing Contractor

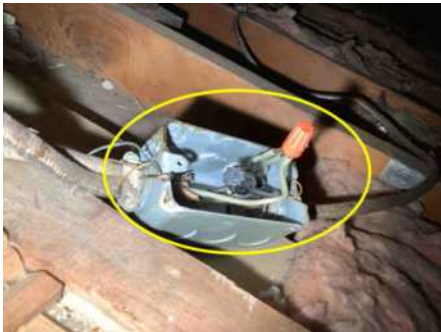
SC Junction box cover(s) missing in attic area, this is a fire hazard, all attic electrical be reviewed. Recommend further review and repair by qualified Electrical Contractor.

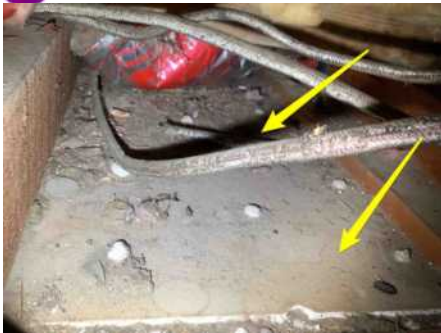
Uneven insulation noted, recommend adding additional insulation.

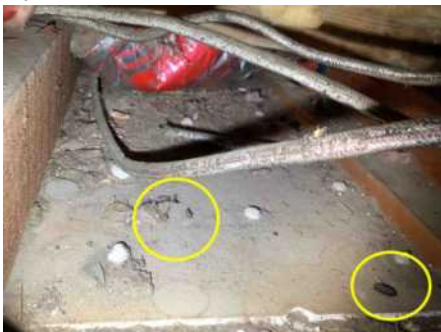
I observed evidence of rodents in the attic. Ask the Sellers about the rodent history and/or contact a Pest Control Operator to further evaluate.

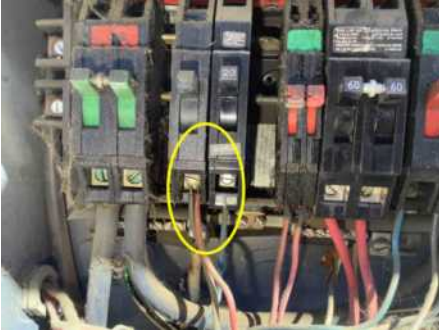
SC Multiple wires are connected to a single lug on a circuit breaker where only one wire should be connected. Recommend further review and repair by qualified Electrical Contractor.

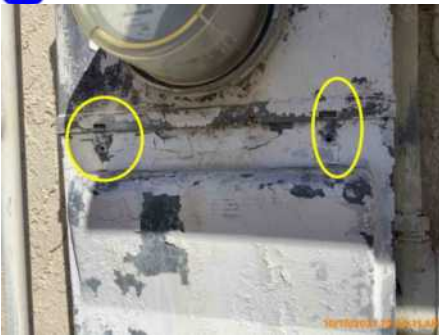
NR Panel cover hinges missing and or damaged.

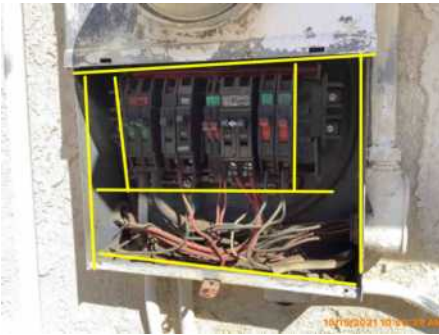
SC Dead front cover missing at main electrical panel, this is a safety concern, installation is needed for safety, Recommend further review and repair by qualified Electrical Contractor.

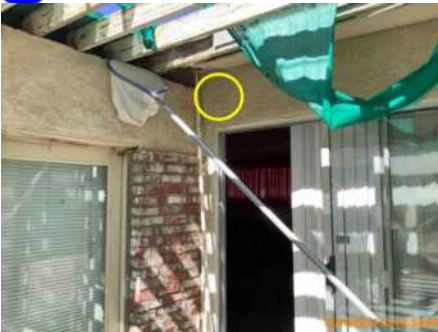
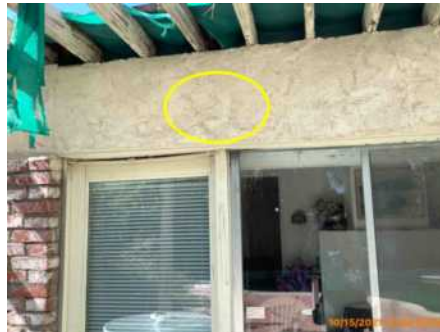
NR Light fixture missing, light fixture required at all grade level doors

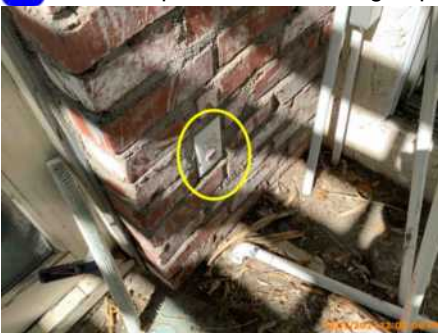
NR Weather proof cover missing at pool light switch.

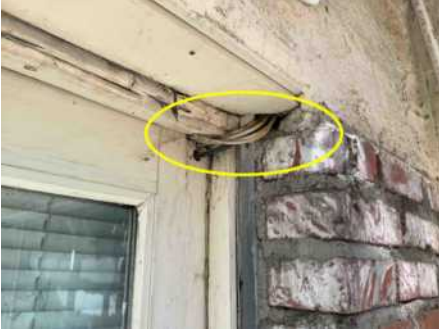
NR Exposed wiring should be properly protected. Recommend further review and repair by qualified Electrical Contractor.

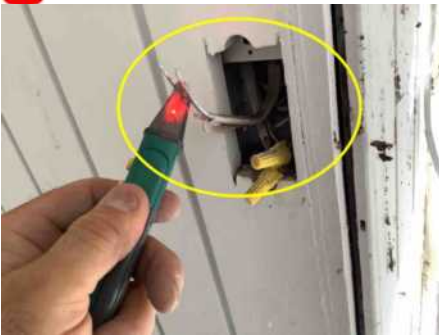
SC Exposed live wires noted at rear room

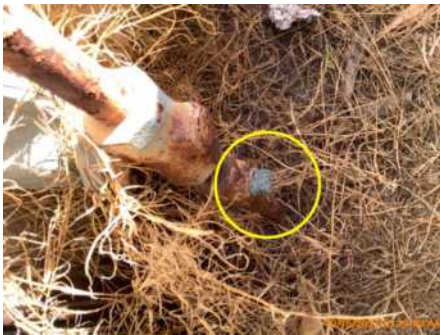
NR Gas service off at time of inspection We recommend the utility provider be notified in order to turn on gas before the close of escrow so a full inspection can be done. Fee for re inspection after gas in turned on is 225.00.

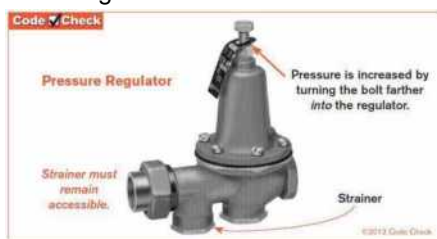
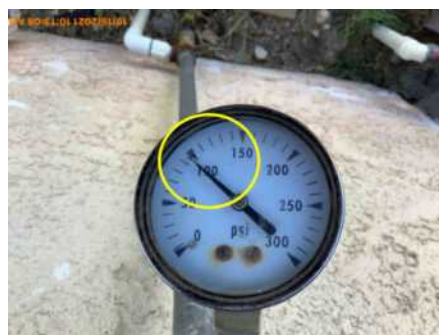
NR The homes water supply pressure exceeded the 80 pounds per square inch (PSI) limit considered the maximum allowable by generally-accepted current standards. Excessively high water pressure is likely to cause leaks. Water pressure noted at time of inspection was **100** psi, recommend the installation of a pressure regulator by a qualified Plumbing Contractor.

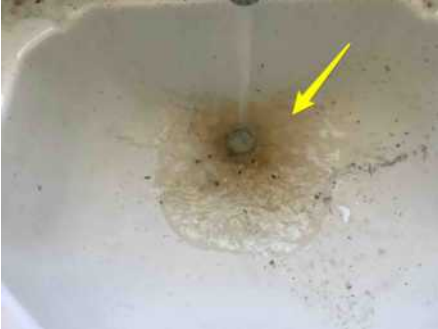
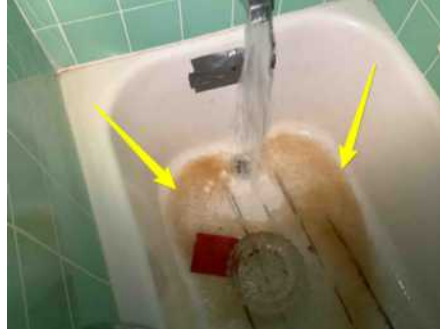
RM The home appears to contain some older galvanized steel water distribution pipes along with newer copper water supply. Galvanized pipes are outdated and subject to corrosion which will eventually result in restricted flow and leakage. We recommend the advice and services of a qualified Plumbing Contractor

RM Discolored water noted from galvanized pipes if water is not run for periods of time, life expectancy of galvanized piping is around 40 years, Galvanized system appears to be nearing/at end of its useful life

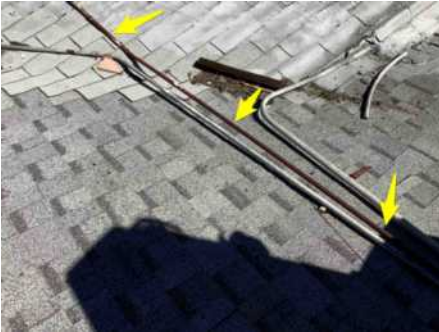
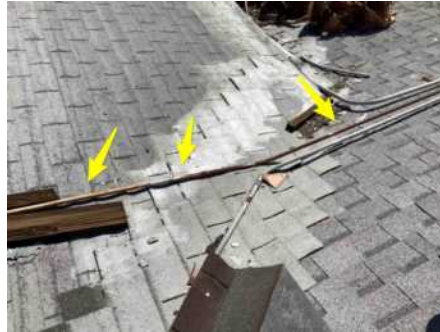
SC Rusting lines noted on roof, We recommend further review and repairs by a qualified specialist in the appropriate trade.

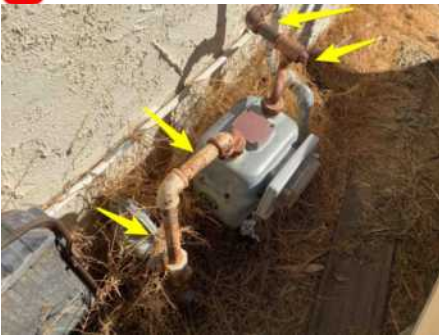
SC Rusting gas line noted at gas meter , We recommend the advice and services of a qualified Plumbing Contractor

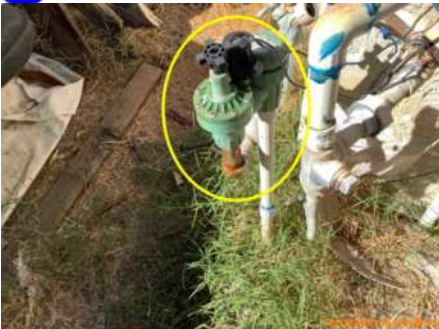
NR Sprinkler supply valve at rear right

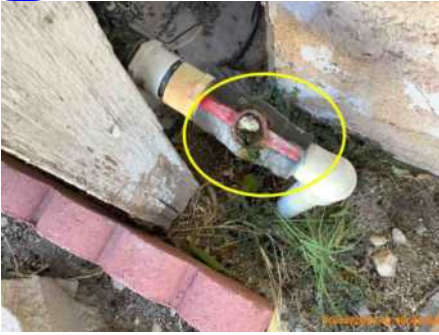
NR Sprinkler main supply line shut off valve handle leaking at front

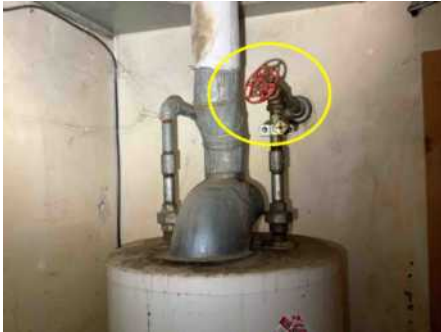
NR Shut off valve at water heater is seized, We recommend the advice and services of a State Licensed Plumbing Contractor

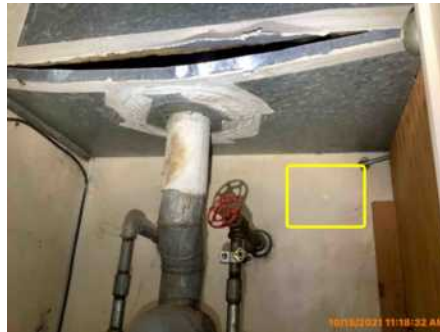
SC Combustion air vents missing. We recommend further review and repairs by a qualified specialist in the appropriate trade.

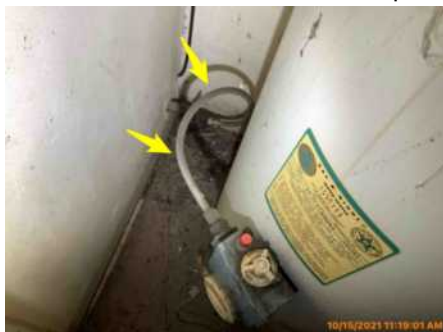
SC Solid aluminum gas line noted, Modern standards recommend the installation/ upgrade of a flexible gas line. Recommend further review and repairs as needed by a Qualified, State Licensed Plumbing Contractor.

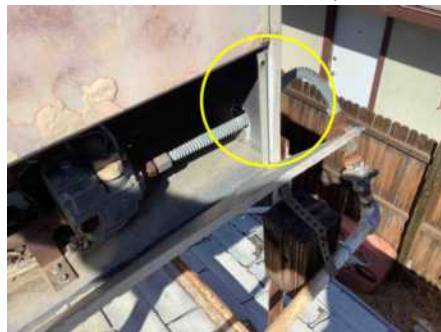
SC Flexible gas line connection shall not be concealed within or extended through any wall, floor, partition or appliance housing, this is a Fire Hazard due to Seismic Issues. The flexible gas line manufacture and the building code no longer permits this installation. We recommend the advice and services of a qualified Plumbing Contractor

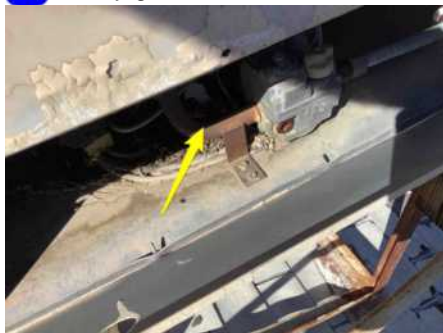
NR Rusty gas line noted at interior of heating unit

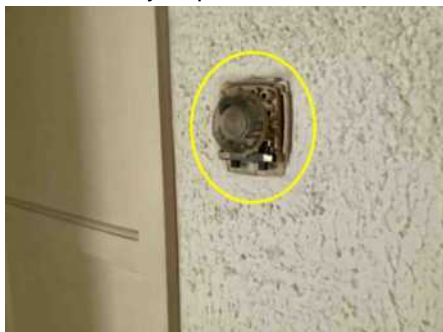
UG Thermostat is old and outdated, recommend a new thermostat be installed, Recommend further review and repairs as needed by a qualified mechanical contractor

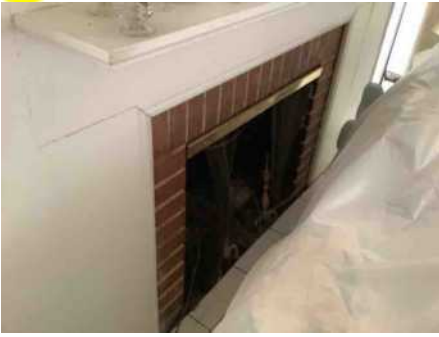
NT Stored items prevented inspection of fireplace

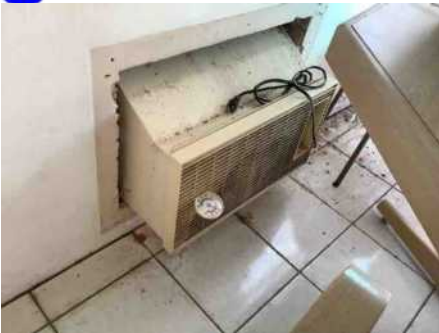
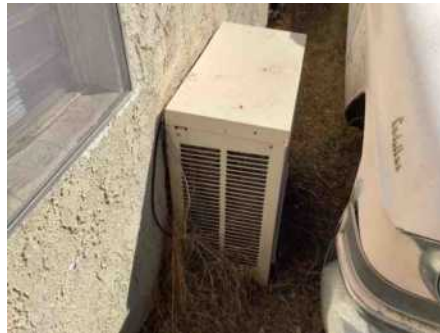
NR Evaporative cooler is no longer operable. Unit should be removed

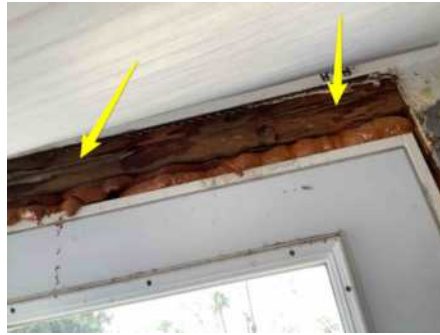
NR Damage and missing wall covering to dining area

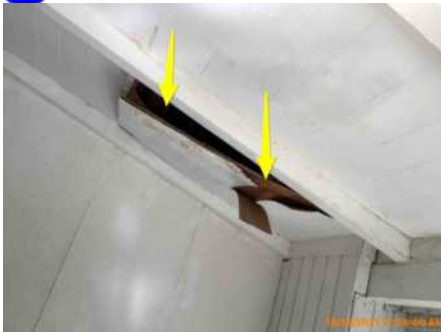
NR Moisture damage noted to rear room ceiling

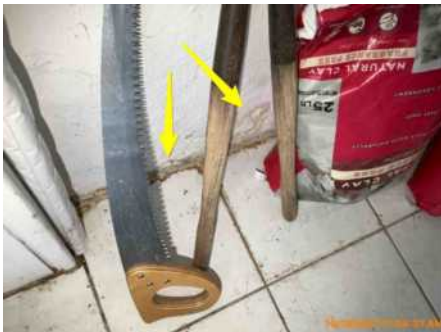
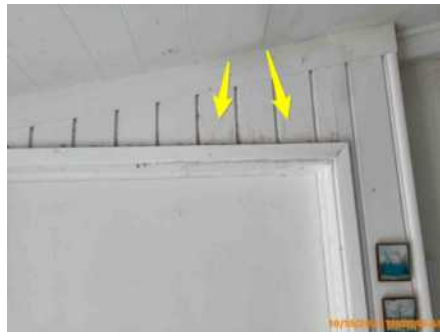
NR Stains noted at throughout home ceilings and walls, possible roof leak . We recommend further review and repairs by a qualified specialist in the appropriate trade.

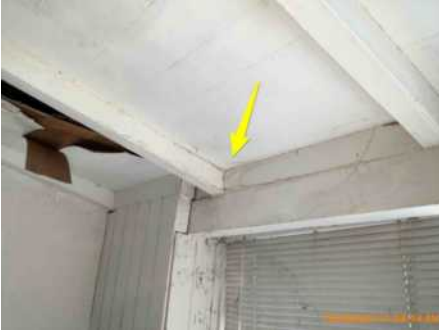
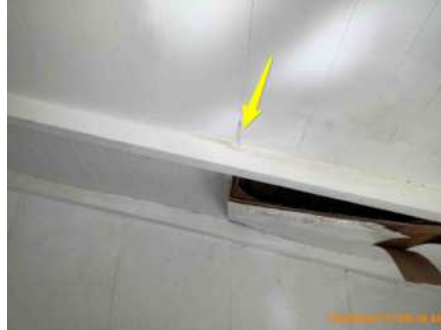
NR Stains noted to ceiling in rear room, roof appears to be leaking. We recommend further review and repairs by a qualified specialist in the appropriate trade.

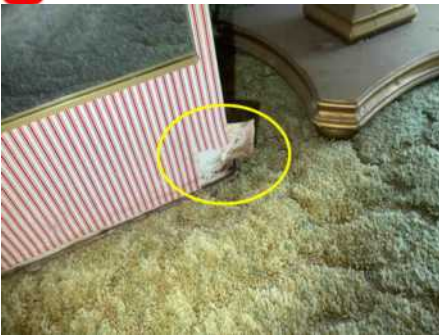
SC Mold like substance noted

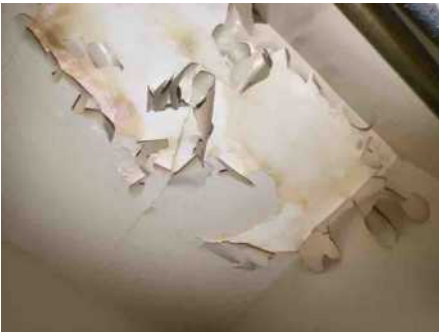
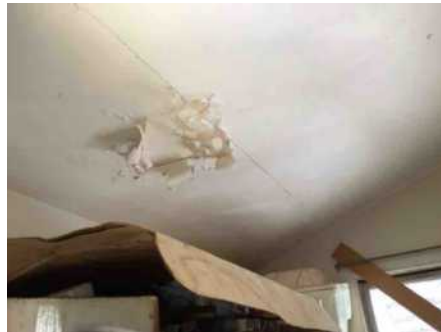
SC Possible lead base paint in walls and ceilings, paint is peeling in several areas throughout home. We recommend further review and repairs by a qualified specialist in the appropriate trade.

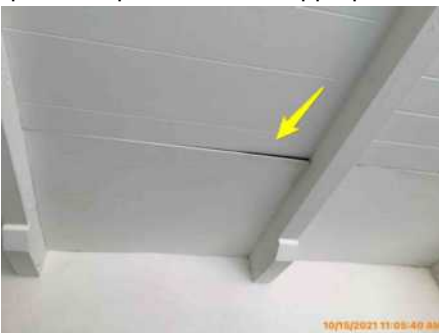
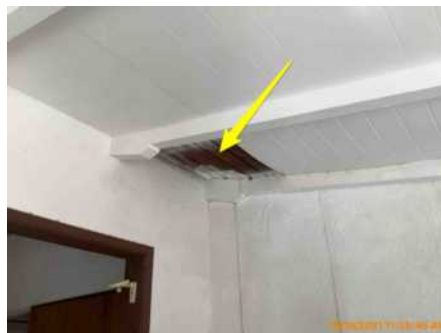
NR Ceiling panels separating, damaged and missing in rear room. We recommend further review and repairs by a qualified specialist in the appropriate trade.

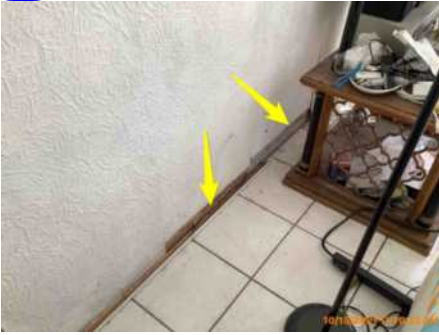
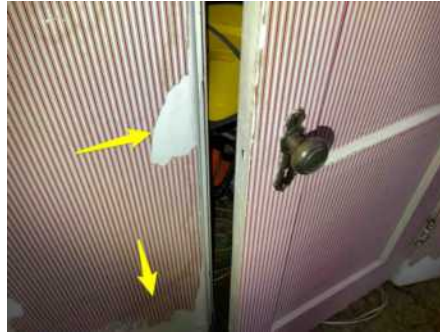
NR Wallpaper peeling/ missing in several areas

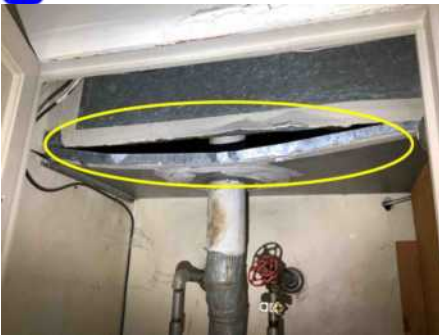
NR Ceiling is damaged at water heater area

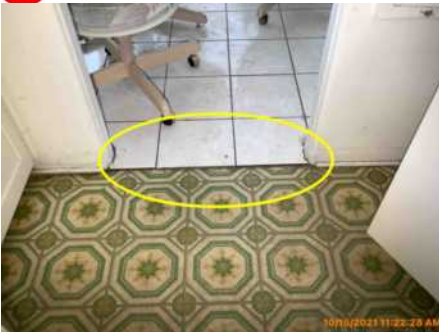
SC Tripping hazards noted.

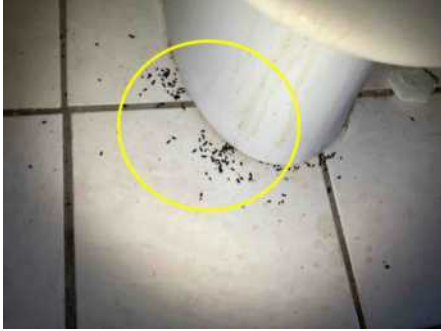
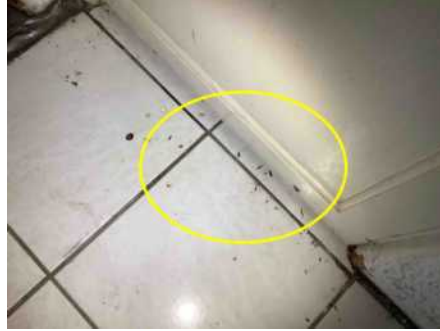
NR I observed evidence of rodents in the hallway and hallway throughout the interior .Ask the Sellers about the rodent history and/or contact a qualified Pest Control Operator to further evaluate.

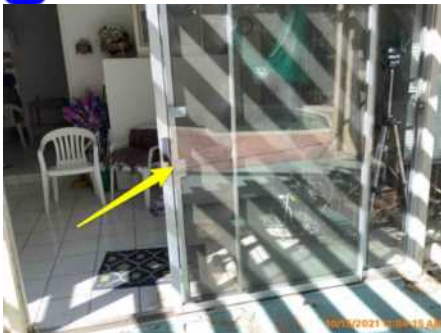
NR All accessible doors were opened and closed. Exterior door would not slide properly at rear.

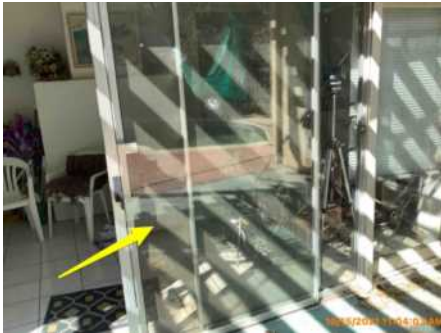
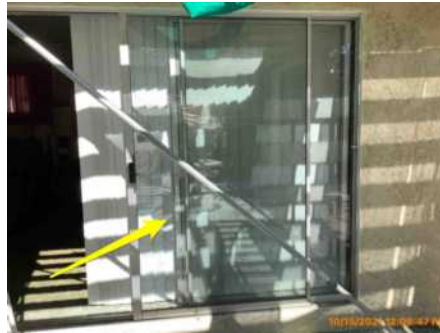
SC Glass tempered markings are not visible at some exterior doors, replacement should be considered to all non tempered sliding doors and fixed windows. Fed law requires companies to replace none tempered glass doors. They are not allowed to repair them.

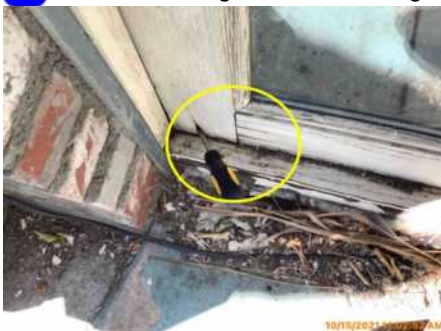
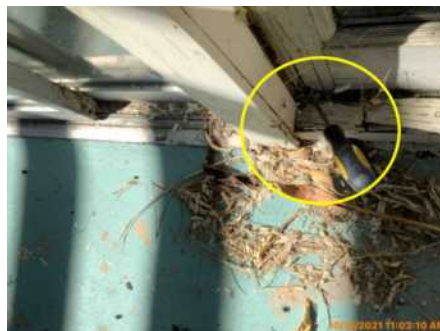
NR Window casing moisture damaged at rear

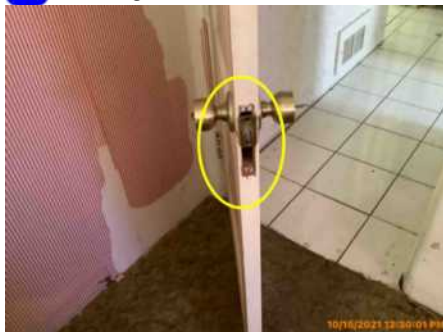
NR Damage noted at master bedroom

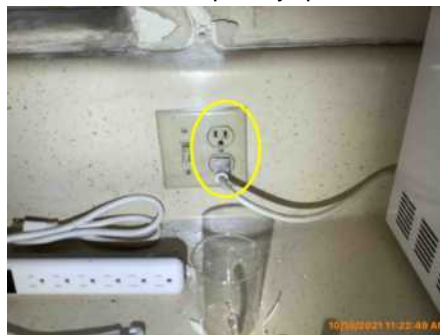
UG All Kitchen receptacles should be GFCI Protected, GFCI protected receptacles were only required by water, the new standard is every receptacles in the Kitchen should be GFCI protected for your safety, installation recommended to all unprotected receptacles, Recommend further review and repair by qualified Electrical Contractor.

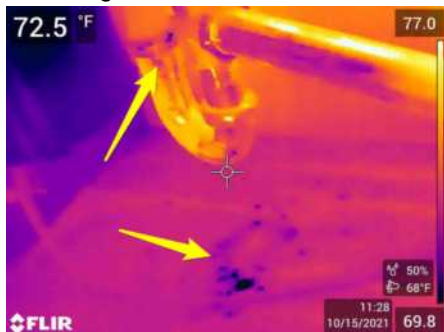
NR Thermal Image shows leak is present under kitchen sink, We recommend the advice and services of a qualified Plumbing Contractor

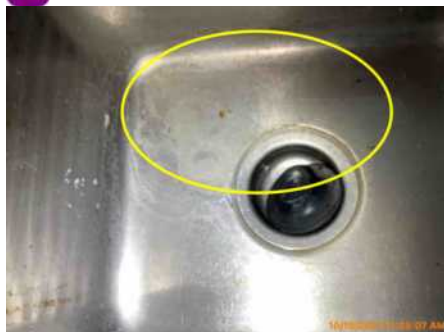
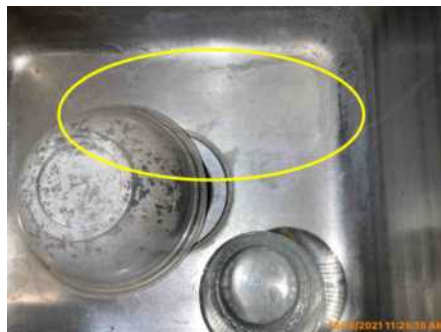
RM Sink stained

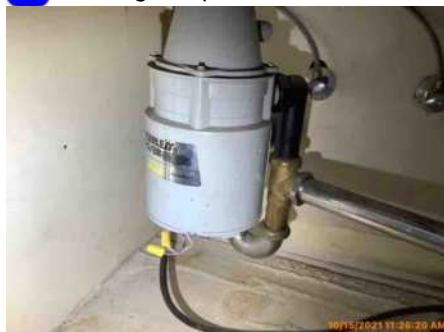
NR Garbage disposal did not work, recommend further review

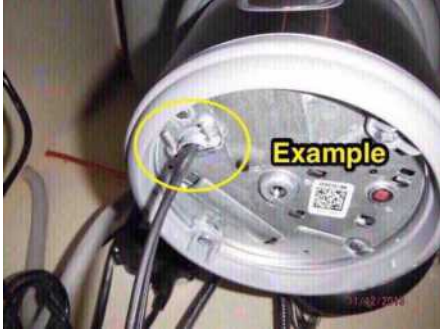
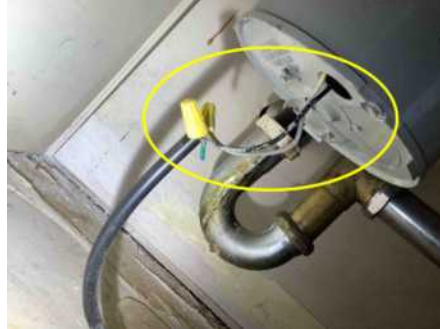
SC Missing wire clamp at disposal connection, wire should be clamped for safety. We recommend further review and repairs by a qualified specialist in the appropriate trade.

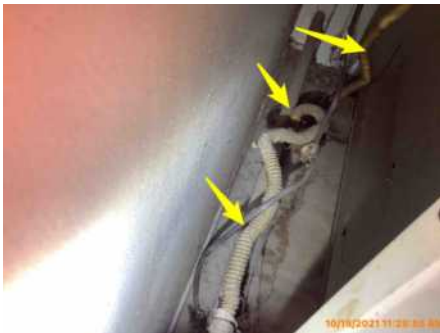
SC The unit is equipped with a flexible gas line. The type of flexible gas line used is an uncoated brass. The Consumer Product Safety Commission issued a news warning in September 1997 that all uncoated brass flexible gas line connectors should be upgraded with newer stainless steel models. The older brass models are prone to cracking or leaking and can cause a serious gas leak, explosion or fire. We recommend the advice and services of a qualified Plumbing Contractor

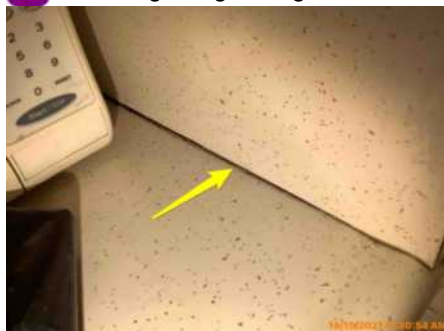
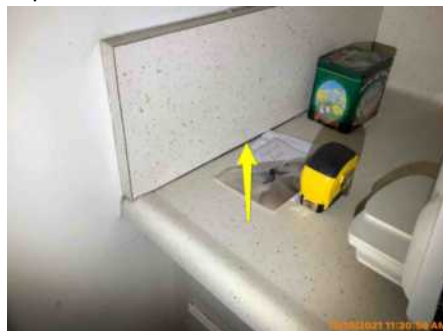
RM Caulking / re grouting needed at backsplash

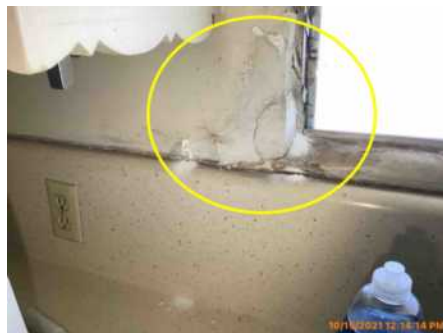
RM Damage noted to wall at near window

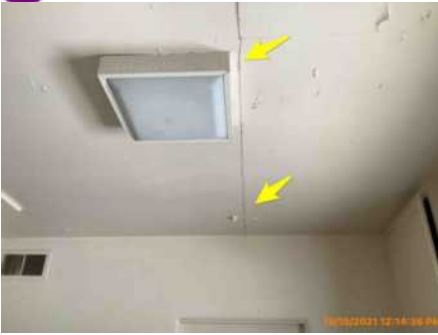
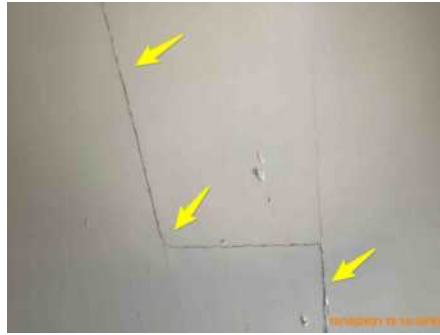
RM Crack noted at ceiling.

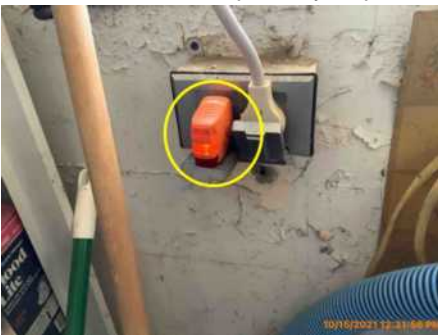
SC The washing machine receptacle(s) are not grounded, this is a safety hazard correction is needed. We recommend further review and repairs by a qualified specialist in the appropriate trade.

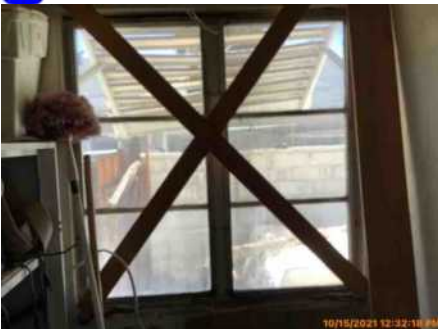
NR Window is damaged and would not open

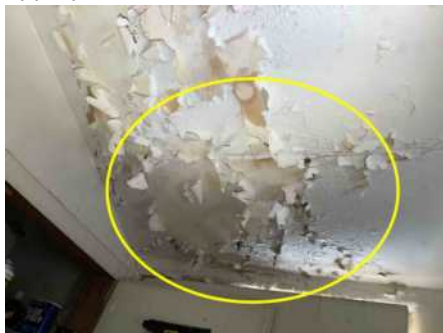
SC Mold like substance noted on ceiling. We recommend further review and repairs by a qualified specialist in the appropriate trade.

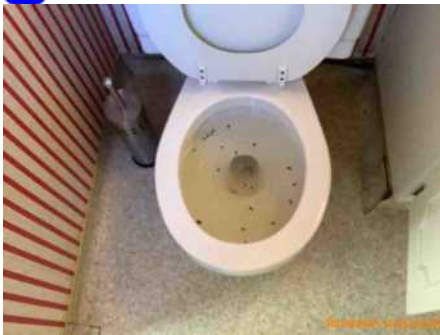
NR Evidence of heavy rodent infestation in toilet, toilet would not flush properly.

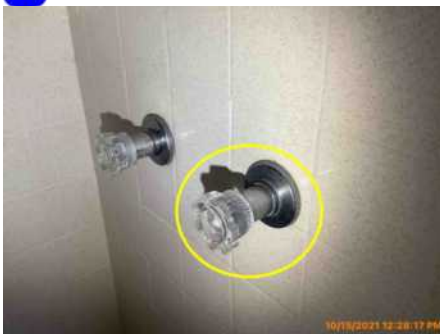
NR Valve seized

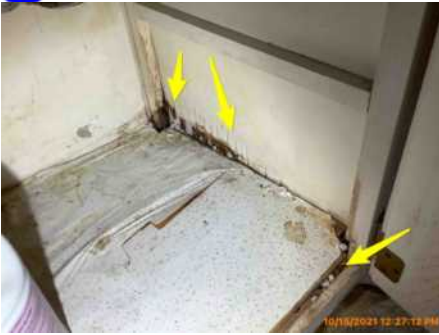
NR Damage noted to cabinet.

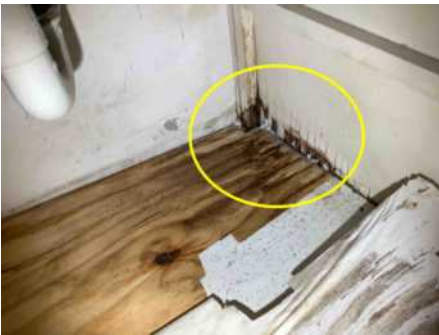
SC Moisture damage and mold like substance noted at cabinet under sink. We recommend further review and repairs by a qualified specialist in the appropriate trade.

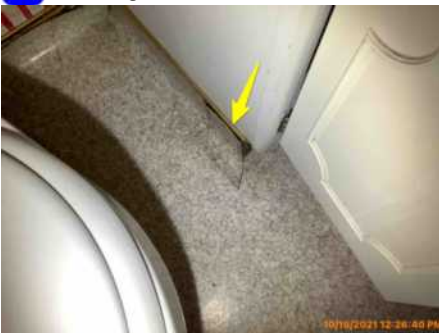
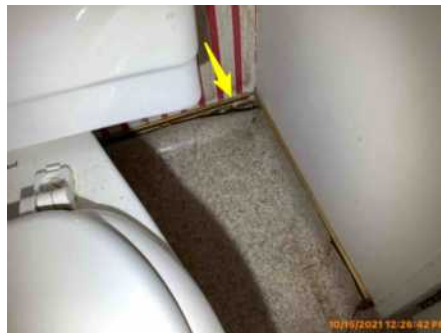
NR Damage noted to floor

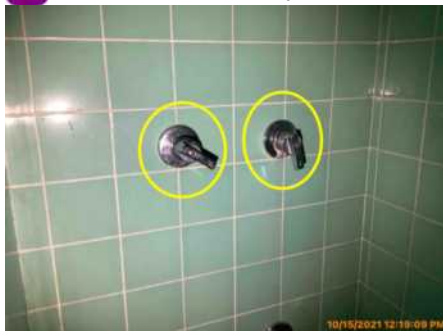
RM Handles don't line up

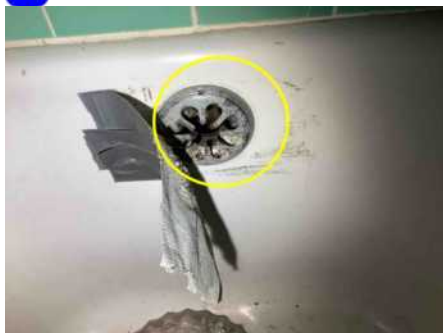
NR Bathtub overflow corroded

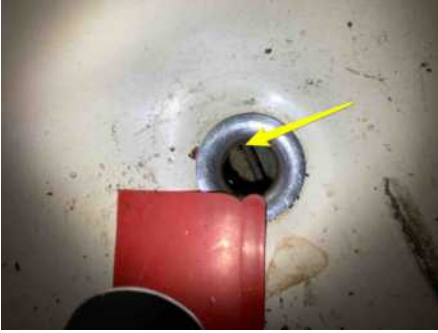
SC Rodent droppings noted in bathtub drain . We recommend further review and repairs by a qualified specialist in the appropriate trade.

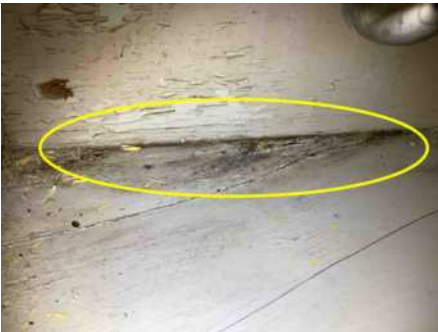
SC Moisture damage and mold like substance noted at cabinet under sink. We recommend further review and repairs by a qualified specialist in the appropriate trade.

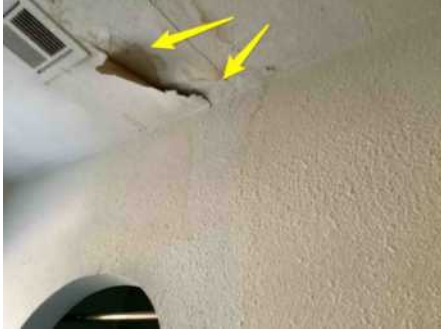
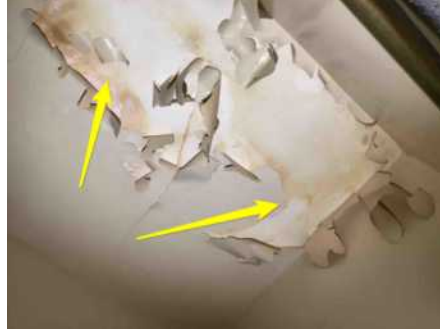
NR Moisture damage noted to ceiling . No moisture was detected. We recommend further review and repairs by a qualified specialist in the appropriate trade.

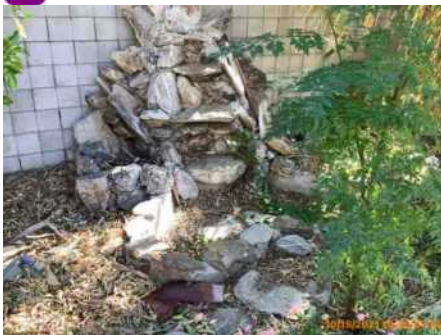
RM Fountain was not filled with water could not test. Inquire with seller.

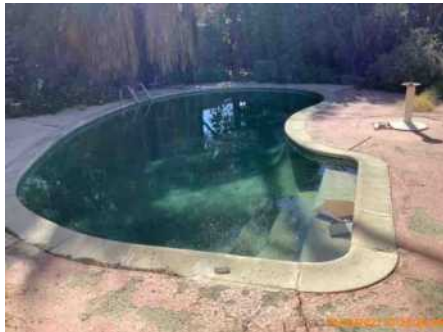
Below Ground

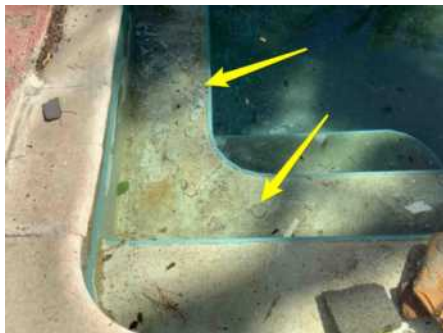
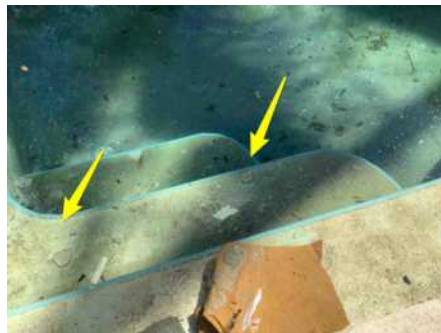
NR Pool surface is worn through, re plastering is needed. We recommend the advice and services of a qualified Pool Contractor

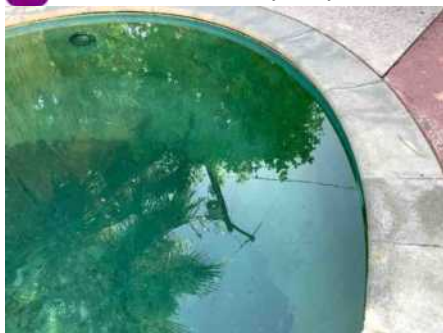
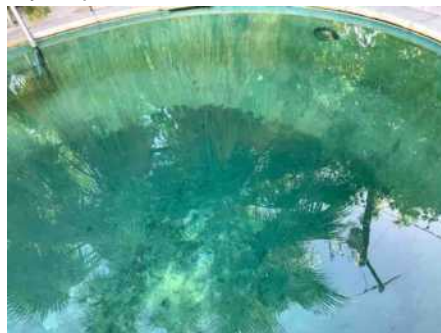
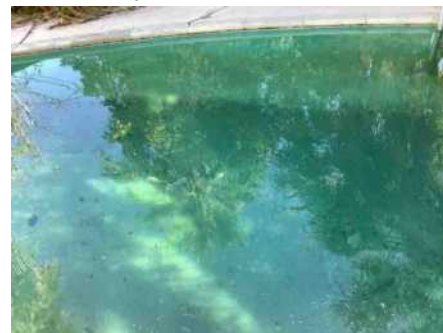
RM Pool was extremely dirty, could not fully inspect surface, recommend further review after pool is cleaned.

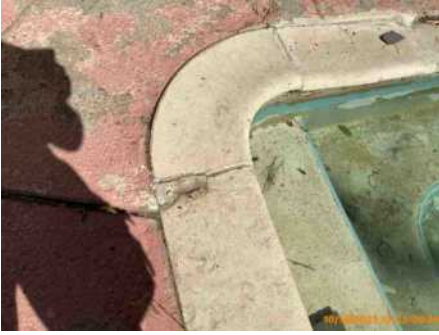
NR Cracking is noted, We recommend the advice and services of a qualified Pool Contractor

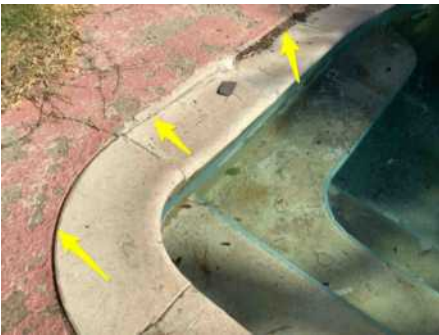
SC The deck has cracked and lifted causing a trip hazard, We recommend further review and repairs by a qualified specialist in the appropriate trade.

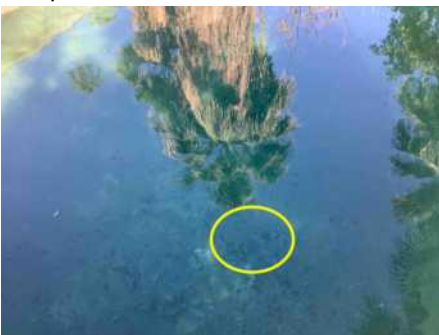
SC Drain cover(s) are older type, recommend installation of a newer type vortex cover(s) and a safety vacuum release at the pool pump. This a major safety/entrapment hazard and the pool or spa should not to be used until repaired is complete. We recommend the advice and services of a qualified Pool Contractor.

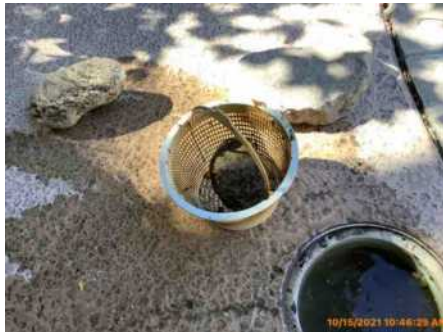
Basket was in serviceable condition at time of inspection

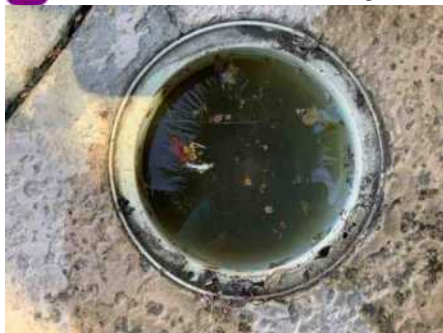
RM Debris in skimmer, cleaning is needed. Weekly cleaning is recommended.
