REAL ESTATE INSPECTION REPORT

Property Address:
686 S Camino Real
Palm Springs, CA 92264

Report # 10777

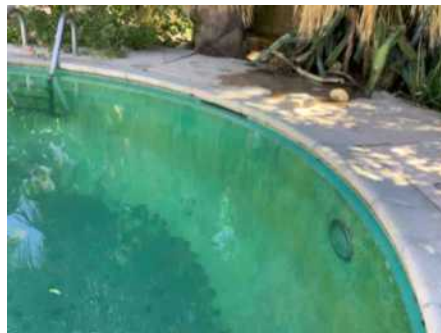
RM Weir door or weir blade or American product skimmer is missing from the skimmer basket and no skimming action is taking place because no surface tension is being created. Recommend adding a weir door. We recommend the advice and services of a qualified Pool Contractor

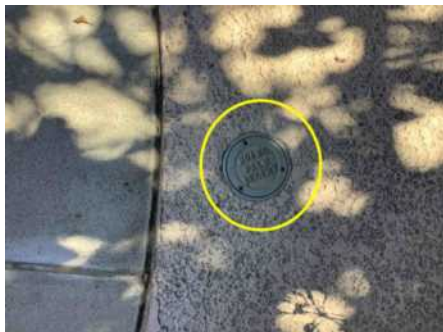
SC Older type light with deck splice box, light and connection should be updated for safety. Pool lighting should be protected by a wet niche 4 ft min from pool water and 8 inch min max above water level. Pool/Spa should not be used until the light is updated due to the possibility of electrocution. We recommend the advice and services of a qualified Pool Contractor or Recommend further review and repair by qualified Electrical Contractor.

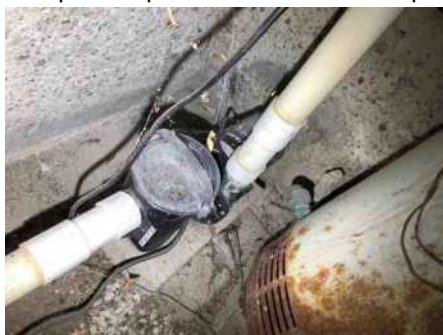
Pump was operational at time of inspection.

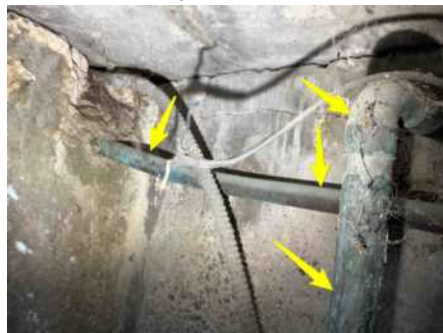
RM Older type original copper piping noted for pool, Copper piping can be a major repair if it is corroded and needs to be replaced. We recommend the advice and services of a qualified Pool Contractor

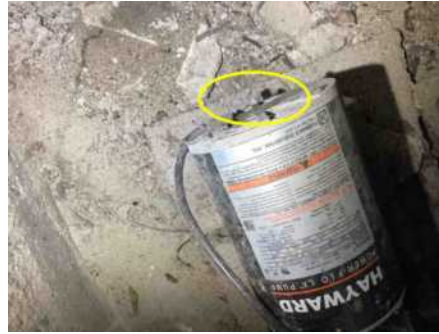
SC External bonding of equipment frames is lacking at the pool pump(s) and the pool heater, All metal pool equipment needs to be bonded to a pool structure. Pool/Spa should not be used until full bonding of the pool system is completed due to the possibility of electrocution. We recommend the advice and services of a qualified Pool Contractor

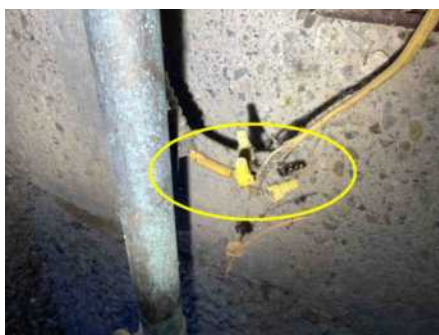
SC Exposed splices are noted, junction box should be installed
