## **Famosa Terrace SB-326 Inspections**

**2828 Famosa Blvd  
San Diego, CA 92107**

**Date: November 18, 2024**

RE: **Famosa Terrace (First Inspection Cycle)**  
**2828 Famosa Blvd, San Diego, CA 92107**  
**SMR Project Number: LGL-24-045**

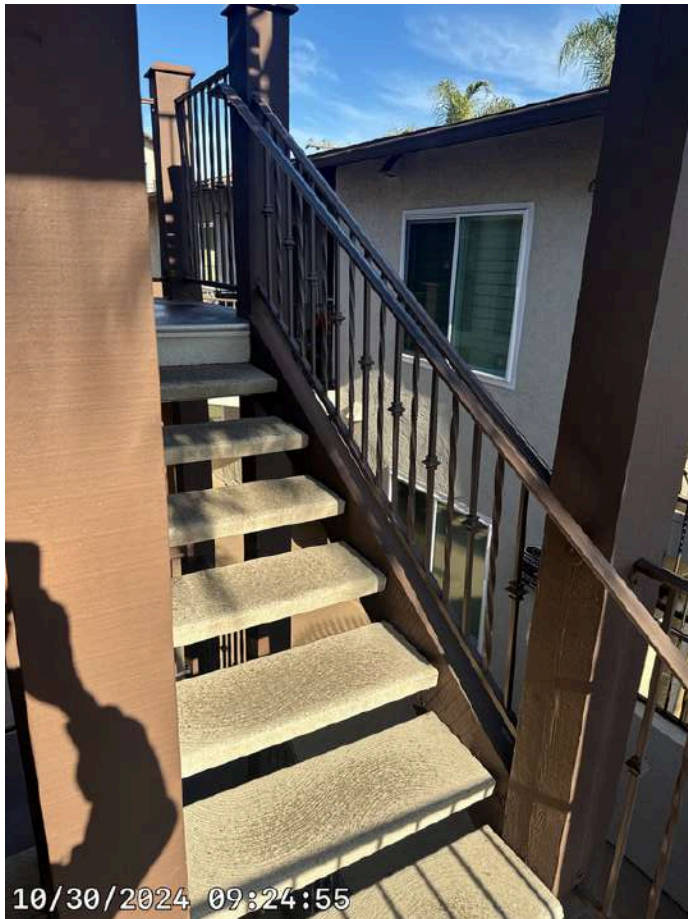
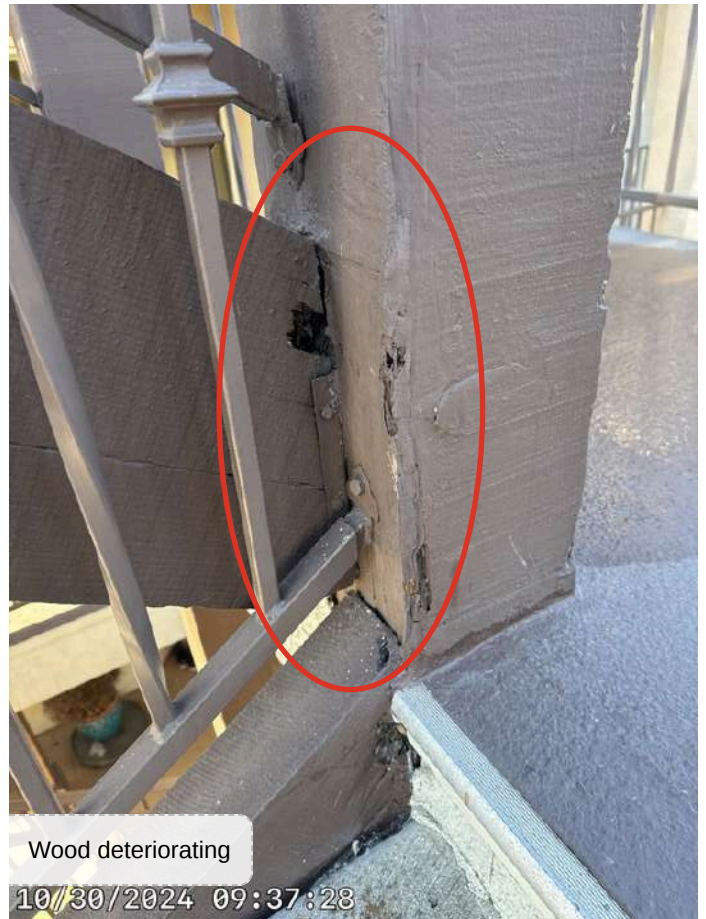
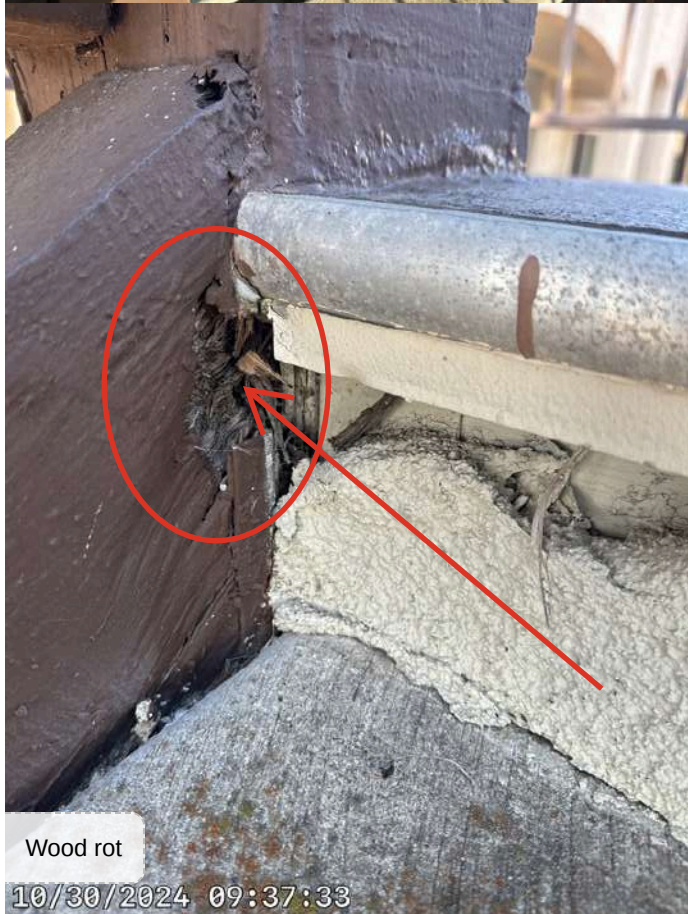
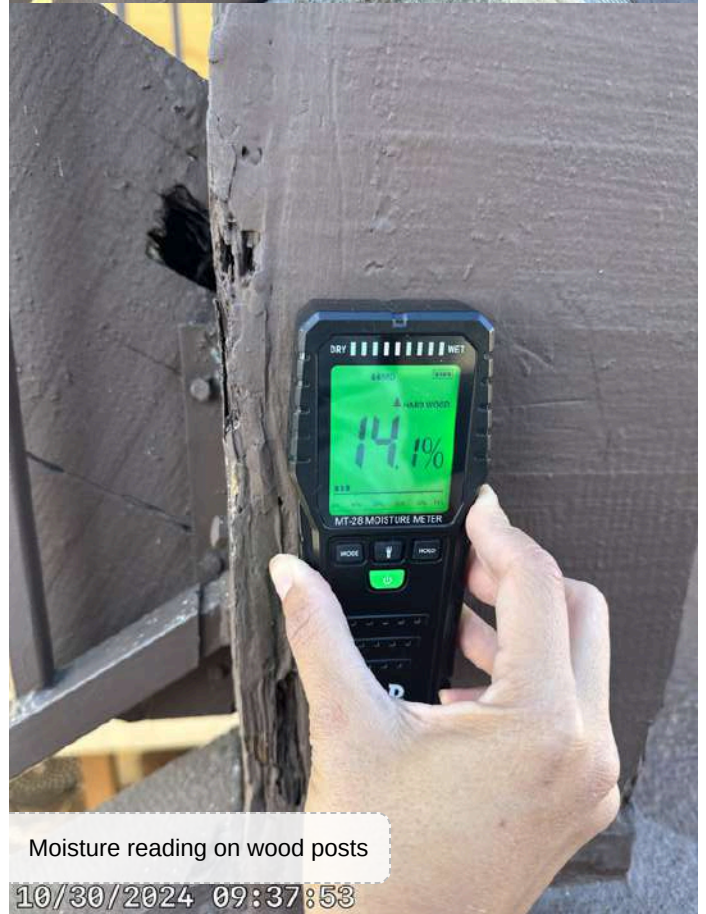
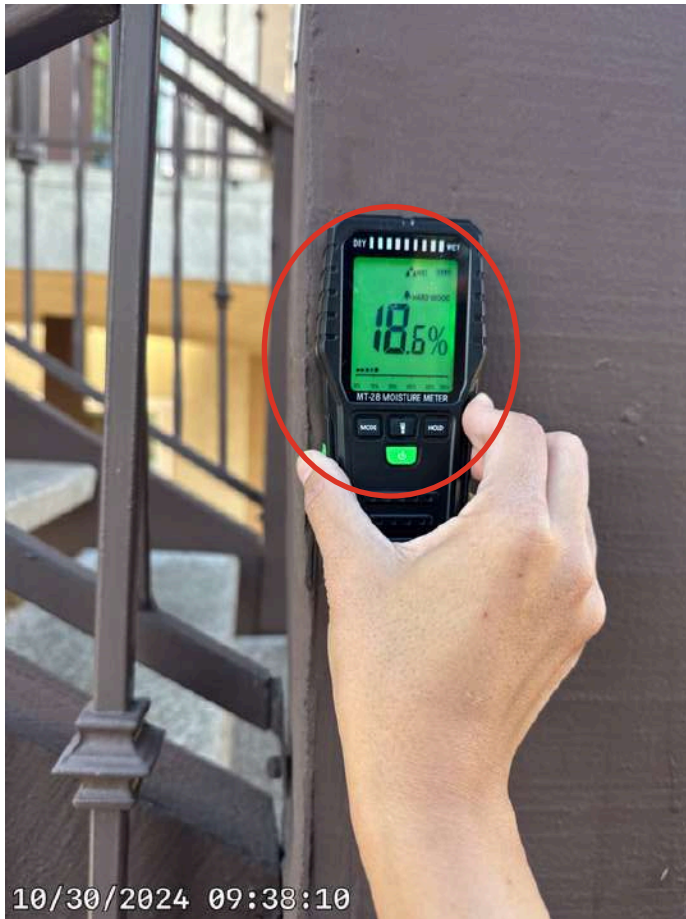
| Framing Condition | Poor |
| Framing Remarks | Water intrusion observed on second and third landing framing as well as wood rot/deterioration on almost all stair posts. |

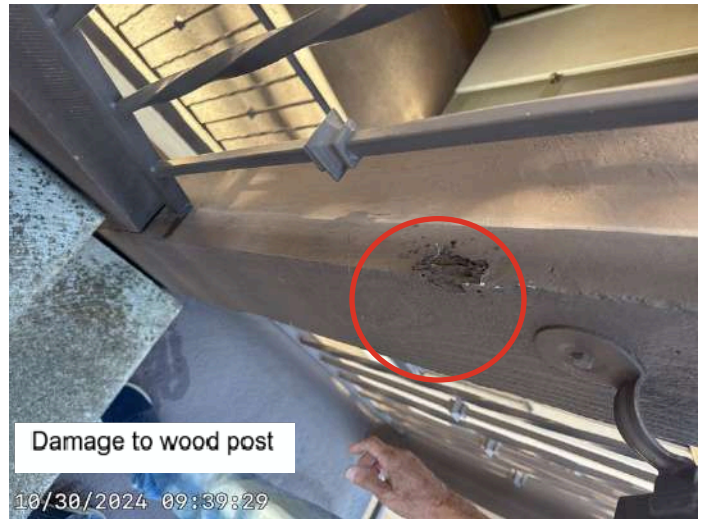
Damage to wood post

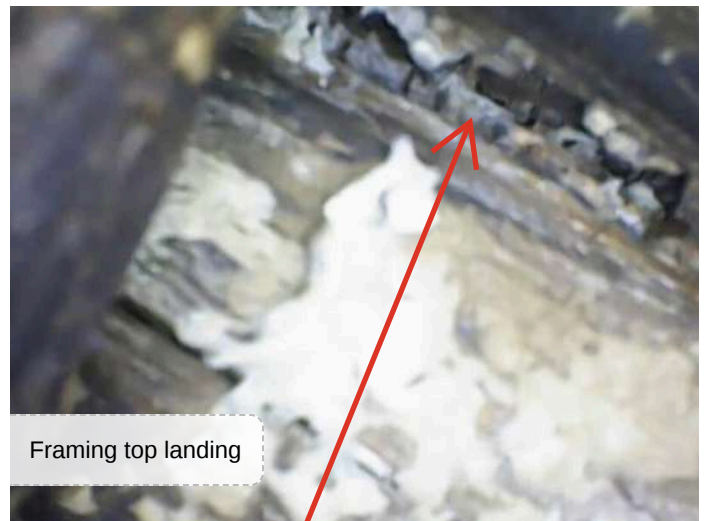
Wood Rot

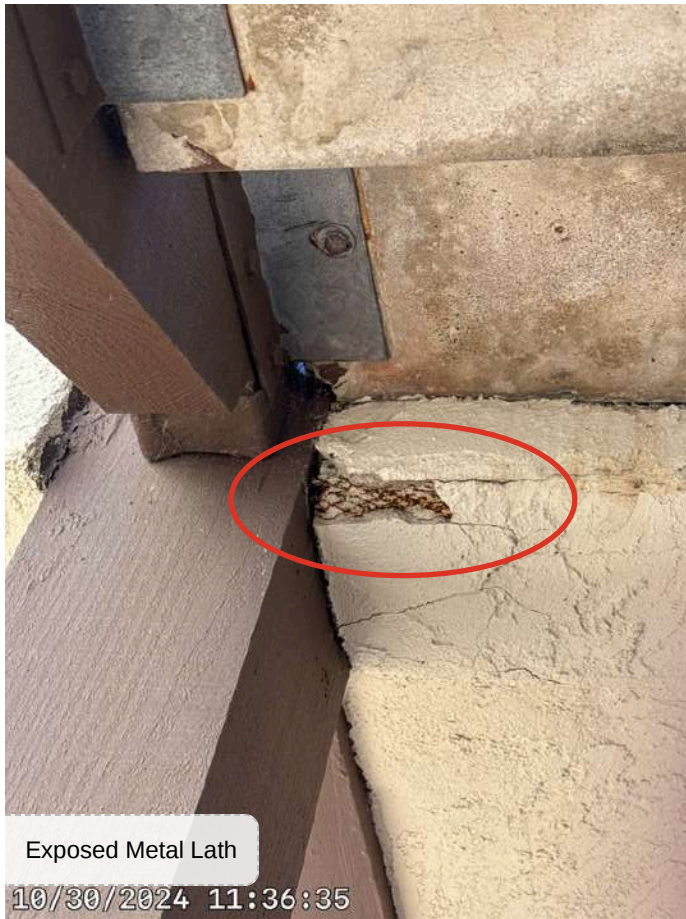
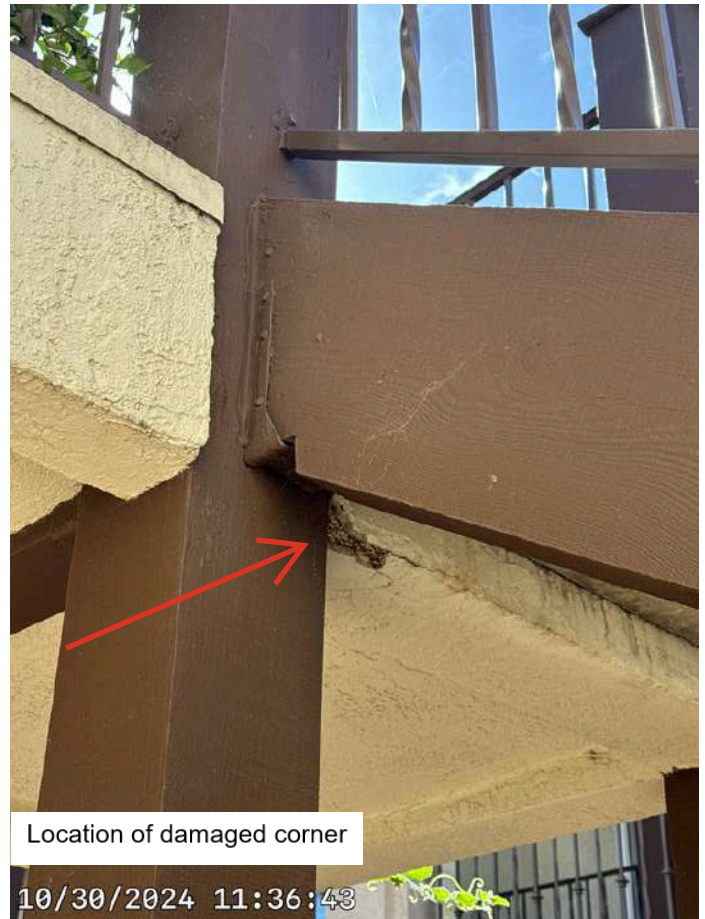
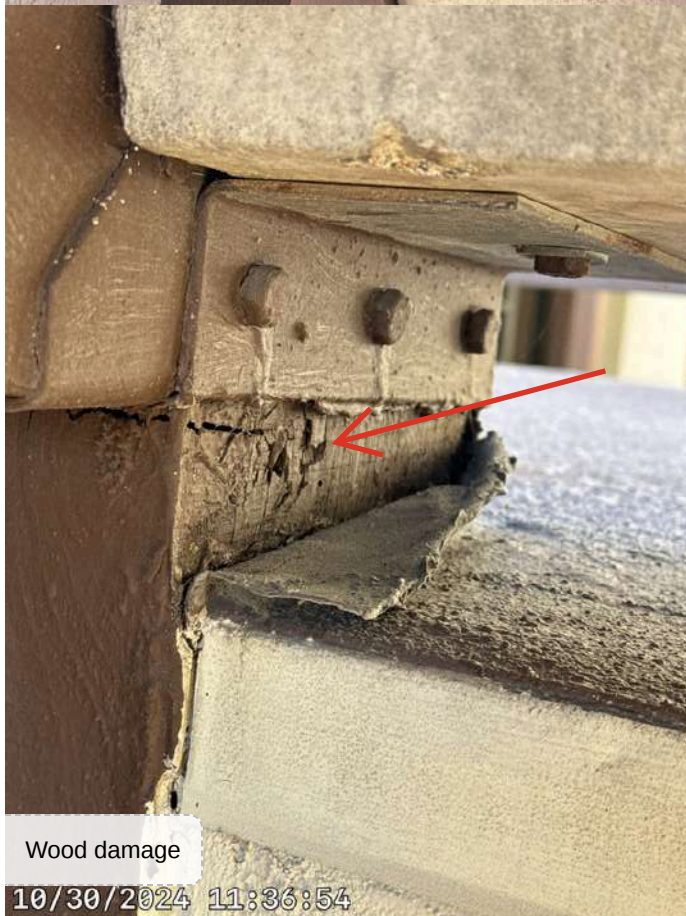
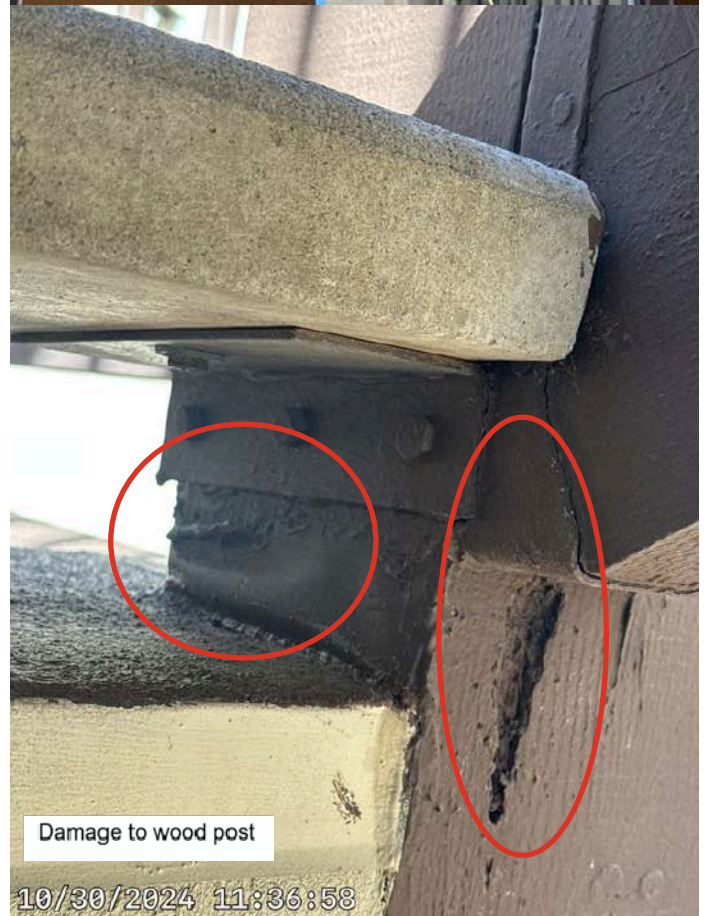
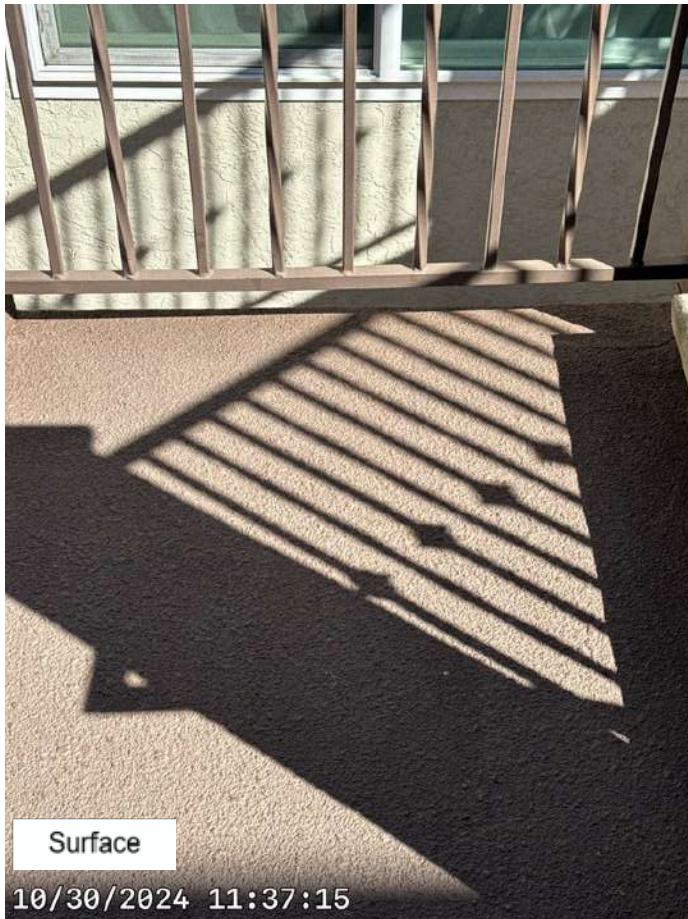
# 2828 Famosa Blvd - Stairs to Unit 210

| Framing Condition | Fair |
| Framing Remarks | Damaged wood posts |

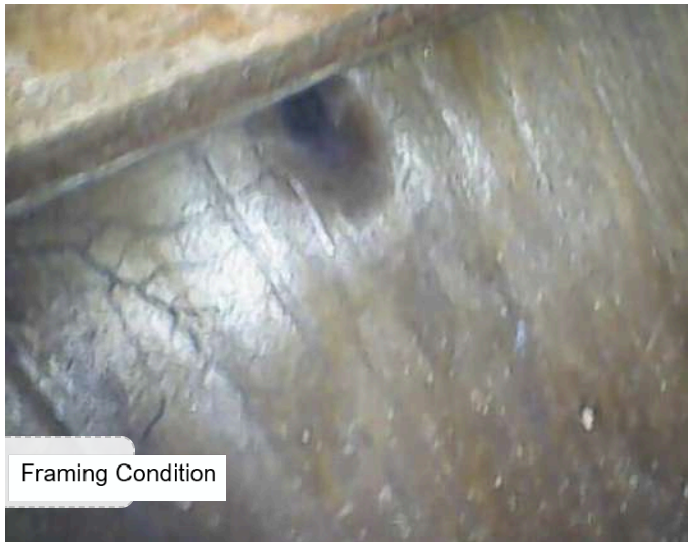
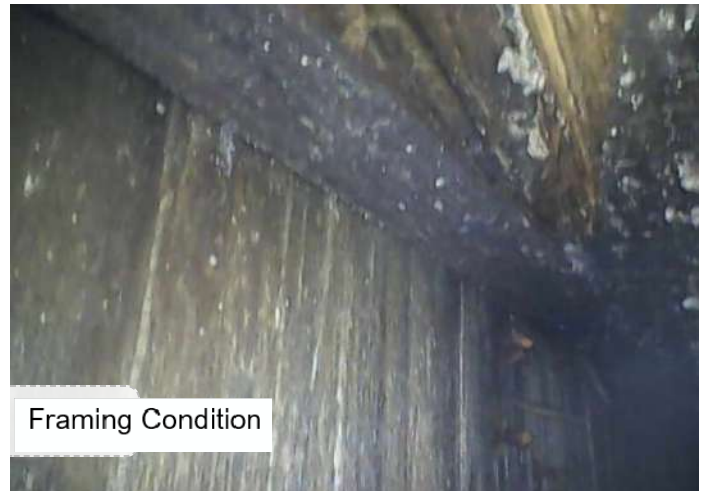
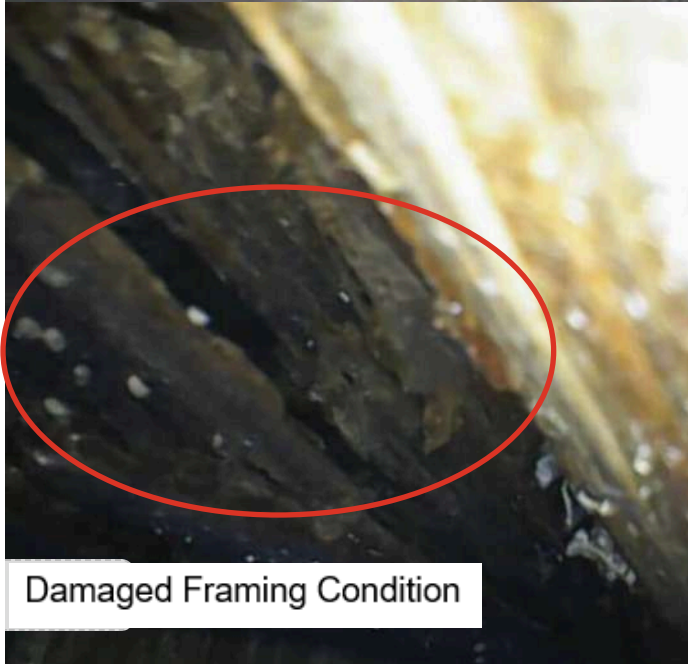
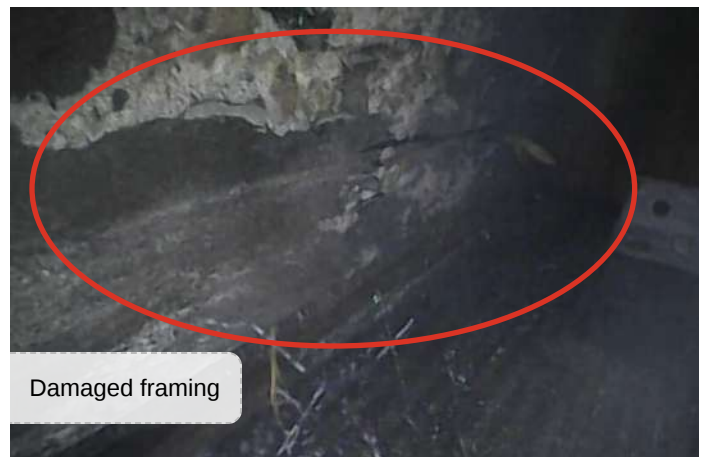
## 2828 Famosa Blvd - Rear Stairs Near Unit 209

| Framing Condition | Fair |
| Framing Remarks | Damaged wood posts |

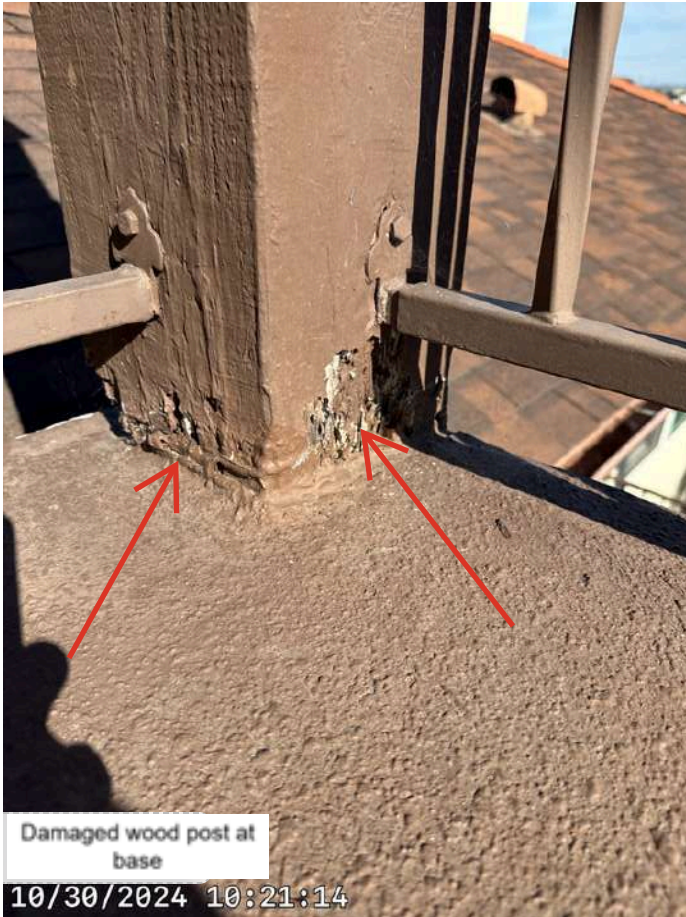
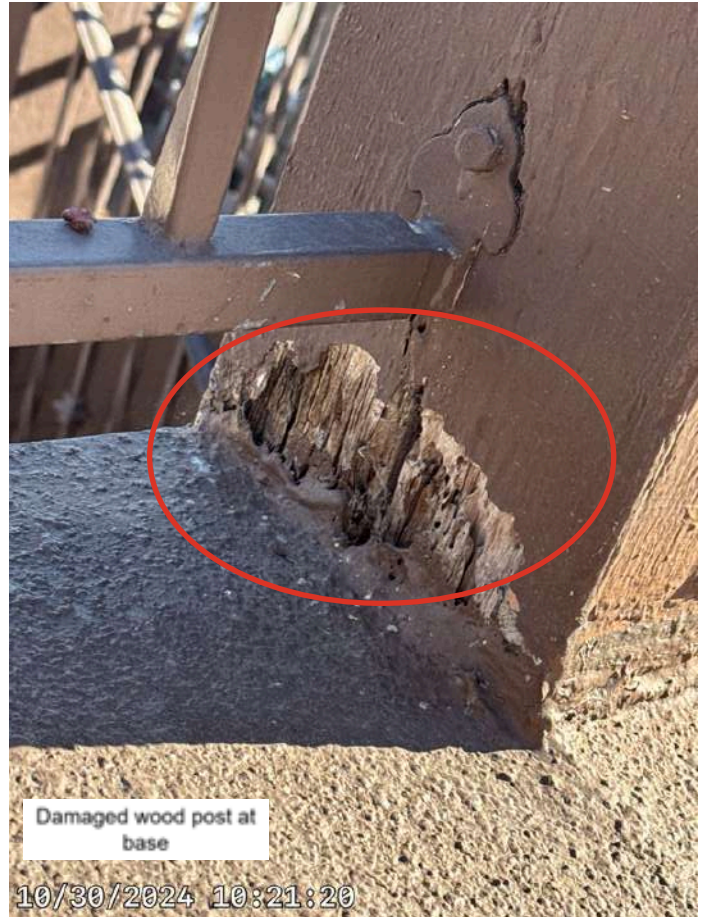
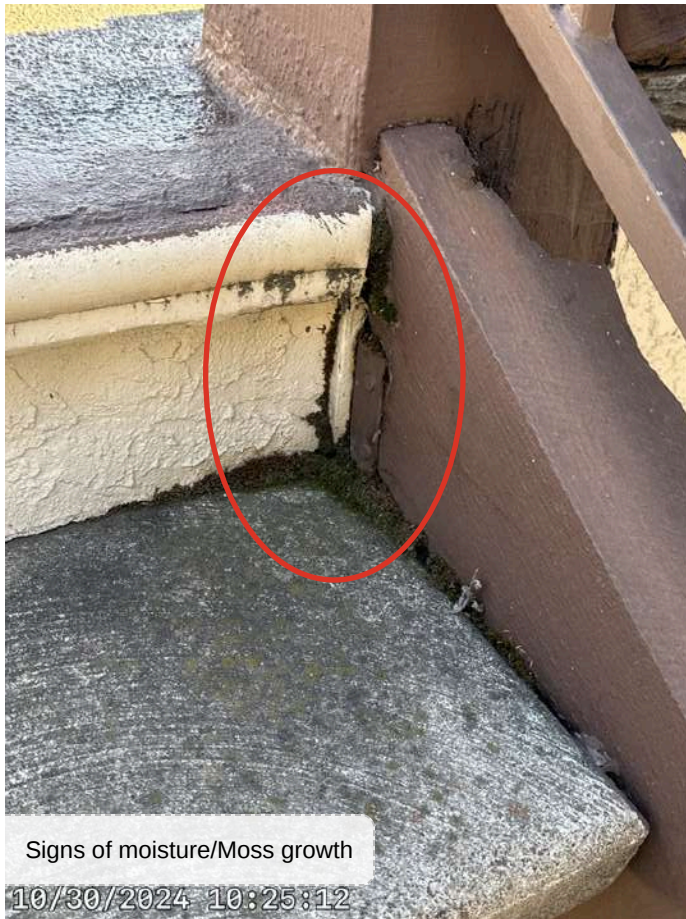
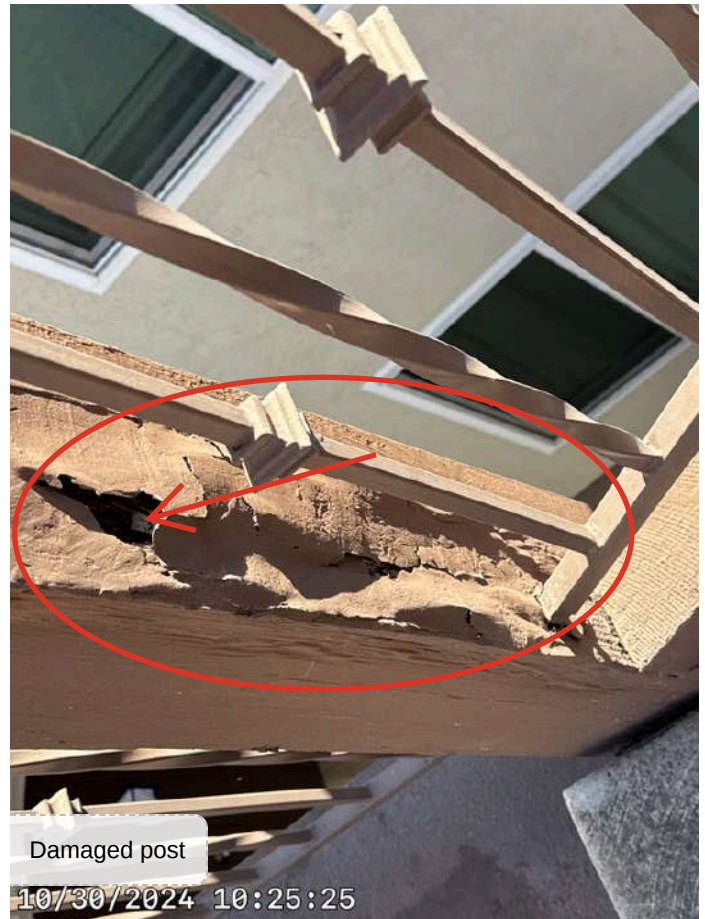
## 2828 Famosa Blvd - Rear Stairs Near Unit 209

| Framing Condition | Fair |
| Framing Remarks | Wood rot/deterioration in stair posts |

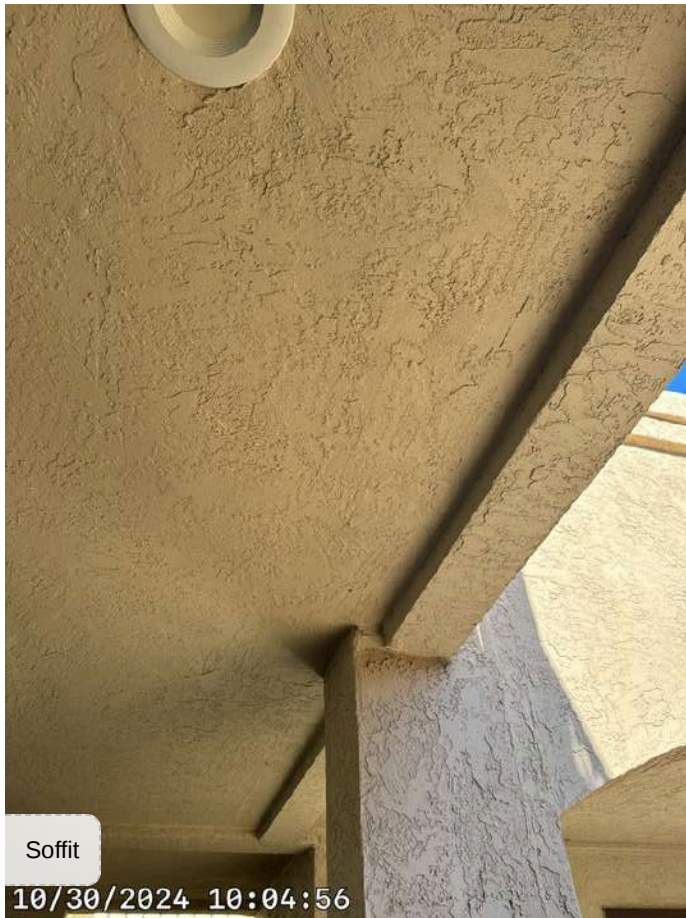
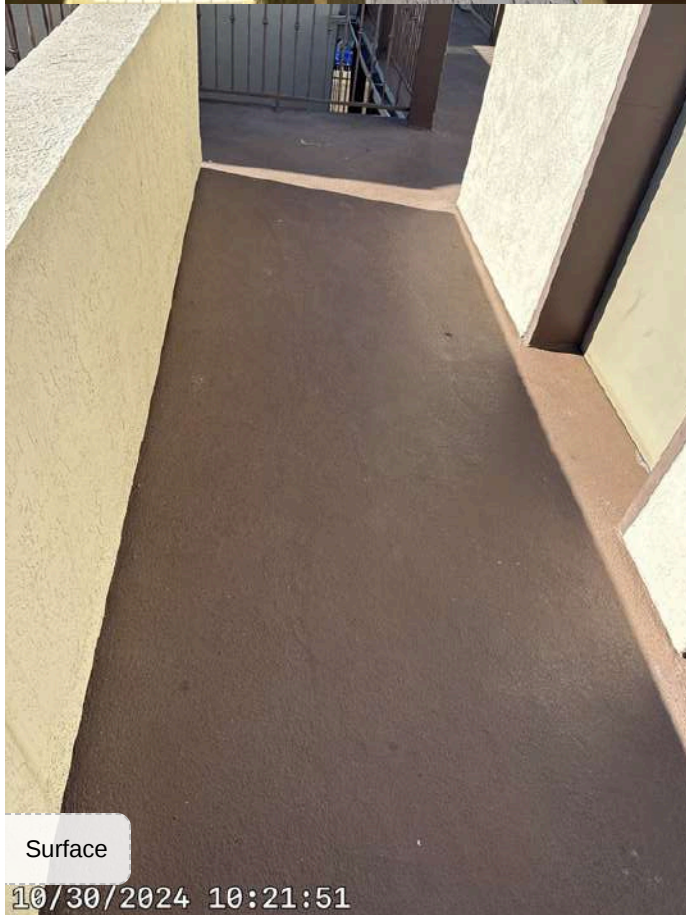
| Framing Remarks | Deteriorated wood posts |

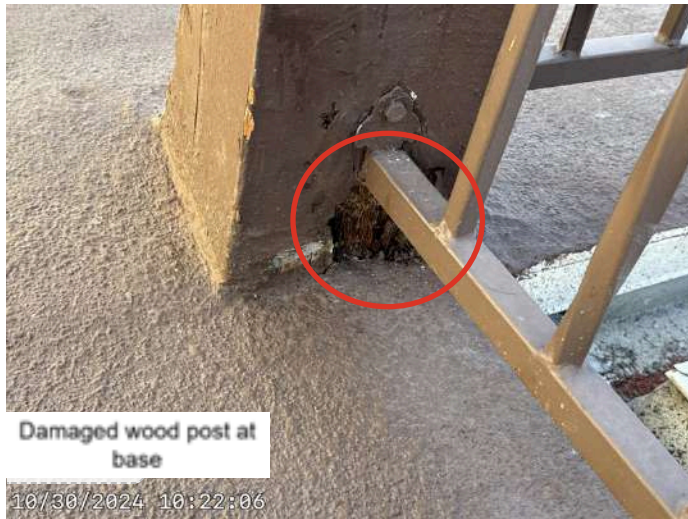
Damaged wood post at base

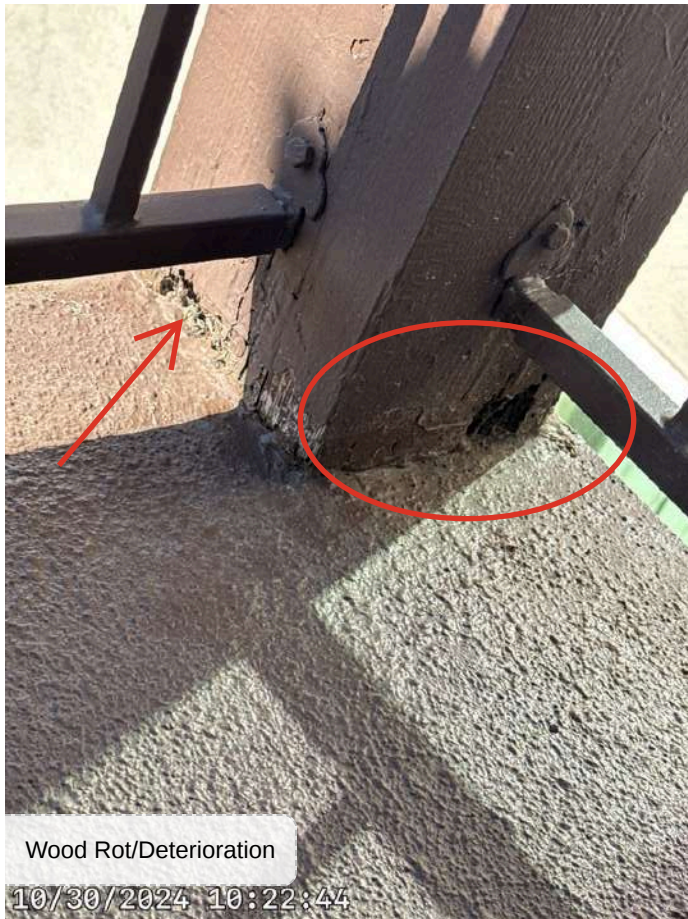
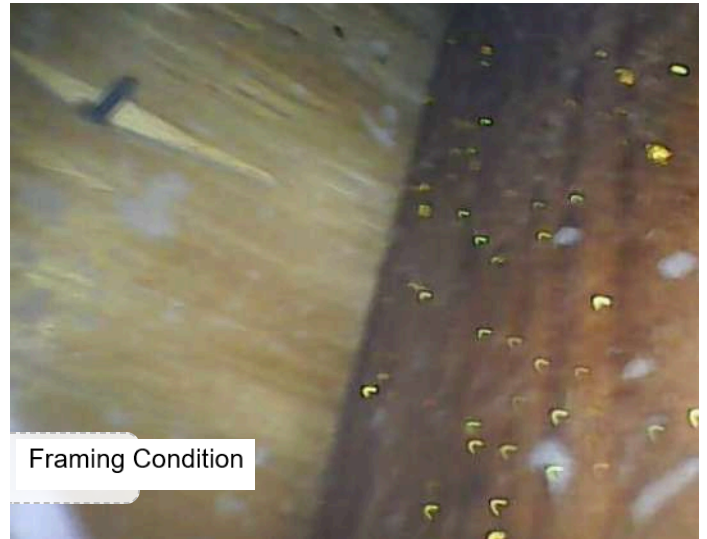
| Framing Remarks | Wood rot observed in posts. |

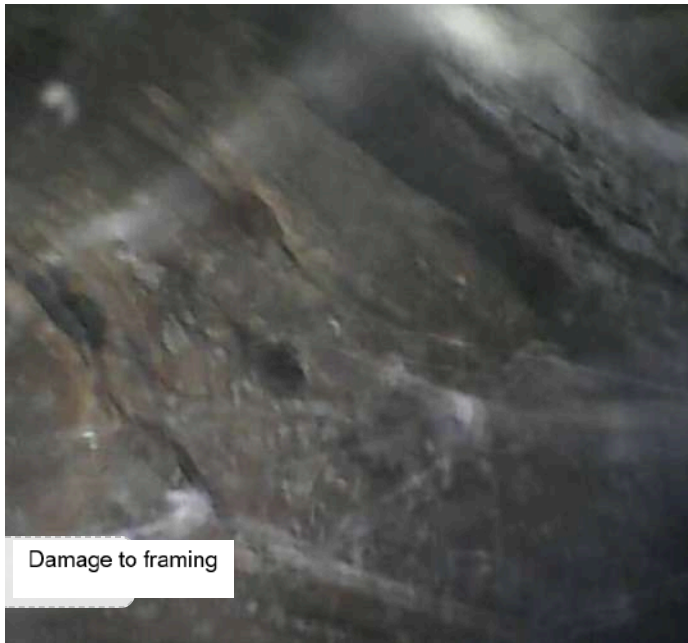
| Framing Remarks | Water intrusion observed |
