**COAST TO CACTUS**  
PROPERTY INSPECTIONS

# HOME INSPECTION REPORT

**7351 Purdue Ave, La Mesa, CA 91942**

| <b>Report Number:</b> | 2026010904 |

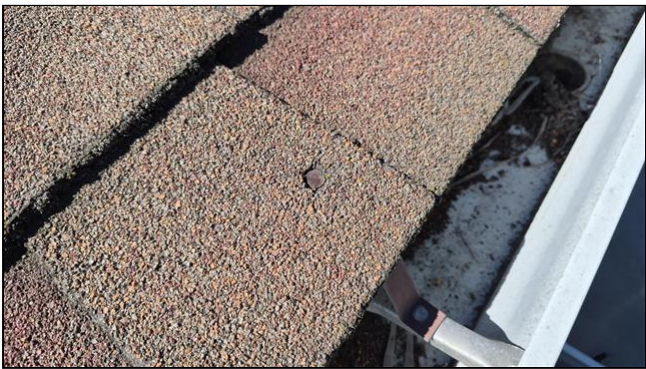
1.0 Item 5 (Picture)

(5) Roof coverings are degranulating in areas. This is an indication that roofing material is approaching the end of its service life.

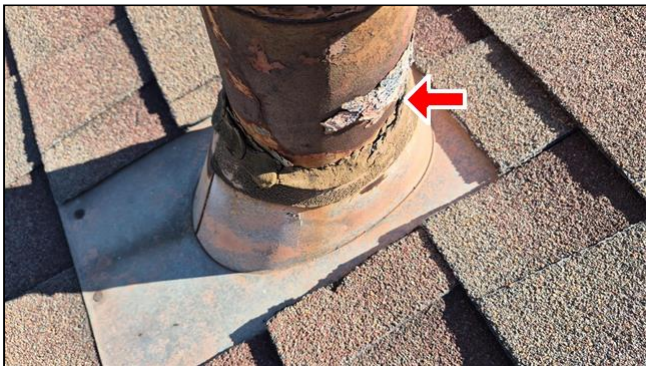
1.1 Item 1 (Picture)

(1) Deteriorated sealant observed at furnace exhaust vent. Recommend re-sealing.

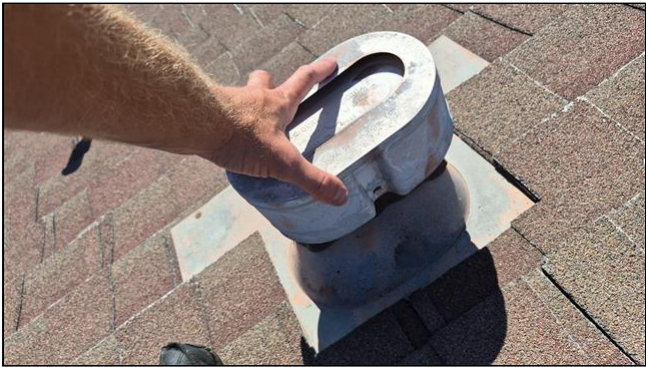
1.1 Item 3 (Picture)

(2) Loose rain cap observed at abandoned heating vent. Suggest securing.

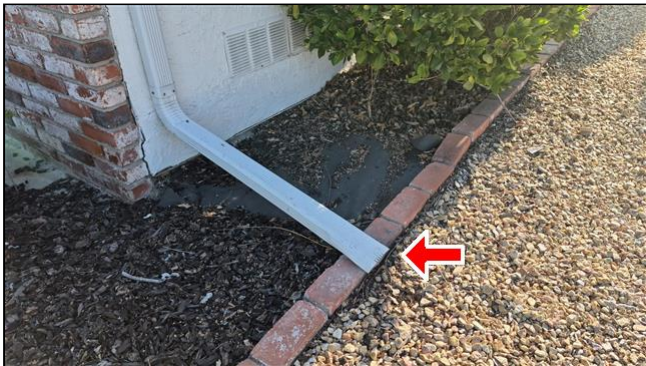
1.3 Item 3 (Picture)

(2) Downspout kick-out is crushed/damaged at front right. Suggest replacement.

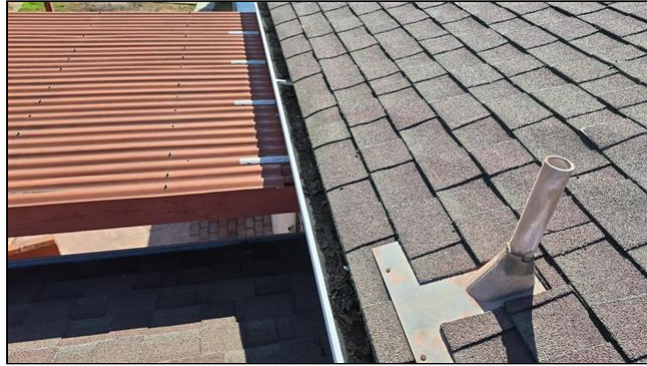
1.3 Item 4 (Picture)

(3) Vegetation/debris observed in gutters. Suggest cleaning to enhance drainage.

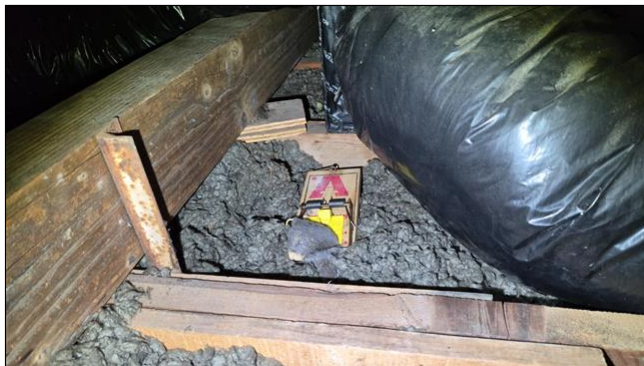
2.5 Item 1 (Picture)

📌 (1) Evidence of animal activity/droppings observed. Recommend further review by a qualified pest control specialist, prior to the end of contingency period.

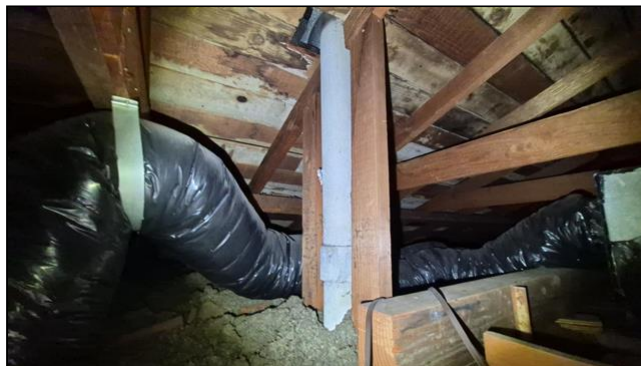
2.5 Item 3 (Picture)

(2) Abandoned transite (asbestos) material observed. Suggest removal.

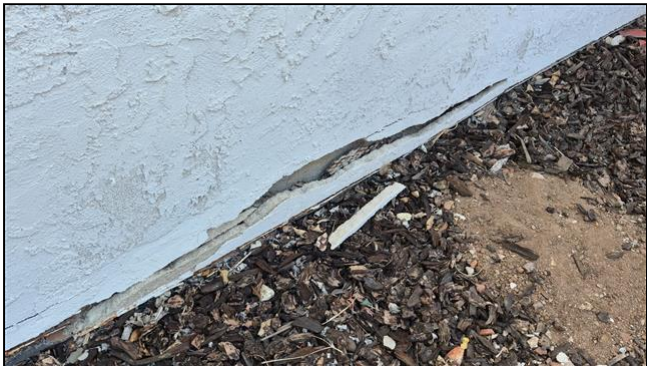
3.2 Item 2 (Picture)

(1) Rusted weep screed, excessive deterioration and inadequate clearance from grade/soil observed at front right side wall cladding. Recommend repair.

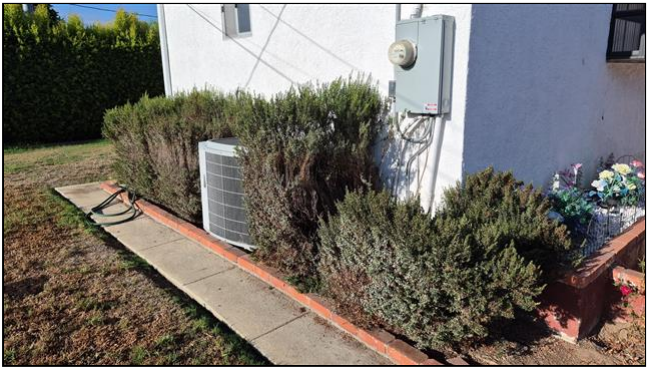
3.2 Item 6 (Picture)

🏠 (2) Vegetation is in direct contact with the wall cladding. Recommend trimming or removal.

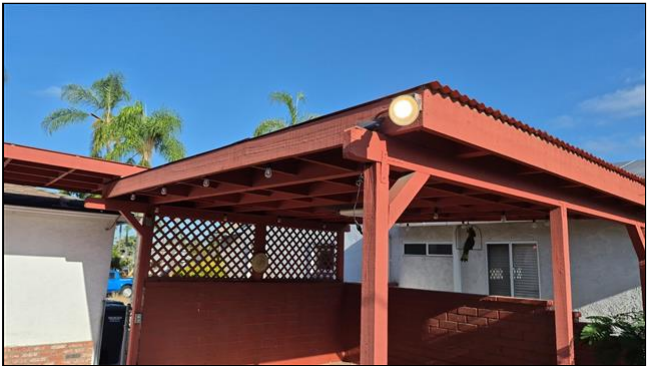
3.3 Item 2 (Picture)

Deterioration observed in areas of the eaves/fascia/exterior wood. Recommend further evaluation by a licensed branch 3 pest inspector, prior to the end of the contingency period.

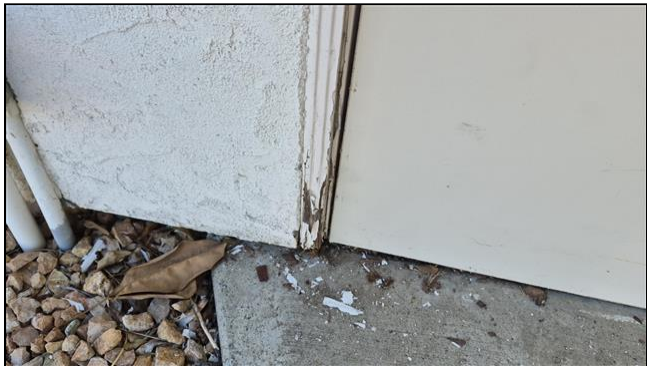
3.3 Item 5 (Picture)

🏠 Deterioration observed in areas of the eaves/fascia/exterior wood. Recommend further evaluation by a licensed branch 3 pest inspector, prior to the end of the contingency period.

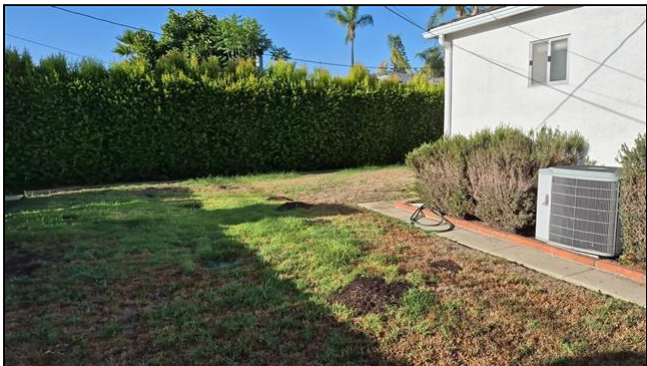
3.4 Item 2 (Picture)

(1) Inadequate grade drainage observed at rear. Regrading, filling low lying areas and/or adding alternative means of drainage is recommended to ensure all water drains away from the foundation and exterior walls.

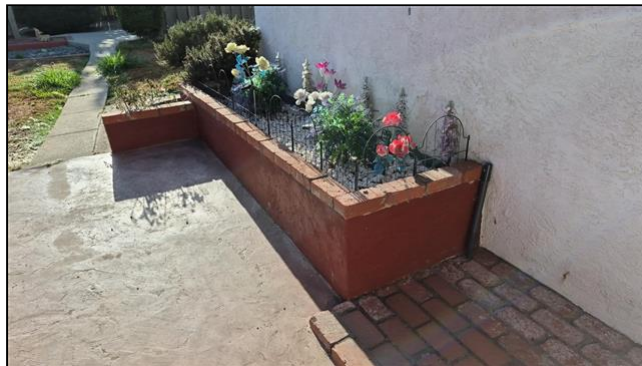
3.4 Item 4 (Picture)

(2) Insufficient clearance observed between planters/planter beds and the exterior wall. A two inch space between the planter/planter bed and exterior wall is recommended to prevent moisture intrusion. Suggest correcting.

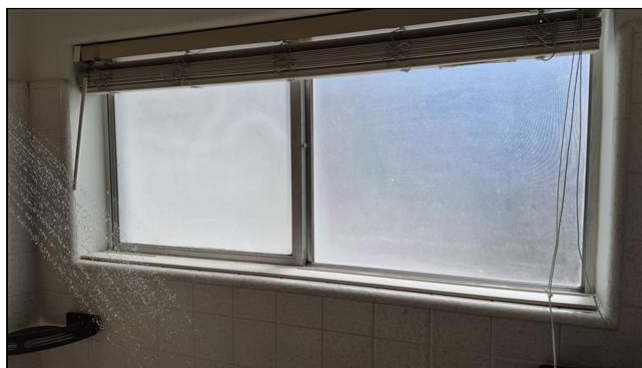
3.6 Item 1 (Picture)

Front bathroom window latch is damaged/missing. Recommend repair.

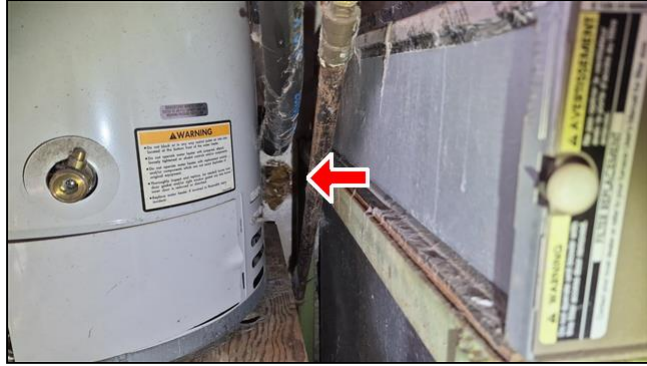
4.1 Item 1 (Picture)

📌 (1) Hole observed at the firewall between the garage and living space behind water heater. Recommend repair.

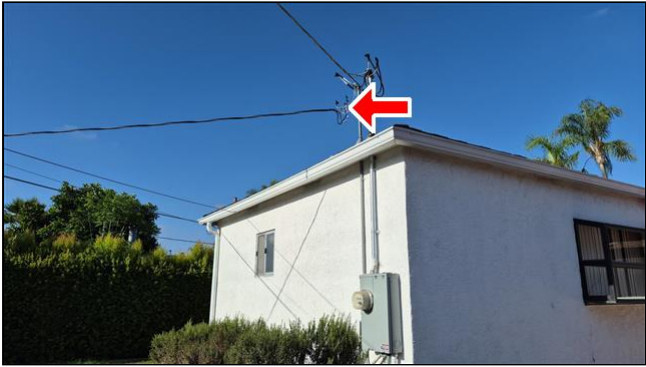
5.0 Item 2 (Picture)

🏠 The rear shed electrical service conductors clearance from the ground is lower than 10 feet. Recommend correcting.

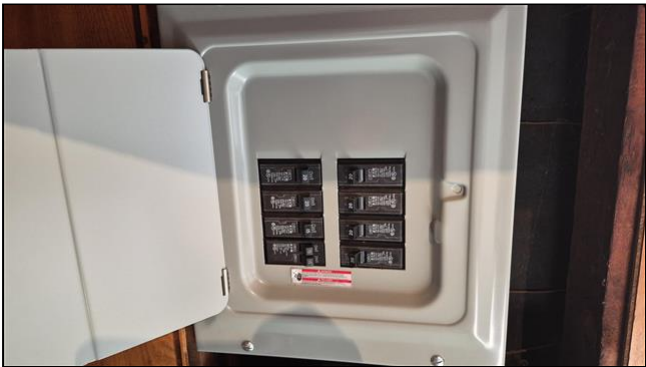
5.2 Item 2 (Picture)

🏠 (1) Circuits are not correctly labeled. Recommend labeling.

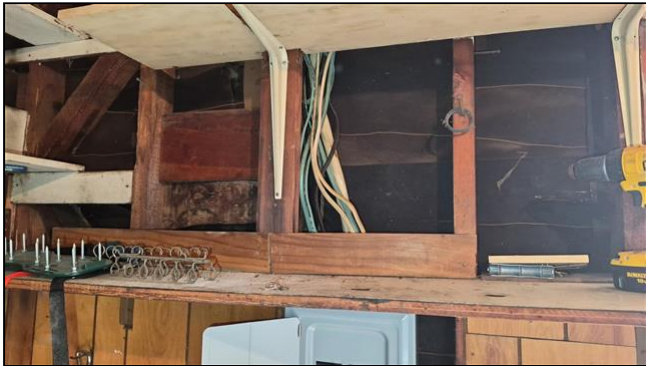
5.3 Item 1 (Picture)

📍 (1) Unprotected wiring observed in areas at the garage. Recommend correcting.

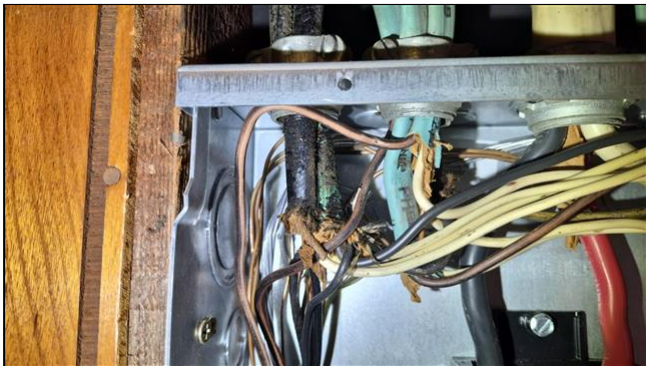
5.3 Item 2 (Picture)

(2) Braided cloth wiring observed. Due to the age of this type of wiring, the client is advised to verify overall condition of the wiring with a qualified electrician, prior to the end of the contingency period.

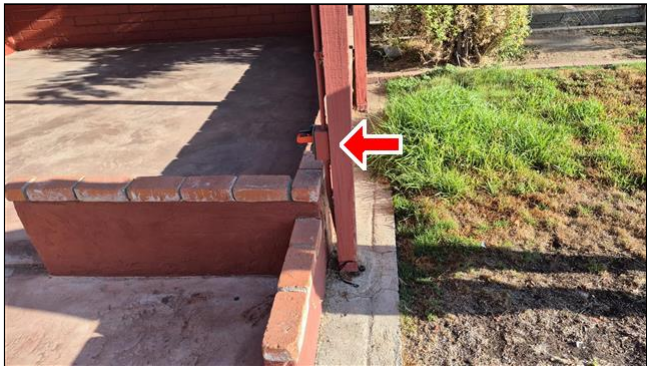
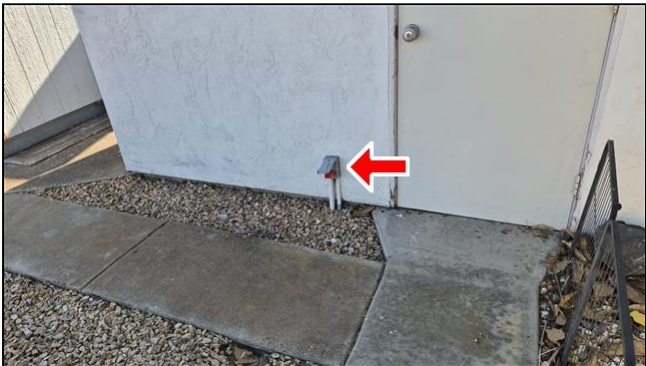
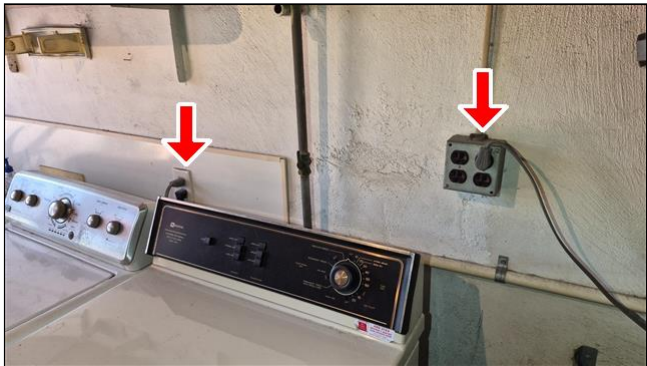
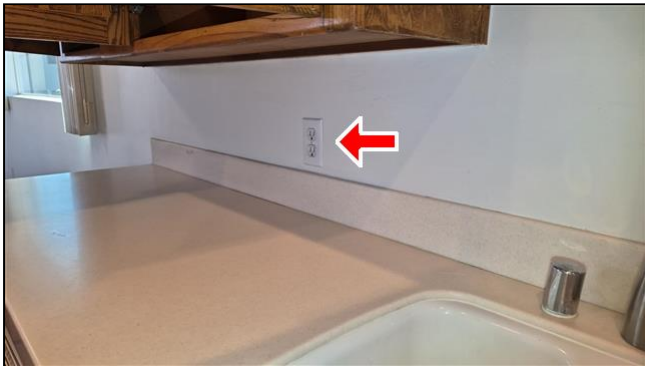
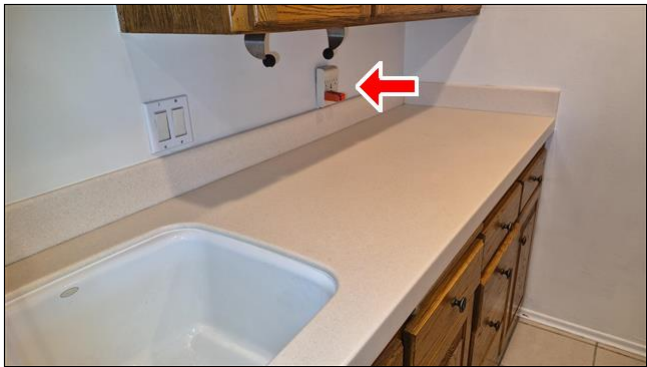
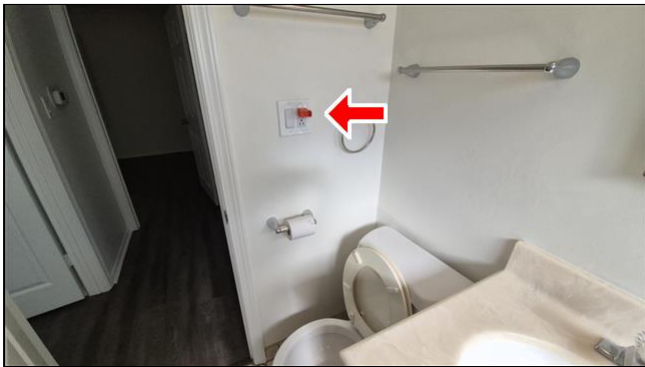
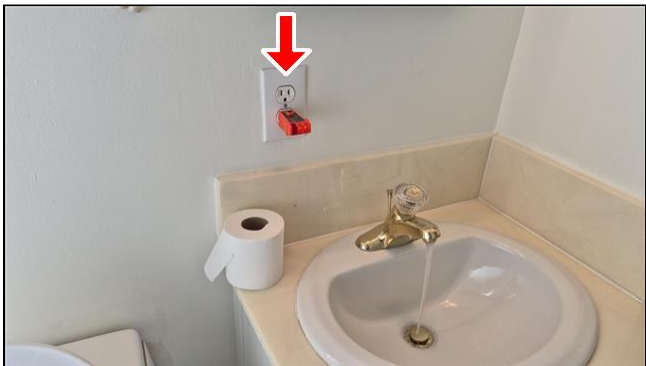
📍 (1) Ground fault circuit interrupters are not installed at all required locations. Recommend installing as a safety enhancement.

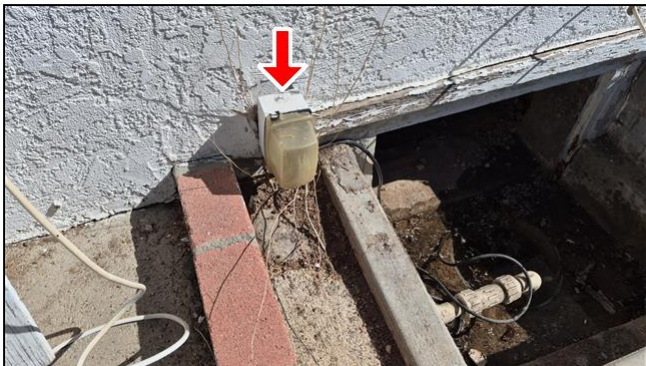
5.4 Item 8 (Picture)

🏠 (2) Exterior outlet cover is loose/damaged at crawlspace sump pump. Recommend replacement.

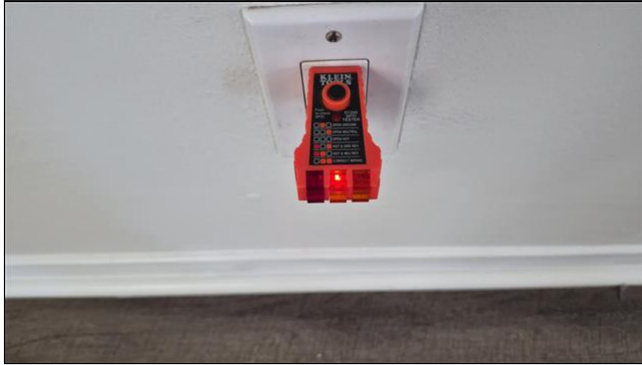
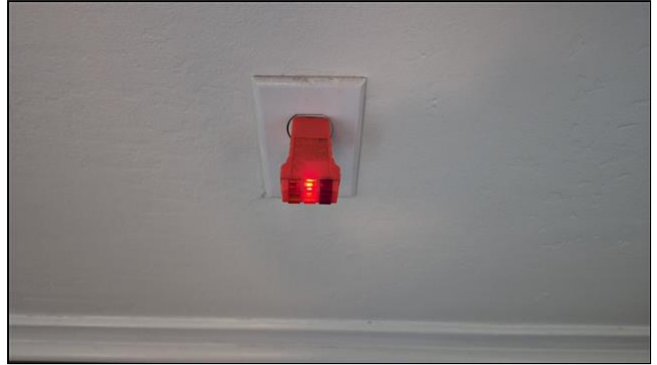
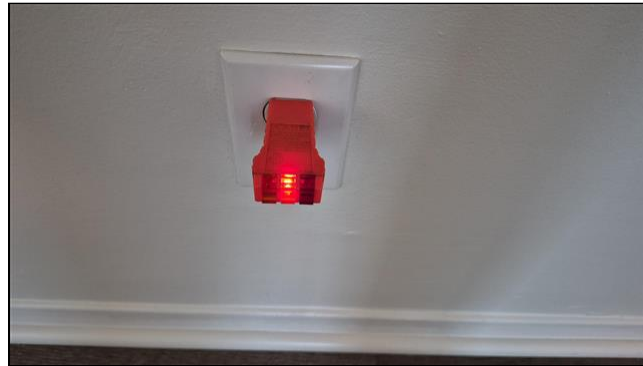
🏠 (3) Ungrounded three pronged outlets observed throughout the home. Recommend correcting.

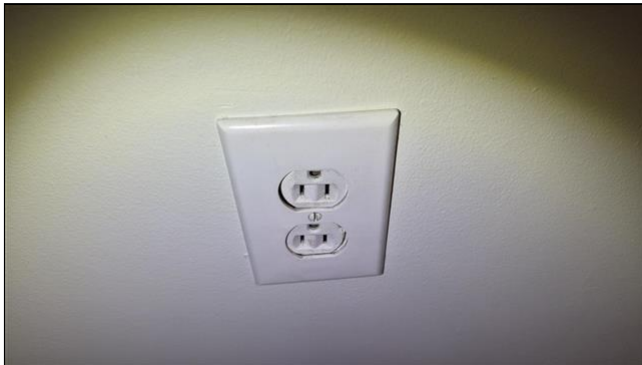
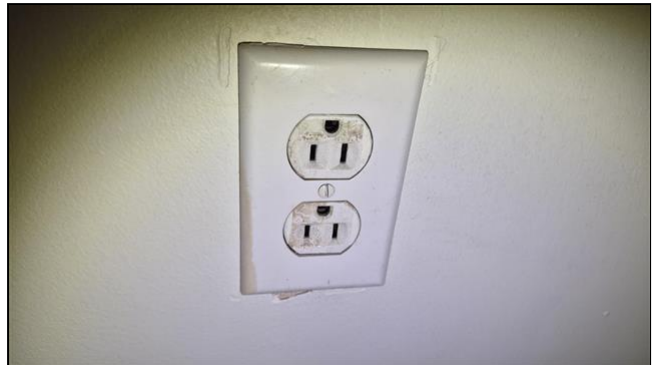
🏠 (4) Painted outlets observed at a number of areas throughout the home. Recommend correcting.

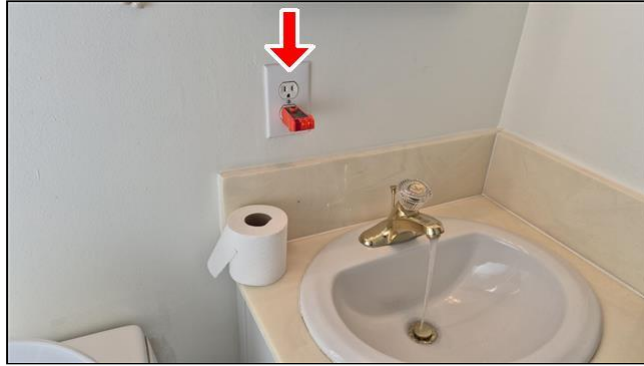
5.4 Item 14 (Picture)

🏠 (5) Outlet is incorrectly installed directly behind the sink in the rear bathroom. Recommend relocating.

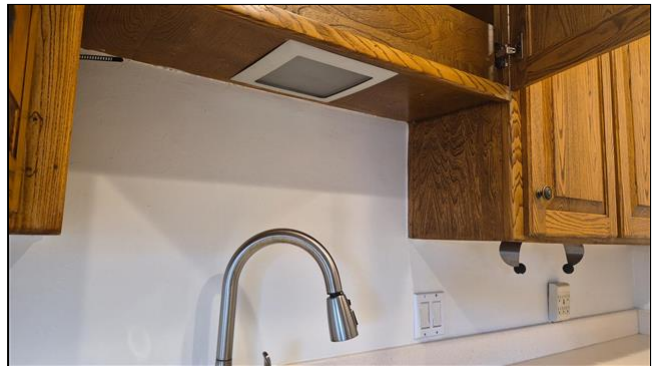
(1) Light fixture did not respond to test or bulb is out at hallway and above kitchen sink. Suggest correcting. K sink

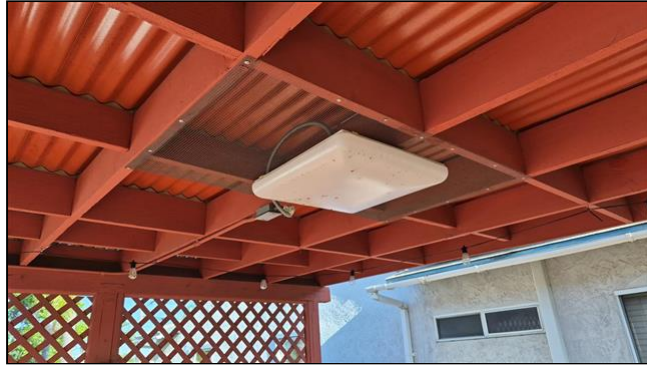
5.5 Item 4 (Picture)

(3) Exterior light fixture is deteriorated at covered patio. Suggest replacement.

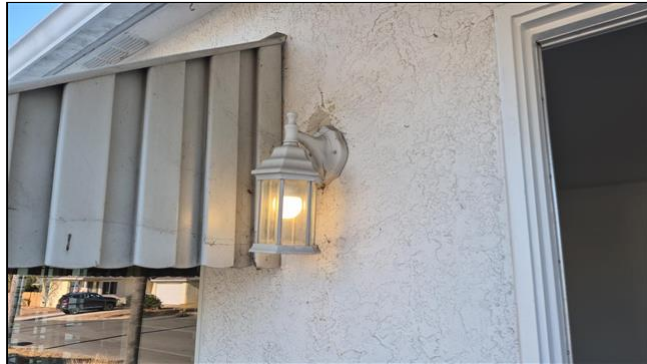
5.5 Item 5 (Picture)

(4) Light fixture is loose/unsealed at front exterior. Suggest correcting.

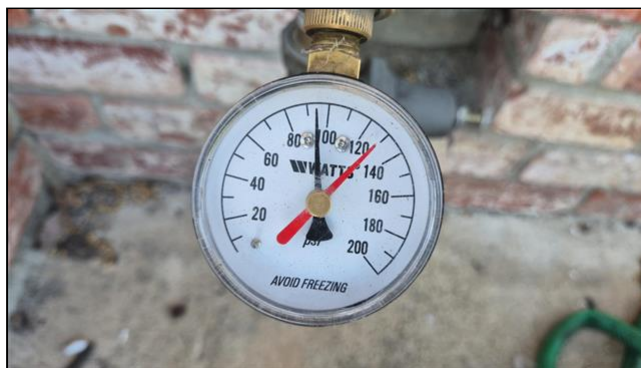
6.0 Item 1 (Picture)

📍 (1) Water pressure at the time of inspection was 95 static PSI . The water pressure is not between the recommended 40 to 80 PSI range. The pressure regulator should be adjusted so the water pressure is between 40 and 80 PSI. Recommend correcting.

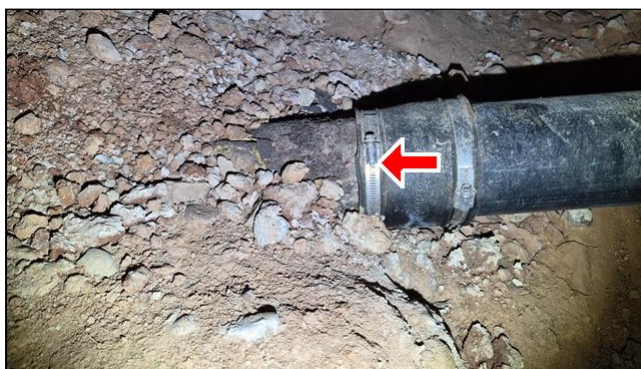
📍 (1) Remaining cast iron/galvanized DWV piping in the crawlspace is beyond its intended service life. Recommend verifying overall condition and remaining service life with a qualified plumber, prior to the end of the contingency period.

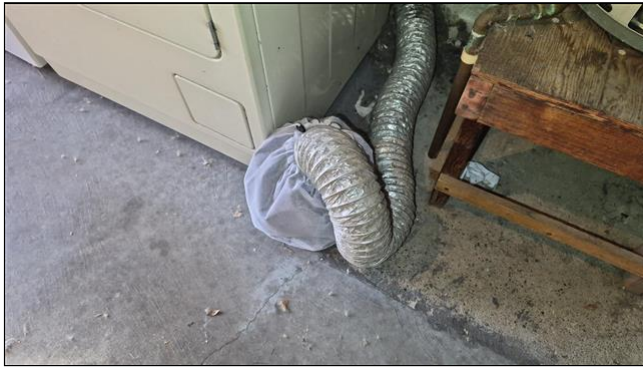
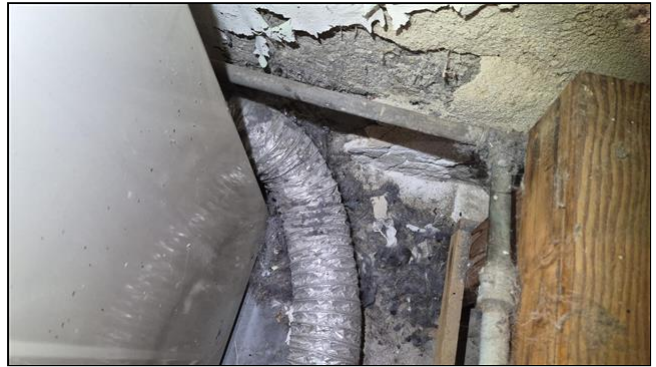
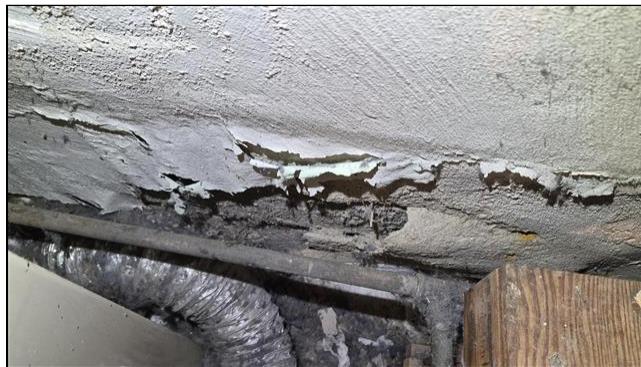
📍 (1) Dryer is not vented to the exterior of the home. Excessive lint and moisture damage observed at/behind dryer. Recommend correcting.

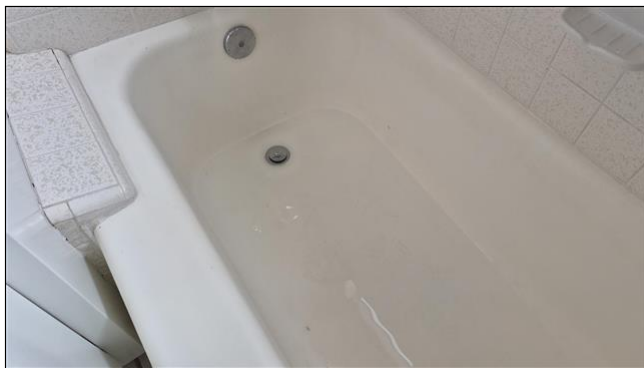
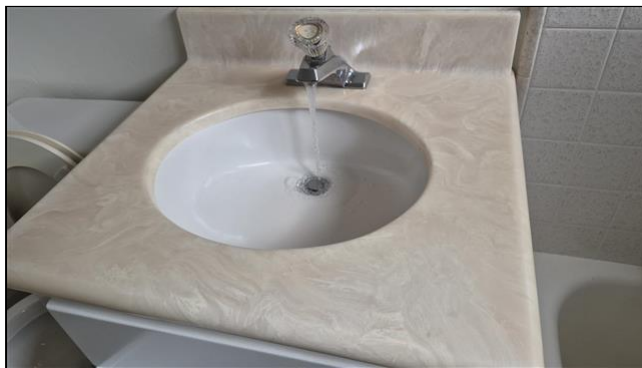
🏠 (1) The sink and tub drain slowly at front bathroom. Recommend correcting.

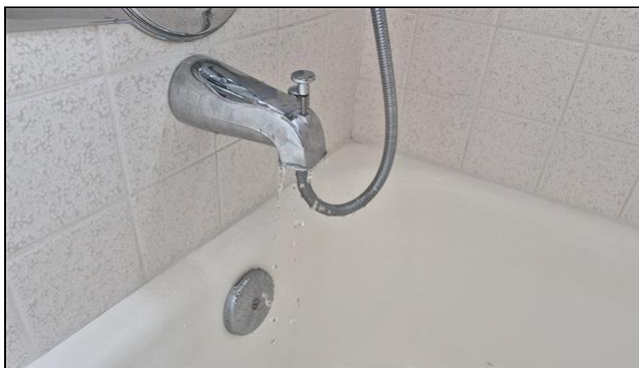
6.5 Item 3 (Picture)

(2) Shower diverter at the front bathroom no longer blocks water flow sufficiently. Suggest repair or replacement.

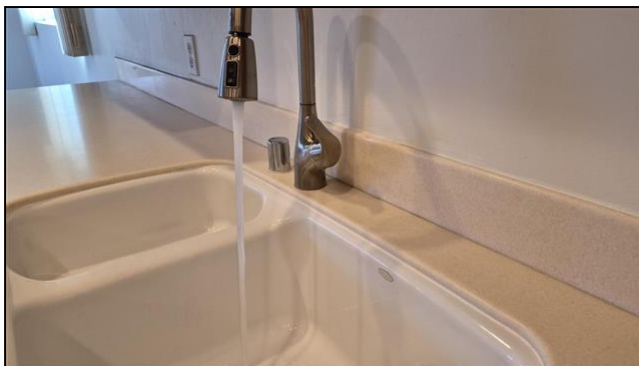
6.5 Item 4 (Picture)

(3) Faucet is loose to countertop at kitchen sink. Suggest correcting.

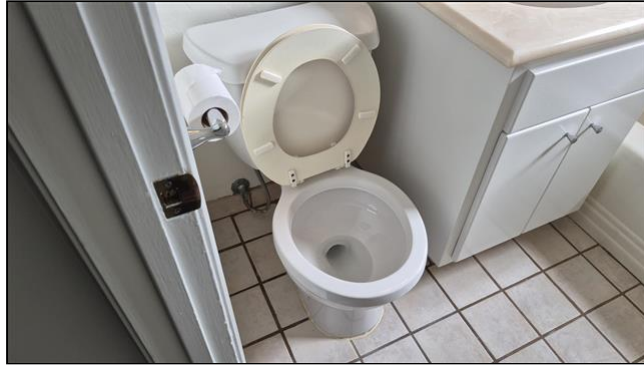
6.6 Item 1 (Picture)

🏠 (1) Toilet does not flush correctly and valve runs at front bathroom. Recommend repair.

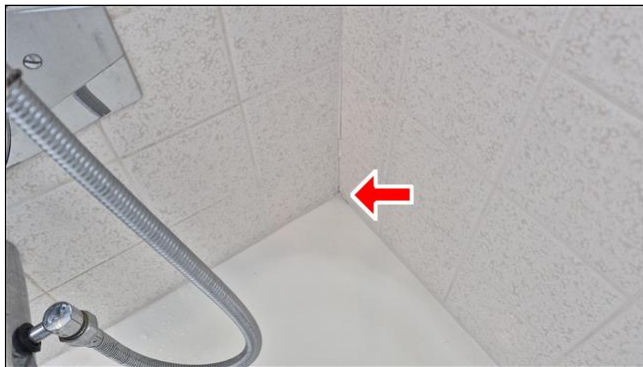
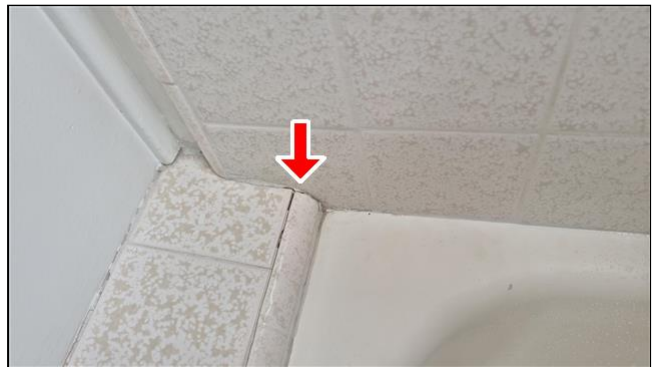
🏠 (2) Caulking/grout at the front bathroom tub/shower is deteriorated or missing. Recommend repair.

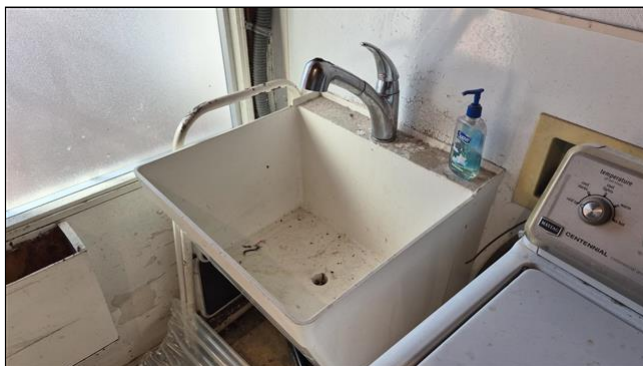
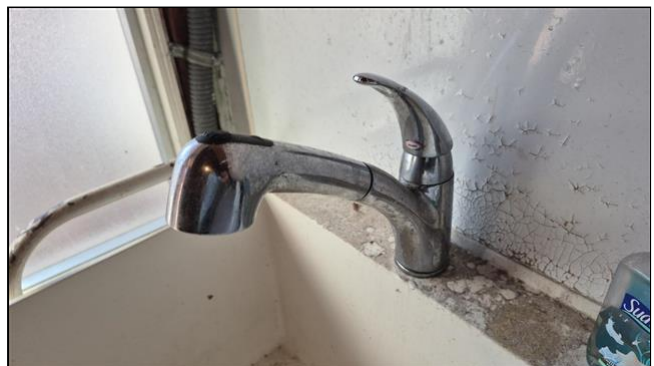
(3) Garage sink is deteriorated. Suggest replacement.

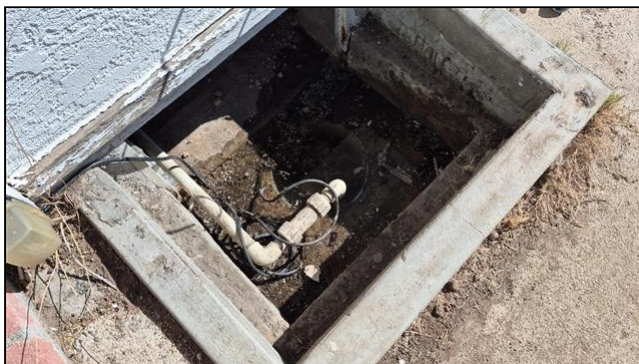
6.9 Item 1 (Picture)

🏠 (1) Sump pump did not respond to test. Recommend repair or replacement.

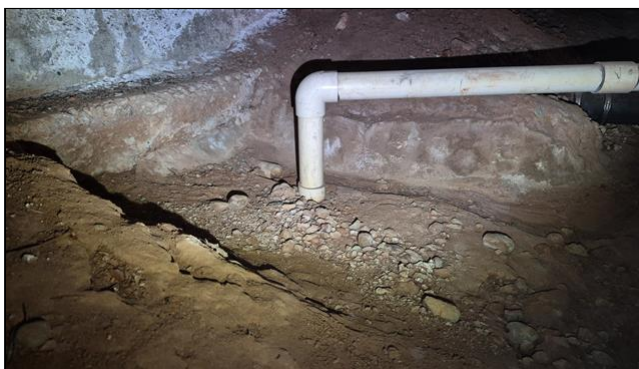
6.9 Item 2 (Picture)

🏠 (2) Unable to determine sump pump discharge termination location. Recommend repair/ replacement of sump pump and verifying full operation.

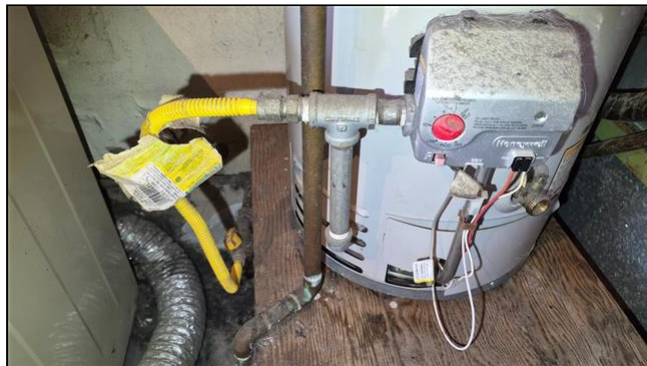
7.1 Item 1 (Picture)

Sediment trap is not plumbed correctly on the gas line. Suggest correcting.

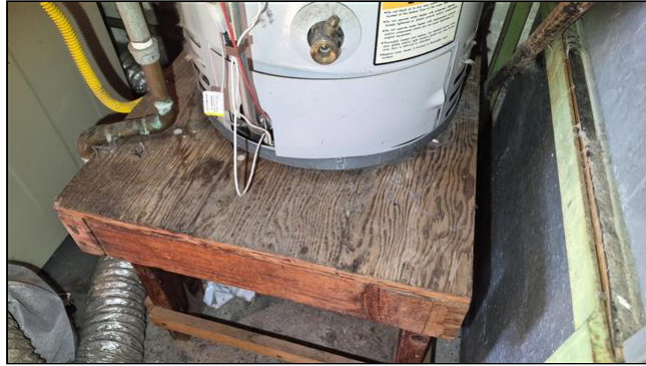
7.6 Item 1 (Picture)

Drip pan with drain line is not installed. Recommend installing.

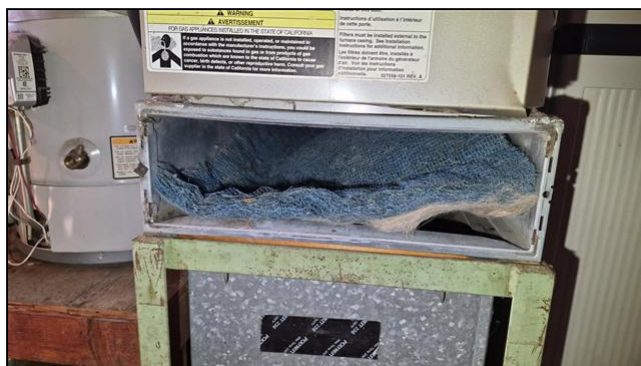
8.7 Item 1 (Picture)

↑ Return air filter is dirty. Recommend replacement and servicing of the system.

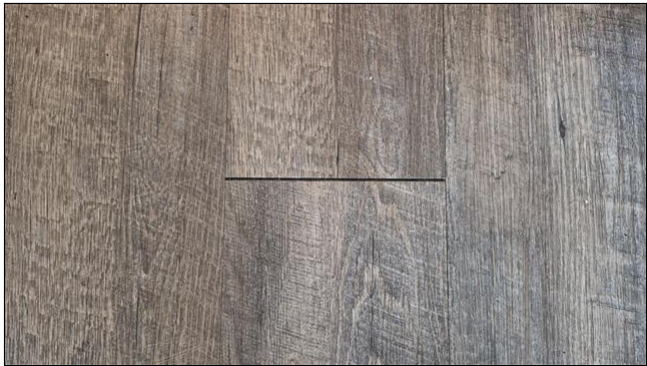
10.0 Item 1 (Picture)

Gaps observed at laminate flooring in areas. Suggest correcting.

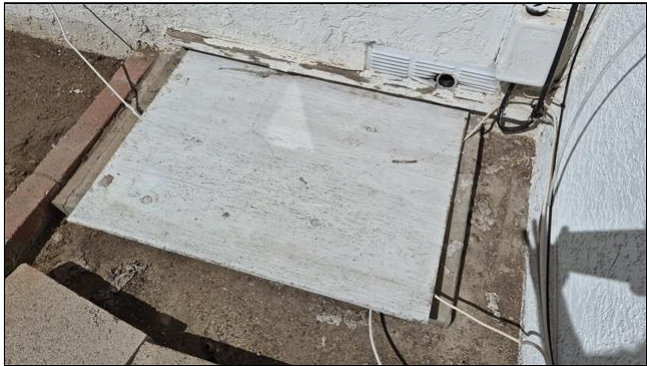
11.1 Item 1 (Picture)

Crawlspace access doors are deteriorated and do not seal/latch shut. Suggest correcting.

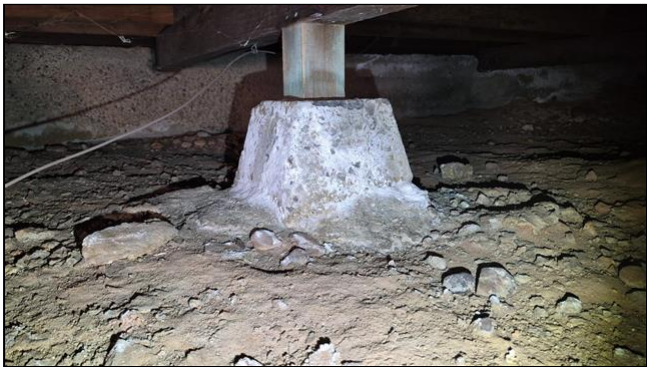
11.2 Item 2 (Picture)

Efflorescence/spalling observed on foundation walls and piers. This is an indication of excessive moisture intrusion into the crawlspace. See grading/drainage comments in the exterior category.

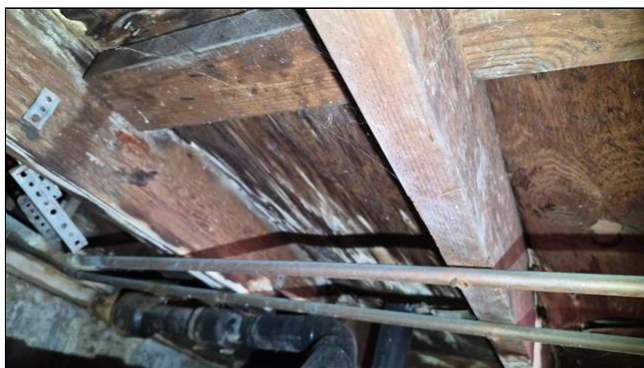
11.3 Item 1 (Picture)

📌 Moisture damaged sub floor observed under the rear bathroom shower. Hidden damage may not be observable. Recommend further review by a qualified professional, prior to the end of the contingency period.

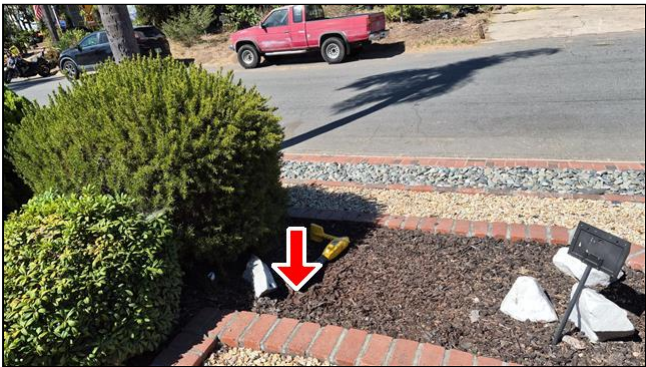
12.1 Item 2 (Picture)

The sewer line from the roof vent access to the stoppage point, measured at a length of 51 feet. Stoppage point is not due to any material defects within the line. Stoppage is due to bends within the sewer line and unavailable additional clean-out access points. (Main line clean-out is not installed/buried at front) - Recommend verifying the condition of the remaining line, prior to the end of contingency period.

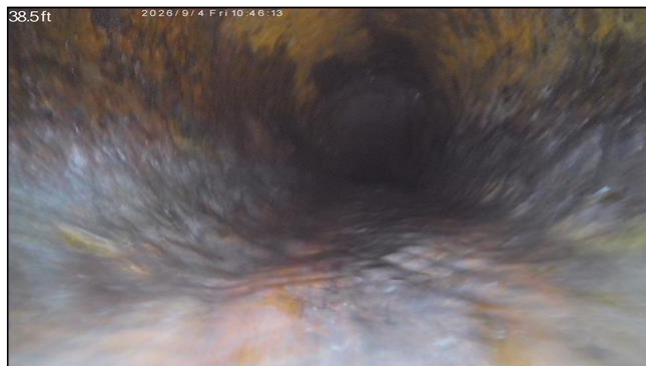
12.3 Item 1 (Picture)

🏠 (1) Scaling observed at cast iron drain lines. This indicates the cast iron drain lines are beyond their estimated service life. Excessive scaling prevents us from determining if there is a crack or leak from the exterior side of the line. Recommend further review by a qualified plumber to update cast iron drain lines.

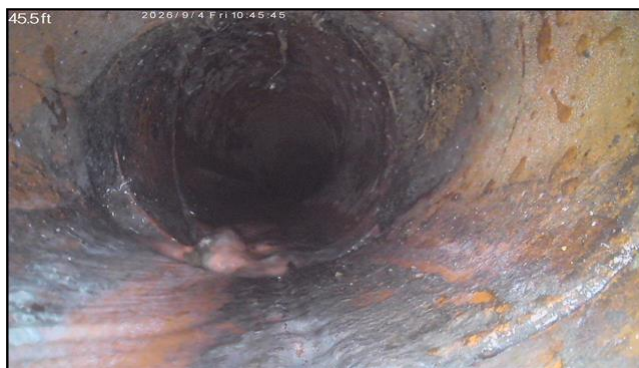
12.3 Item 3 (Picture)

🏠 (2) Cracking and off-set joints observed in the clay sewer line in the front yard. Recommend further review by a qualified plumber, prior to the end of the contingency period.
