Dec 1st, 2025

2136 Silver Dr., Arnold, CA, 95223

# Home Inspection Report

Sandra Lattin / Streamline Inspections

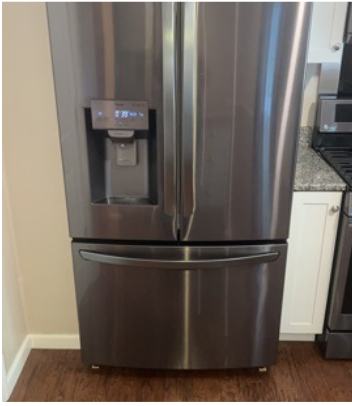
☒ Acceptable

This item was noted as acceptable; functional at time of inspection.

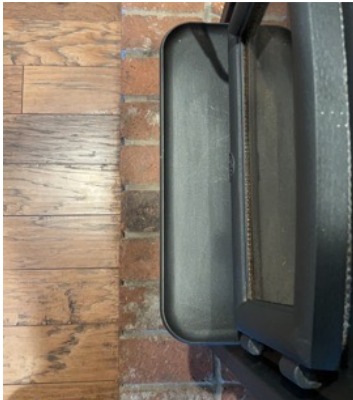
Marginal

(Any firebox less than six feet in square footage must have a hearth extending forth by a minimum of 16 inches. This hearth must also span eight inches on either side of the firebox. Hearths measuring over six square feet must include a hearth that juts forward at least 20 inches and extends 12 inches to each side. The building materials permissible for a California fireplace hearth include: Brick, Concrete, Quarry Tile, Marble, Slate, Stone, Terrazzo)

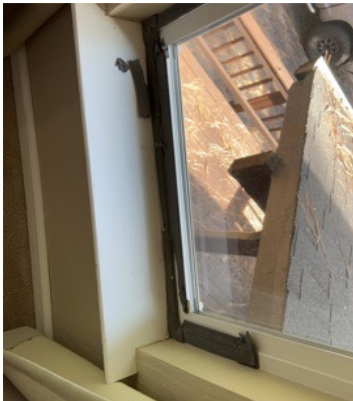
Marginal

Foam weather stripping has been installed at window.

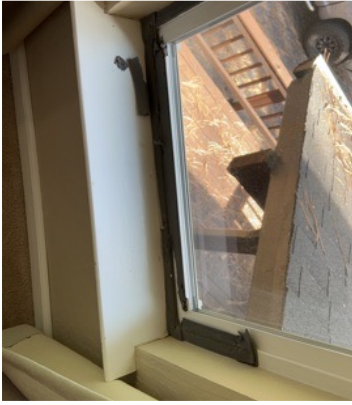
Marginal

Foam weather stripping has been installed at window.
