Kevin Kelpin  
7177 Sunny Place  
Yucca Valley, CA 92284

Date of Inspection: 3/20/2025 - 2:00pm

Inspection type: General Home Inspection

Year Built: 1963

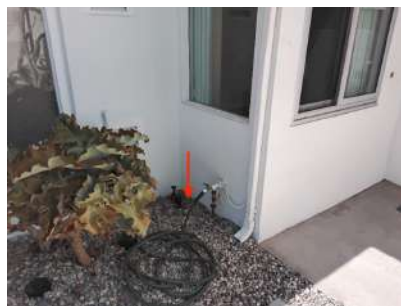
Low Spot - South

Water should always be diverted away from the house and foundation. There are low spots and evidence of pooling next to the house and foundation in a few areas around the home. All 3 gutter downspouts terminate next to the house and foundation. It is recommended that all downspouts have a splash block or extension for proper diversion away from the house and foundation. Recommend licensed landscaping contractor correct and maintain proper drainage and sloped grading away from the home in all areas.

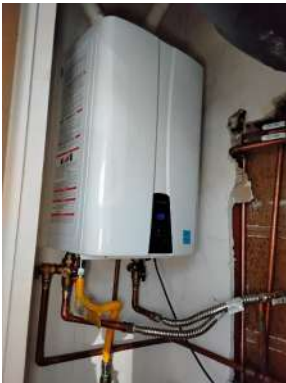
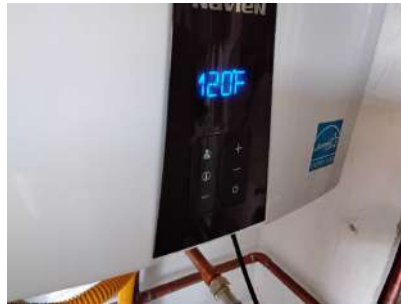
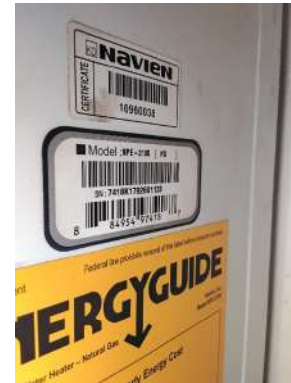
The water heater was manufactured in 2017. The unit was producing hot water at time of inspection. No gas leaks detected. **The TPR (Temperature Pressure Relief) valve extension is improperly installed with T-fittings and serves multiple drains.** Per CPC code, TPR valve extensions shall not have T-fittings, and shall not connect to piping serving any other relief device or equipment (must be installed independently). Recommend licensed plumbing contractor repair.

Inadequate TPR Valve Extension

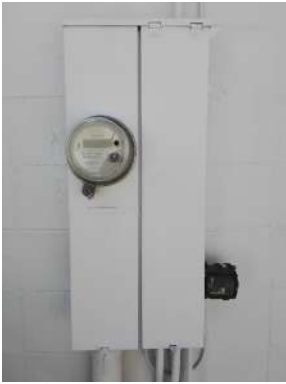
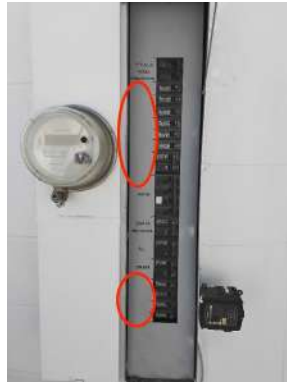
Numerous circuits are missing labels. Main service disconnect was present (200amp). The dead front cover is a make shift installation (not from electrical manufacturer), leaving gaps and exposed wires accessible.

Missing Circuit Labels

Recommend replacing dead front cover with an exact duplicate from the same manufacturer to comply with the UL rating. There was rust on the ground/neutral bus bar inside the panel. Note: Corrosion inside a panel is an indication of unwanted moisture and can lead to poor connections and overheating. Recommend licensed electrician repair noted items and clearly label all circuits.

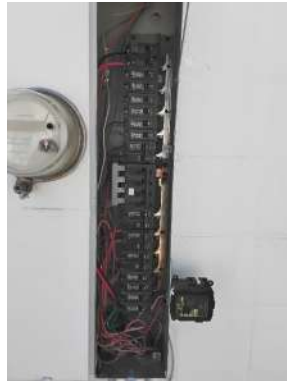
Rust/Corrosion - Neutral/Ground Bus Bar

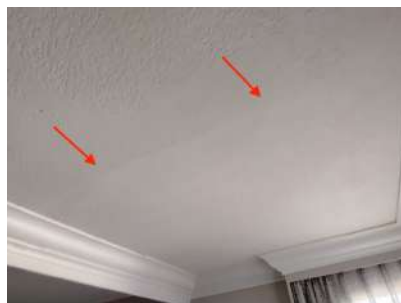
Hairline cracks, blemishes + evidence of patchwork were observed at the ceilings in the primary bedroom and kitchen. Water stains were observed in the guest bedroom closet. No moisture was detected at time of inspection. Note: Hairline cracks are typically caused by normal settlement and thermal expansion. Cracks less than 1/8-inch thick are considered stress cracks and are typically harmless. Recommend qualified professional repair/repaint.

Patchwork - Primary Bedroom

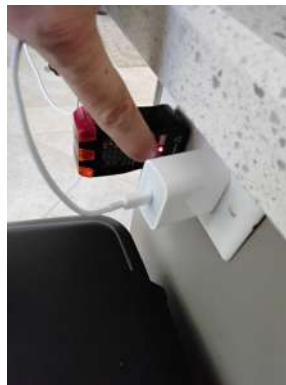
Both outlets at the kitchen island are without GFCI protection. Per current NEC code, all outlets serving kitchen countertops are required to have GFCI protection (including islands). Recommend licensed electrician replace.

Non-GFCI - Tester

- 9) KITCHEN – Receptacles: Power receptacles on the island were repaired by Home Team Electric.
- 10) LAUNDRY – Washer/Dryer: A new washer/dryer was installed 1/13/2026, incorporating an improved ventilation system.

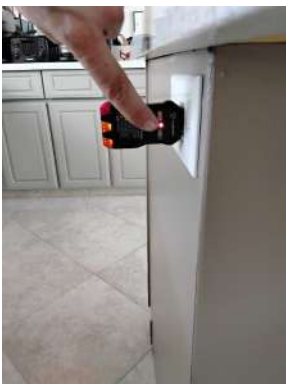
Non-GFCI - Tester

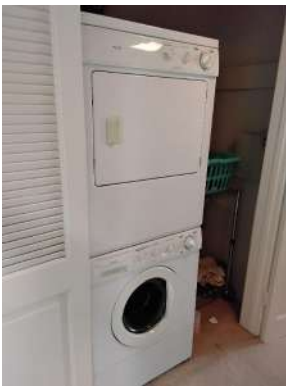
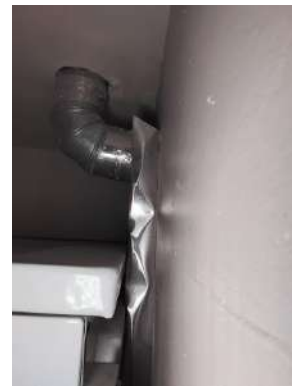
The washer and dryer were operational at time of inspection. No leaks were detected at the plumbing valves. There was excessive lint buildup behind the units, indicating a poor dryer vent connection or clogged dryer vent duct (safety hazard).

**Note:** Clogged dryer vents are one of the leading causes of house fires. Recommend qualified professional evaluate further/repair. Recommend periodic monitoring and cleaning of the dryer vent duct for safety.

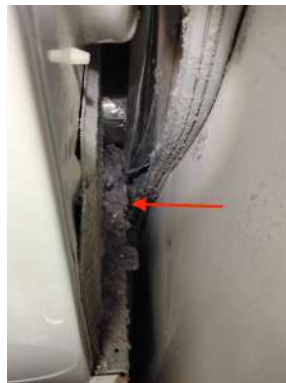
Lint Buildup
