# PROPERTY INSPECTION REPORT

489 E San Jose Rd.  
Palm Springs, Ca

Prepared for: Doug Bayer (6-4-25)

Prepared by: CTS Inspections

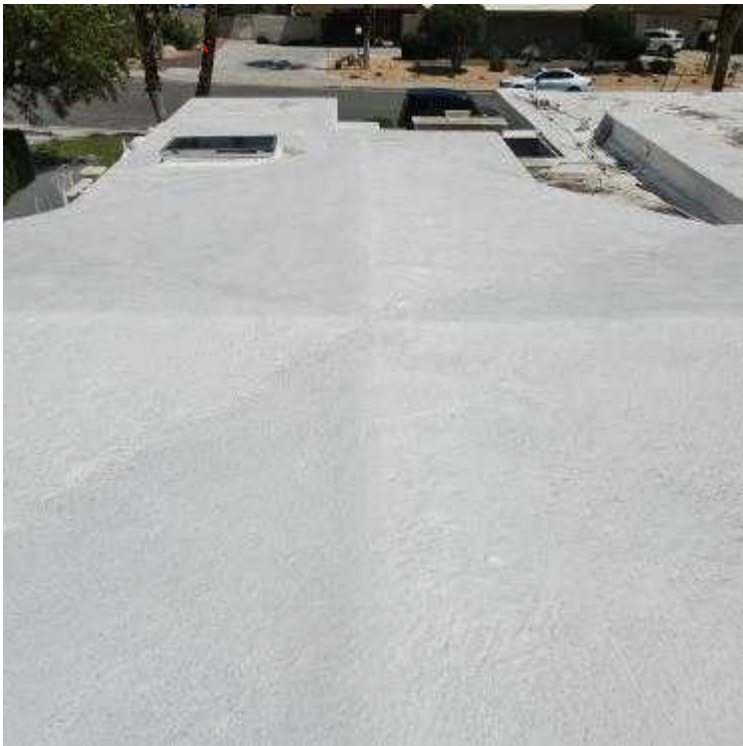
Roof GV-Standing water present (Rained overnight on 6-3-25)

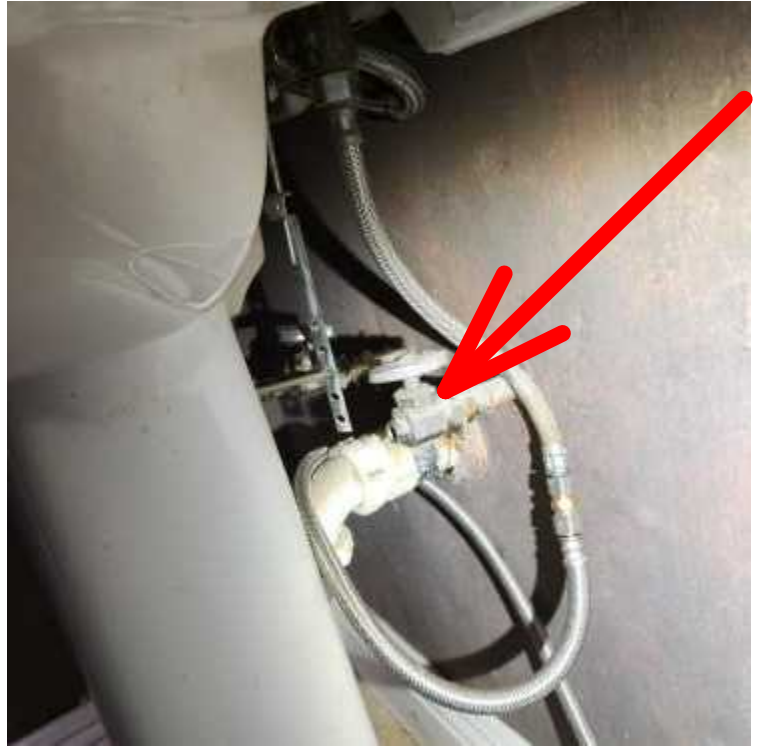
Sink in north bathroom drains slow
