## RESIDENTIAL INSPECTION REPORT

1325 5th St  
Imperial Beach, CA 91932

07/25/2025

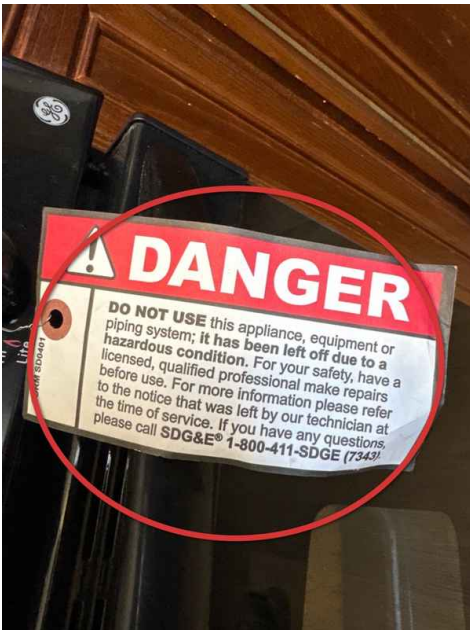
Red tag placed by SDGE

Contact your local utility company

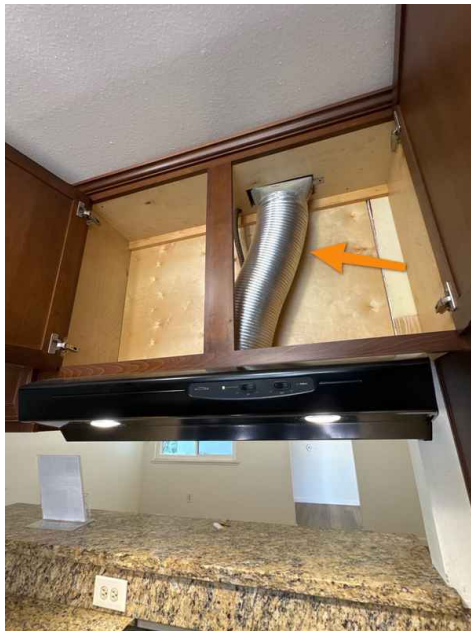
Flex vent

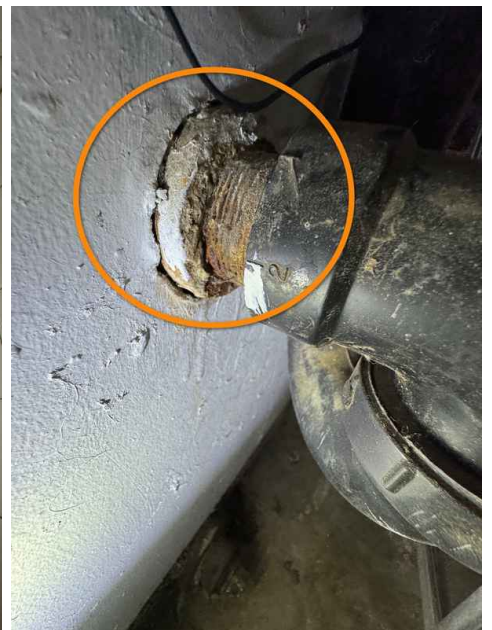
Example noted at Primary Bathroom Shower drain

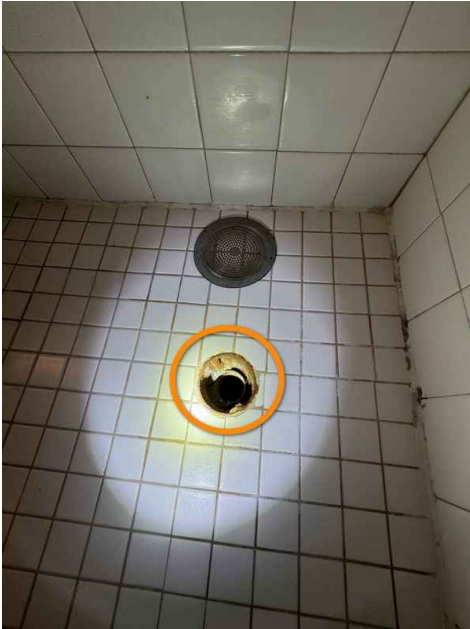
Primary Bathroom Shower

#### **SHOWER DRAIN COVER NOT INSTALLED - DEBRIS NOTED IN DRAIN**

The primary bathroom shower drain cover was not installed at the time of inspection. Debris was also visible in the drain. Recommend further evaluation of the drain and installation of a cover by a licensed plumbing contractor.

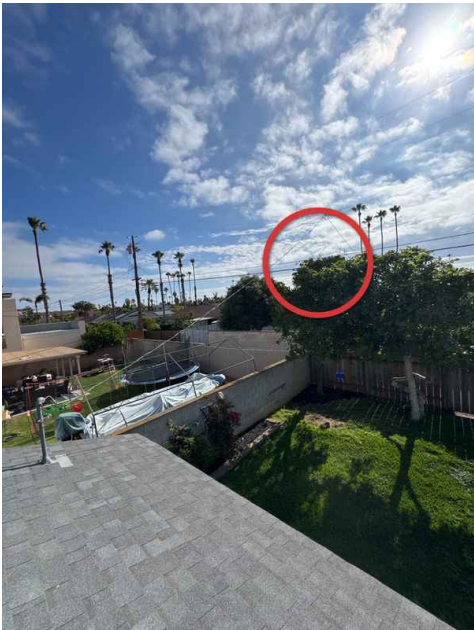
Rear Yard

INSUFFICIENT CLEARANCE/DAMAGED INSULATION AT ELECTRICAL SERVICE CONDUCTORS

There did not appear to be sufficient clearance from the tree at the overhead electrical service entrance conductors at the rear yard. This can be an electrical safety hazard. Also, protective insulation on service entrance conductors appeared to be damaged in one or more areas. Wires should not be exposed to sunlight, unless rated. Recommend further evaluation by a licensed electrical contractor to determine corrections necessary at this time for safety.

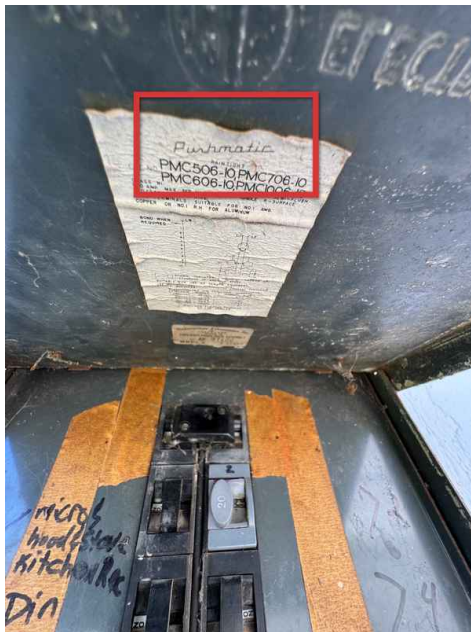
Pushmatic panel

Contact a qualified electrical contractor.

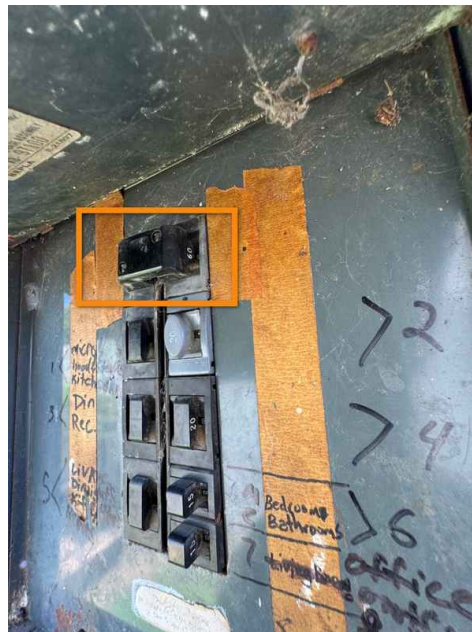
Main Panel, 60 amps

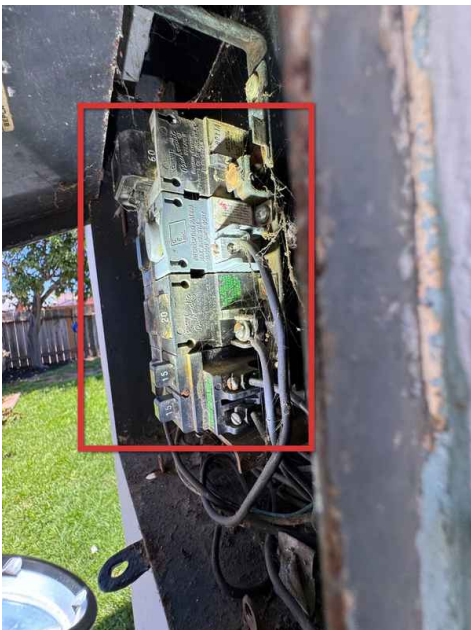
Example noted Inside Main Panel

Contact a qualified electrical contractor.

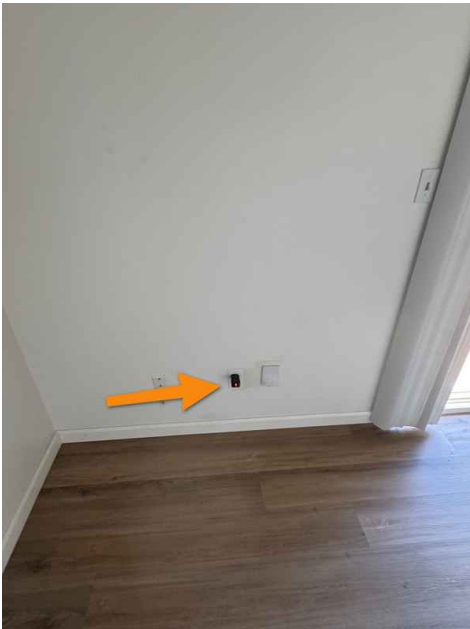
Electrical receptacles (outlets/switches) in several locations in the home and/or at the exterior noted excessively loose, damaged and/or missing adequate faceplates. These conditions are an electrical safety concern, if left uncorrected. Recommend further evaluation of all electrical receptacles throughout the home and exterior by a licensed electrical contractor to determine any repairs or replacement as necessary for safety.

Example noted at Hallway Inside Utility Closet, loose

Recommendation  
Contact a qualified electrical contractor.

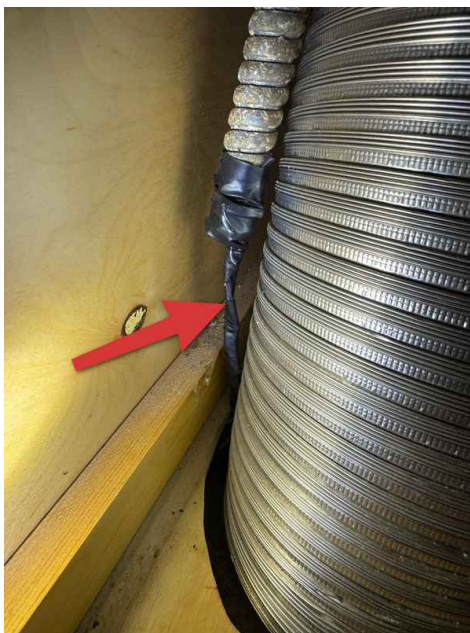
Example noted

Exposed "Romex" type wiring noted at one or more locations. Wires located where they may be subject to physical damage (typically lower than 7 feet.) is a safety concern. Romex type wiring is typically located inside of walls or in approved conduit. Recommend further evaluation by a licensed electrical contractor to determine repairs necessary for safety.

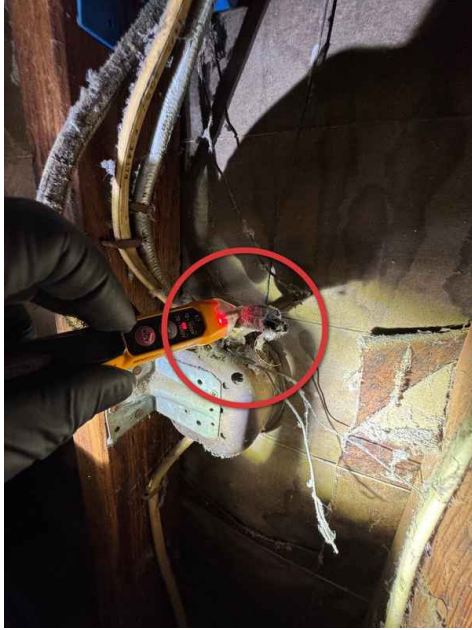
Wires appeared to be improperly terminated at one or more locations. The wire in the garage appeared to be powered or "live". This is a potential electrical shock safety concern. Other wires appeared unpowered, however, verifying this is beyond the scope of this inspection. Recommend further evaluation by a licensed electrical contractor to determine corrections necessary for safety.

Example noted, wire appeared powered

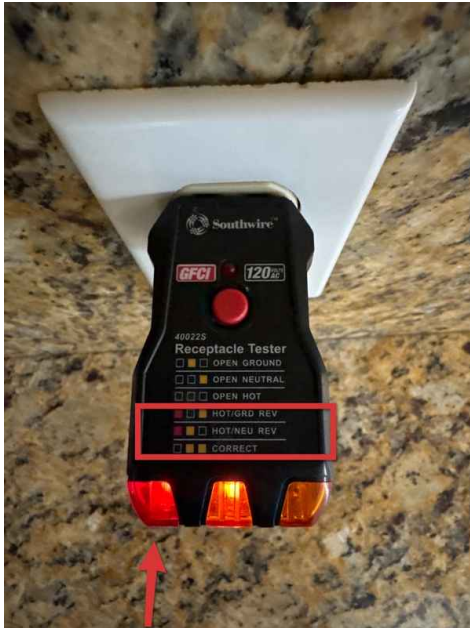
Example noted

One or more receptacles appeared to have been wired improperly, or with reverse polarity. This can create an electrical shock hazard. Recommend further evaluation by a licensed electrical contractor to determine corrections necessary at this time to ensure proper polarity and safety of the receptacles in the home.

Contact a qualified electrical contractor.

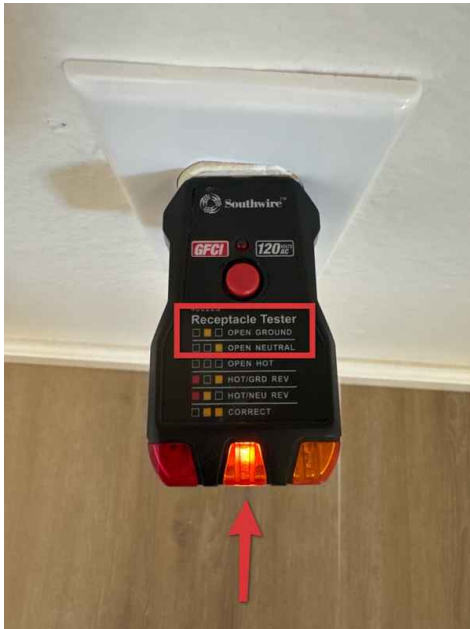
Example noted

Most electrical receptacles throughout the home appeared "open" or ungrounded. This is an electrical safety concern. Recommend further evaluation by a licensed electrical contractor to determine repairs necessary at this time to ensure proper grounding and safety in the home.

Contact a qualified electrical contractor.

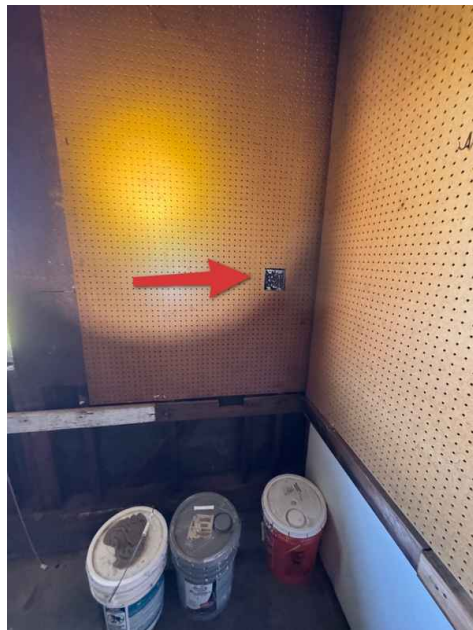
This home was built prior to the requirement for the installation of GFCI receptacles in certain locations throughout the home. The locations where GFCI protection is required has increased due to known safety hazards, however, it is not generally required to retrofit older homes unless a substantial remodel takes place. No exterior receptacles found, recommend adding as an upgrade to comply with today's electrical safety standards. I highly recommend a licensed electrical contractor further evaluate and upgrade all required receptacles, including but not limited to; receptacles located within 6 feet of a plumbing fixture, in the garage, all receptacles serving the kitchen counter top, laundry receptacle, and all exterior receptacles, to GFCI protected receptacles.

Example noted at Garage, Right Side facing outwards

Contact a qualified electrical contractor.

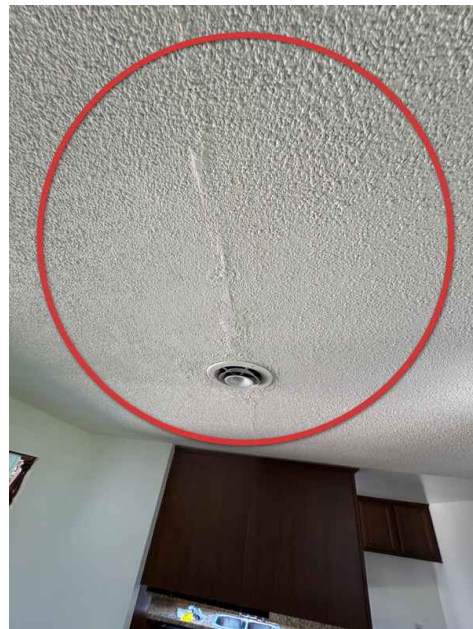
Example noted

Contact a qualified professional.

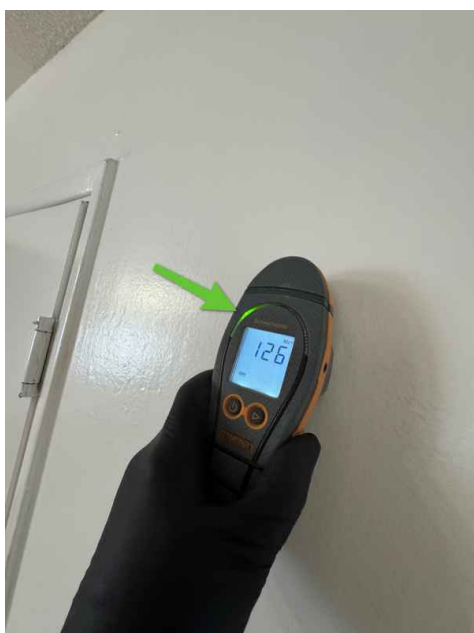
The area appeared to be dry

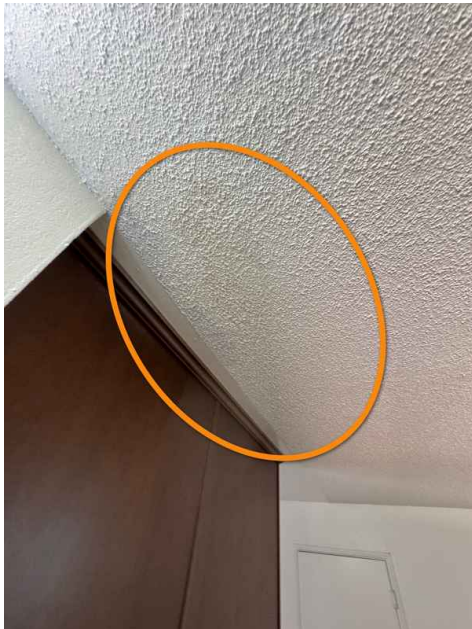
Example noted

Contact a qualified professional.

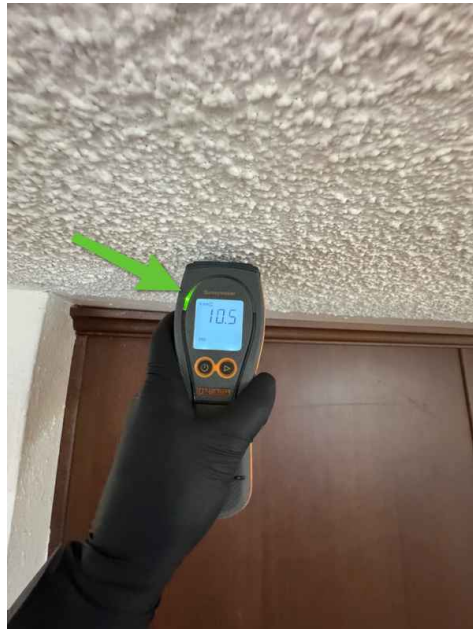
The area appeared to be dry

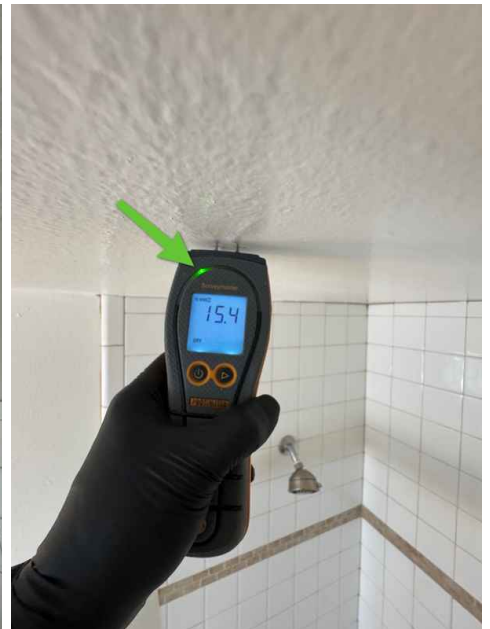
The area appeared to be dry

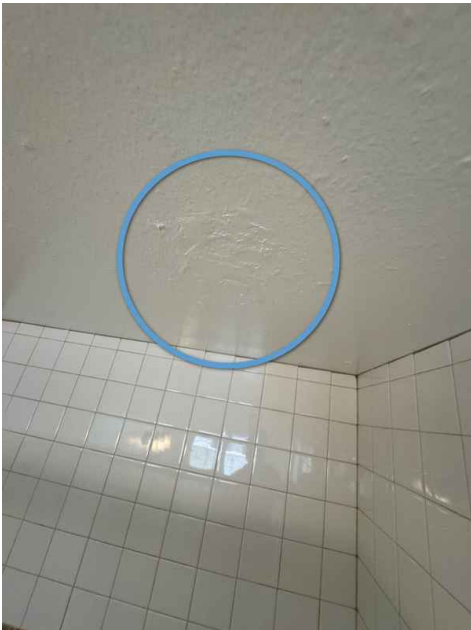
Example noted

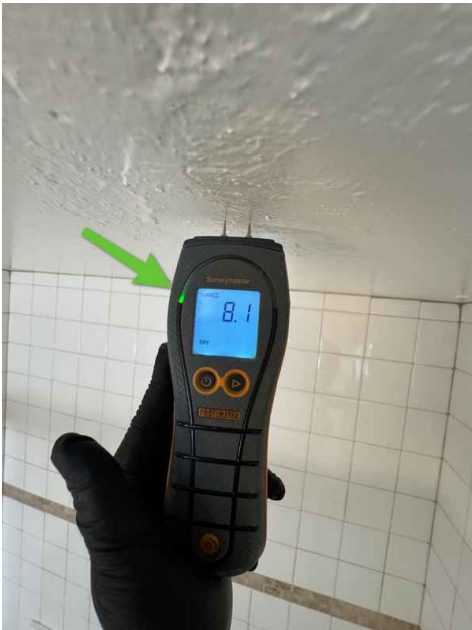
The area appeared to be dry

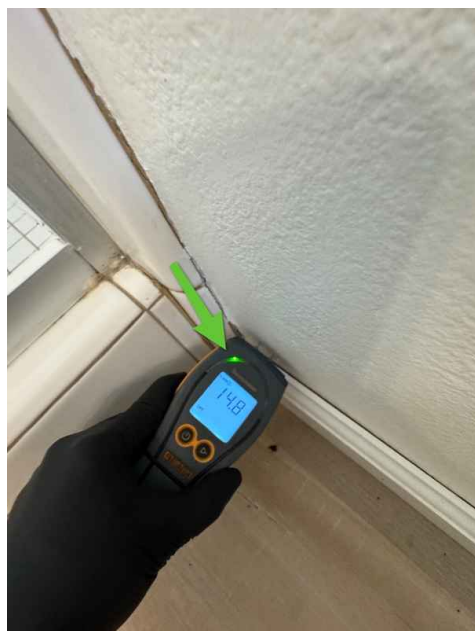
#### PREVIOUS REPAIRS - WALLS

Mis-match paint and/or patching/evidence of previous repairs noted at the walls in areas. Determining the cause is outside the scope of this inspection. Should the client have concerns, we recommend asking the seller for any information regarding previous repairs, and/or further evaluation by a qualified professional as necessary.

Example noted at Kitchen

Example noted at Living Room

Example noted at Primary Bedroom

Example noted at Dining Room

Example noted at Bedroom #2

Example noted at Primary Bathroom

The area appeared to be dry

Contact a qualified professional.

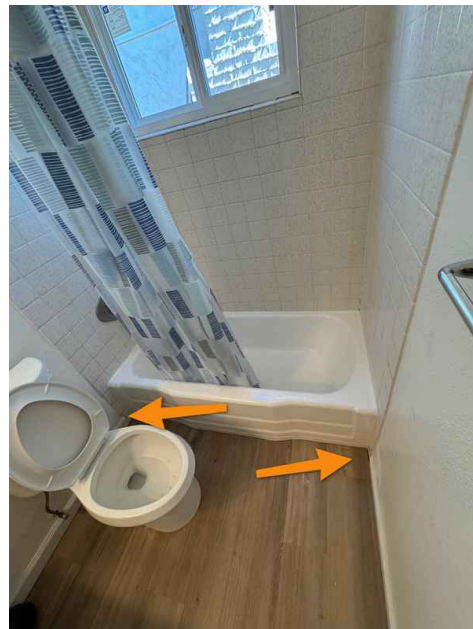
Hall Bathroom

## MOISTURE AT WALL BY SHOWER/BATHTUB

Elevated levels of moisture detected at the wall/baseboard by the shower/bathtub at the bathroom(s). This is often the result of water spilling out of the shower/bathtub enclosure. This condition is conducive to moisture damage, such as mold growth. Recommend further evaluation by a licensed restoration contractor to verify cause and any repairs necessary. Note: Determining if damage (such as mold growth) exists beyond the surface is beyond the scope of this inspection.

Elevated levels of moisture detected

Contact a qualified professional.

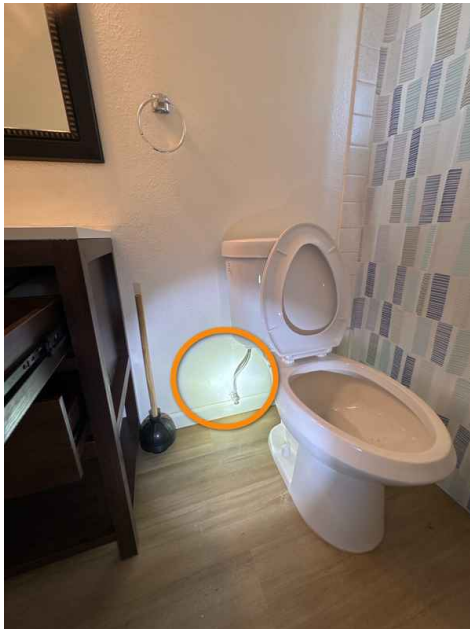
**MOISTURE AT WALL - UNKNOWN CAUSE**

Elevated levels of moisture noted at the walls in several locations. Unable to determine the exact cause. This condition is conducive to moisture damage, such as mold growth. Recommend further evaluation by a licensed restoration contractor to determine the cause and any repairs necessary to forestall further damage. Note: Determining if damage (such as mold growth) exists beyond the surface is beyond the scope of this inspection.

Elevated levels of moisture detected

Kitchen, Inside Sink Cabinet

Hall Bathroom, next to Toilet

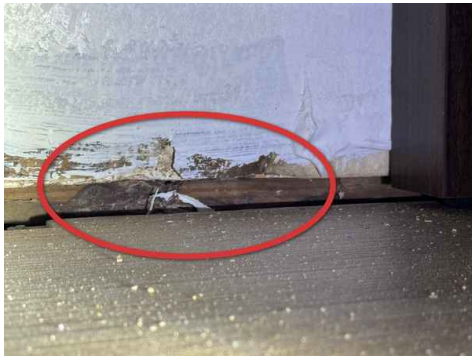
Dark staining, possible organic growth (mold), noted at the wall in one or more location. An elevated level of moisture was also detected. Determining the cause and if any organic growth may be a health concern requires specialized testing, which is beyond the scope of this inspection. Recommend further evaluation by a licensed restoration contractor to determine the cause and any repairs necessary. I also recommend a licensed environmental contractor to further evaluate the area(s) to determine if additional measures are necessary at this time to ensure proper air quality in the home and for health and safety of any occupants.

Example noted

Elevated levels of moisture detected

Example noted at Hall Bathroom, Below Sink

Contact a qualified environmental contractor

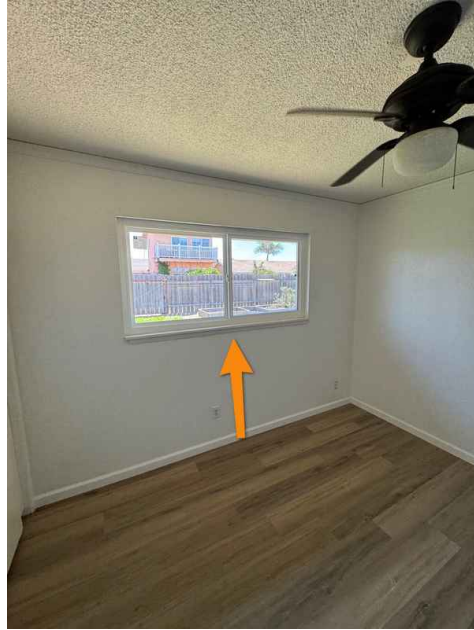
The window sill height at two bedrooms appeared to be too high for emergency egress by today's building standards. The max sill height should typically be 44" from the floor. This may have been acceptable at the time of original construction, and the seller is generally not required to update the windows. However, I recommend further evaluation by a licensed general contractor to determine any corrections possible to comply with today's building safety standards.

Example noted

Bedroom #3

Bedroom #2

Contact a qualified general contractor.

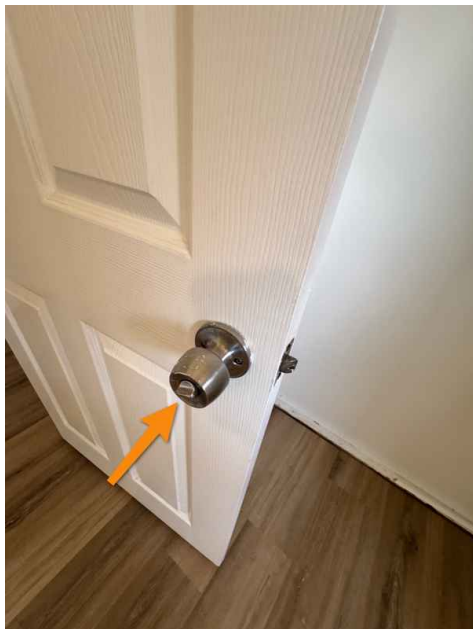
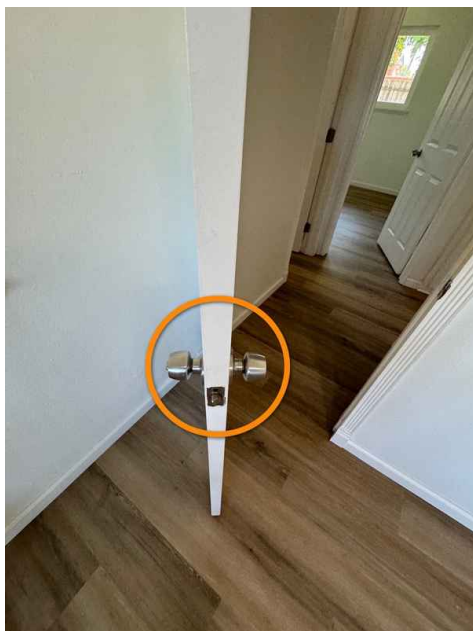
**INTERIOR DOORS/DOOR HARDWARE REQUIRE FURTHER EVALUATION & REPAIR**

Loose door handles, Door stopper(s) missing/inadequate, Door lock installed on outside of room

Interior doors/door hardware noted loose and or did not operate properly. Door lock noted installed at exterior side of bedroom, this condition may prevent egress in the case of a Door lock noted installed at exterior side of bedroom #3, this may prevent egress in the case of an emergency, if the door is locked from the exterior side. Door stoppers noted inadequate at most doors. Missing door stops at glass doors can lead to damage. Due to the Discovery Items listed here, I recommend further evaluation of the doors by a licensed door contractor and repair or replacement as necessary to ensure proper function.

Example noted at Bedroom #3, lock on exterior side

Example noted at Bedroom #3, loose hinge, missing stopper

Example noted at Bedroom #2, handle loose, missing stopper

Example noted at Primary Bedroom, loose handle

Example of damage noted, Primary Bathroom, stopper missing

Contact a qualified door repair/installation contractor.

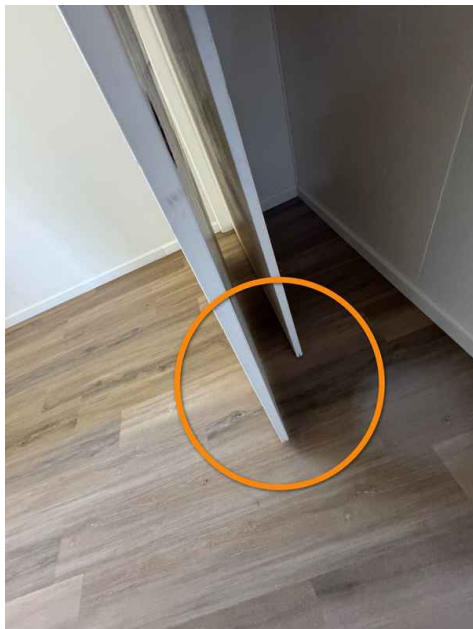
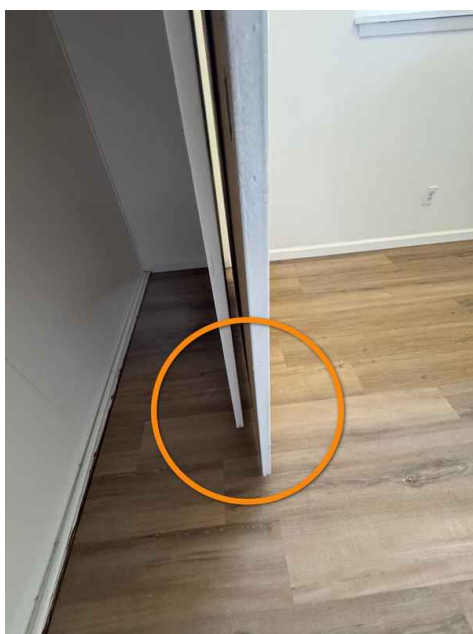
### CLOSET DOOR TRACKS MISSING - DAMAGE NOTED

Closet door track(s) noted missing at the floor. This condition can allow the doors to swing when operated, which can be a potential pinching hazard. Damage also noted at the closet doors in areas. Recommend further evaluation by a qualified professional to determine repair or replacement necessary to ensure proper function.

Bedroom #2 Closet

Example of damage noted, Bedroom #2 Closet

Primary Bedroom Closet

Bedroom #3 Closet

Contact a qualified professional.

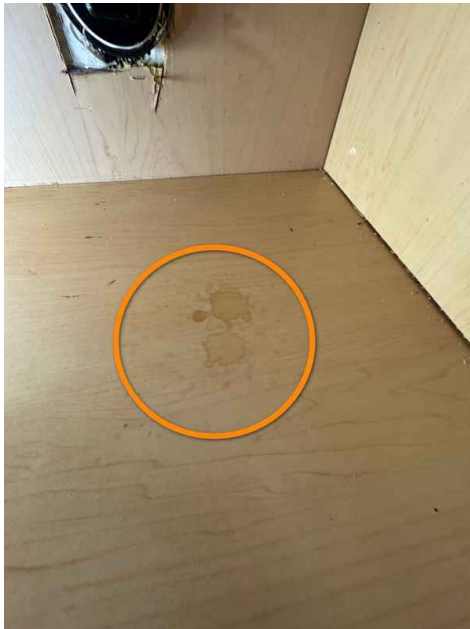
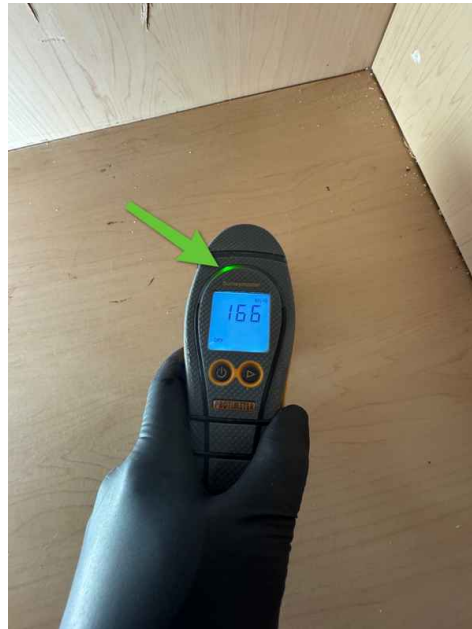
### MOISTURE STAINING/DAMAGE AT SINK CABINET(S) - DRY

Moisture damage/staining noted at the cabinet below one or more sinks. This condition can be indicative of a previous leak. The area(s) appeared dry at the time of the inspection. Recommend further evaluation by a licensed plumbing contractor and/or licensed termite inspector to determine any repairs necessary at this time. Note: Determining if hidden damage (such as organic growth) exists beyond the cabinets, walls, floors or other surfaces of the home is beyond the scope of this home inspection.

Example noted

The area appeared to be dry

Example noted at Primary Bathroom Sink Cabinet

Contact a qualified plumbing contractor.

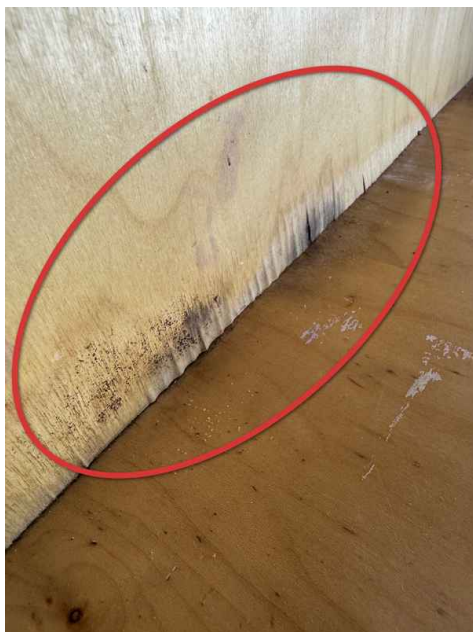
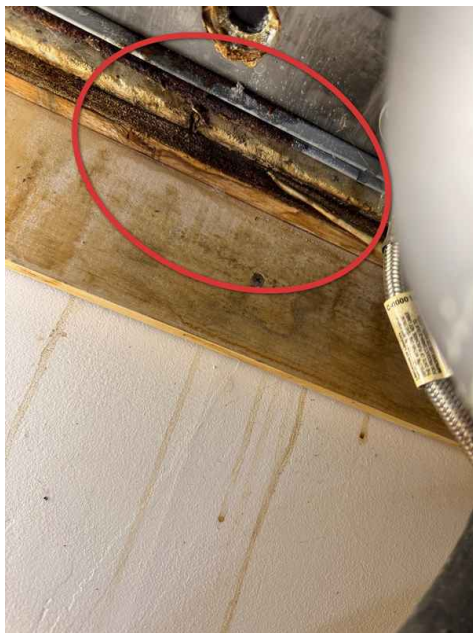
Dark staining, possible organic growth (mold), noted in areas of the sink cabinet. An elevated level of moisture was also detected in the areas. This can be indicative of failing seals at the above sink counter, or it may indicate a leak at the sink plumbing. Determining the exact cause, and if any organic growth may be a health concern, requires specialized testing, which is beyond the scope of this inspection. Recommend further evaluation by a licensed restoration contractor to determine the cause and any repairs necessary. I also recommend a licensed environmental contractor to further evaluate the area(s) to determine if additional measures are necessary at this time to ensure proper air quality in the home and for health and safety of any occupants.

Example noted

Elevated levels of moisture detected

Example noted at Kitchen Sink

Contact a qualified environmental contractor

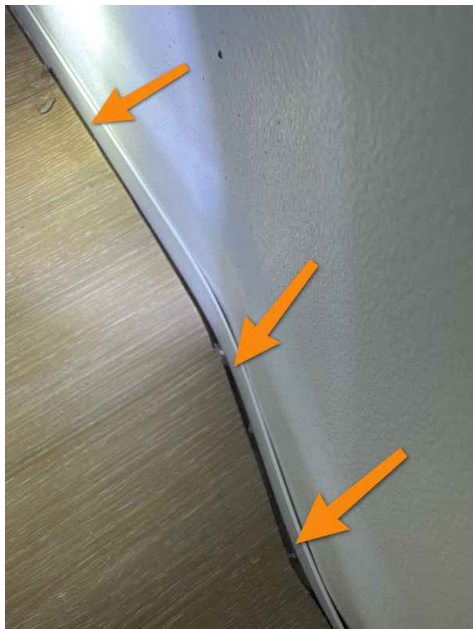
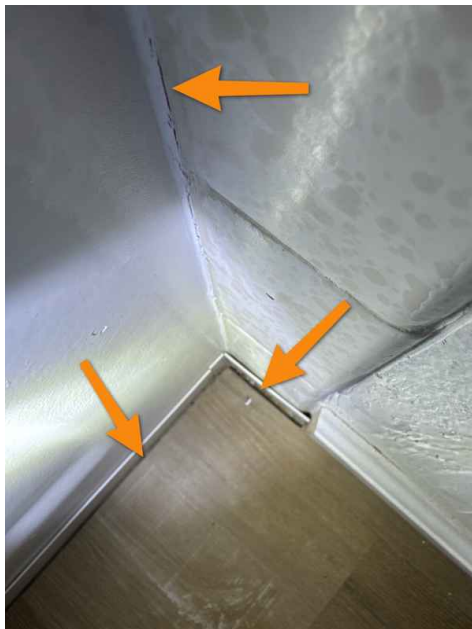
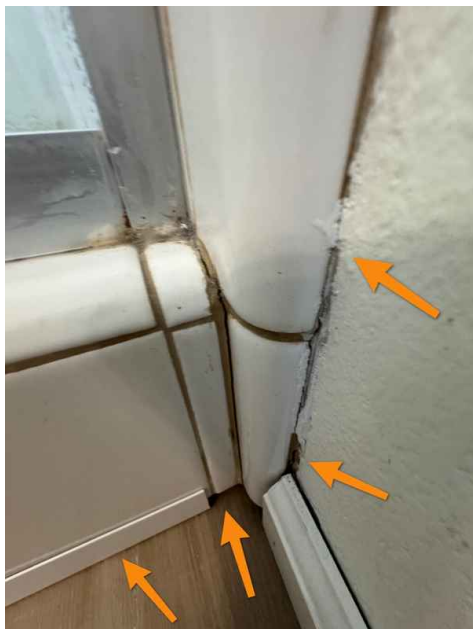
Recommend the shower/tub enclosures, fixtures and floor to tub/shower junctions be cleaned and re-caulked/sealed by a qualified professional as necessary to prevent moisture intrusion beyond the tub and shower enclosure(s).

Example noted

Half Bathroom Shower Bathtub

Example noted at Primary Bathroom Shower

Contact a qualified professional.

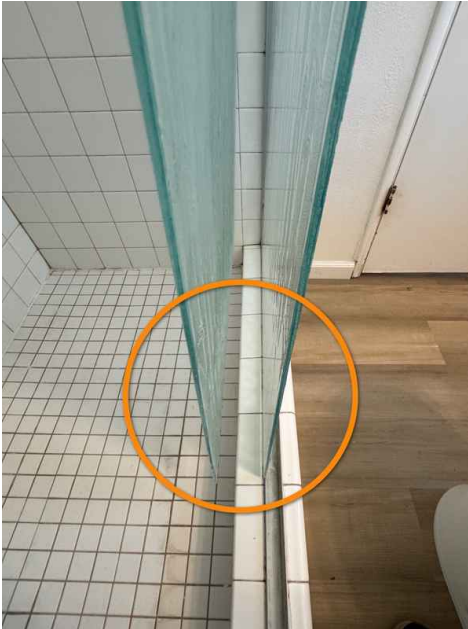
Primary Bathroom Shower

Glass doors appeared loose and swing freely at the frame. This can lead to a pinching hazard and breakage, which can also be a potential injury concern. There did appear to be possible safety glass marking, however, I was not able to verify as it was faint and corrosion blocked my view. Recommend further evaluation and repair as necessary by a qualified professional, and to verify the panels are made of an approved safety glass.

Contact a qualified professional.

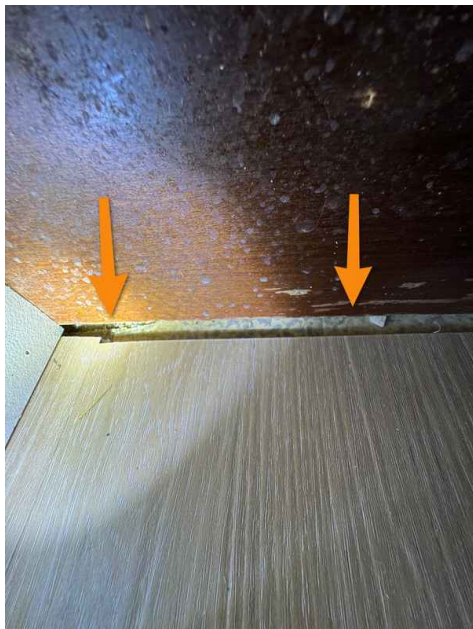
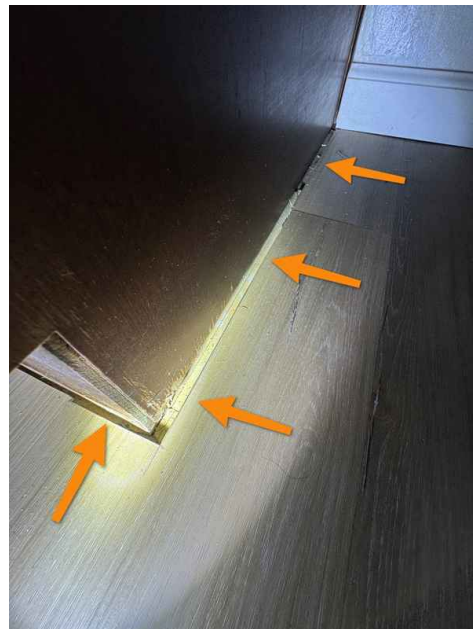
The installed flooring did not appear adequately secured in several locations, this condition can lead to flooring becoming loose or even damaged over time. This condition is also generally considered unworkmanlike finish, and can sometimes be indicative of work that was not completed by a licensed contractor. Recommend inquiring with the seller if any warranty exists for the replaced flooring installation, and/or further evaluation by a licensed flooring contractor to determine any corrections possible to ensure proper function.

Example noted

Example noted at Kitchen

Example noted at Bedroom #3

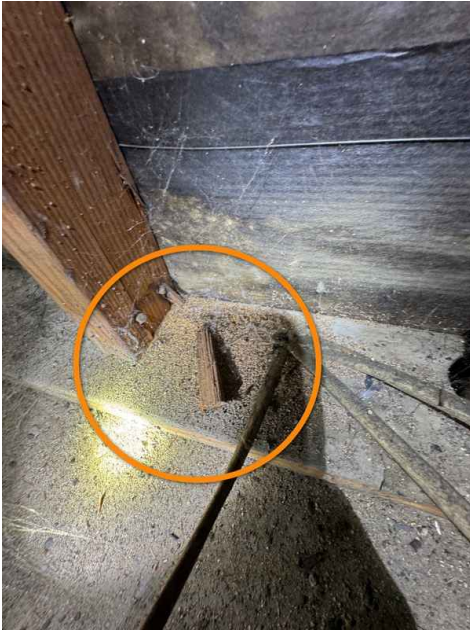
They appeared to be pest nests noted in several areas of the attic space. Evidence of possible recent wood boring organism activity and/or moisture damaged wood also noted in the attic in several areas. The accessible areas appeared dry, however, this is a very limited test and due to a lack of recent heavy rain at time of inspection I am unable to determine if any roof leaks exist at this time. Recommend a licensed termite inspector or licensed pest control company be consulted to determine any preventative measures and/or repairs necessary. Note: Home inspectors are not licensed termite or pest inspectors and are therefore not qualified to verify the presence of termites or any pests, or to evaluate the extent of possible damage that may be the result of termites or other wood boring organism activity, please refer to the pest inspection report (if one exists).

Example noted

Example noted at Attic, Right Side

Example noted at Attic, Front

Contact a qualified pest control specialist.

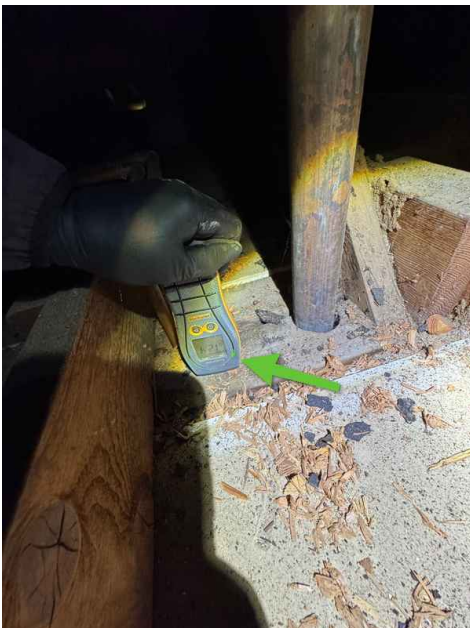
The area appeared to be dry

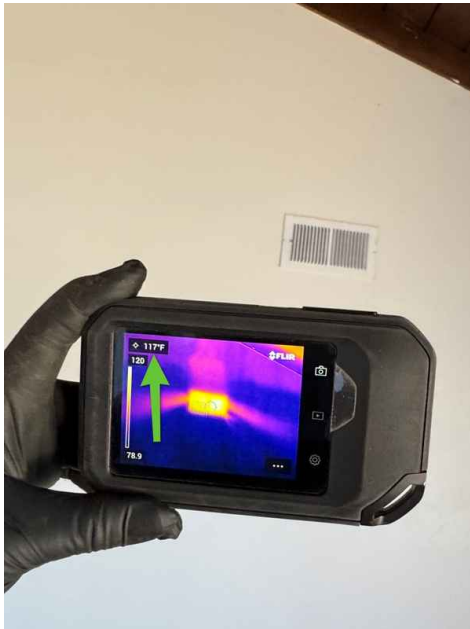
Thermal Image of heat

The furnace appeared to produce heat when tested using standard controls. However, the unit is aging and appeared noisy when turned on, often indicative of aged components. There did not appear to be a gas sediment trap installed as required. The unit also does not appear original to the home. Recommend further evaluation and repair as necessary by a licensed HVAC contractor, also, recommend inquiring with the seller for documentation showing the unit was installed by a qualified professional according to manufacturer's requirements.

Contact a qualified heating and cooling contractor

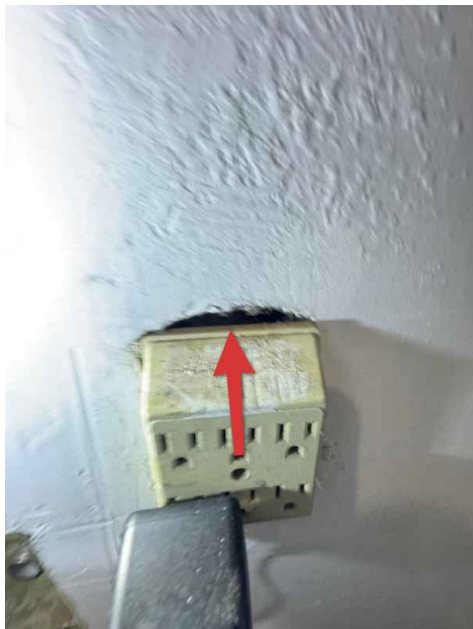
Example of gap noted

Contact a qualified drywall contractor.

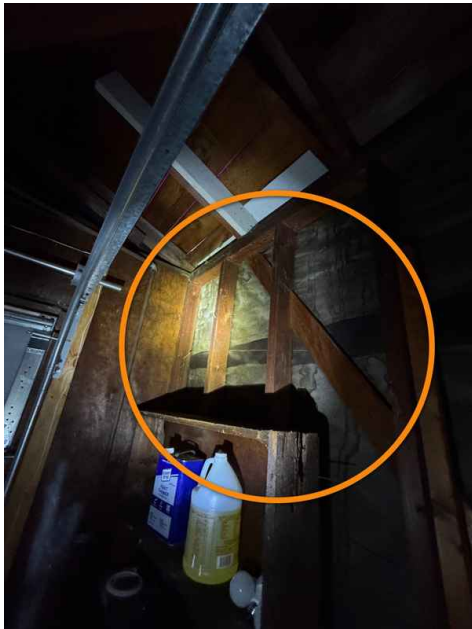
Moisture staining/damage noted at the garage walls in several areas. The areas appeared dry at the time of the inspection. Determining the exact cause is beyond the scope of this inspection. Recommend further evaluation by a licensed restoration contractor to determine any repairs necessary. Note: Determining if hidden damage (such as organic growth) exists beyond the surfaces is beyond the scope of this inspection.

Example noted

Contact a qualified professional.

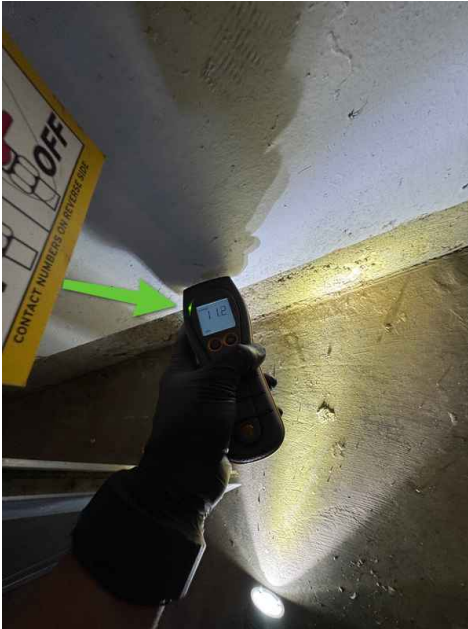
The area appeared to be dry

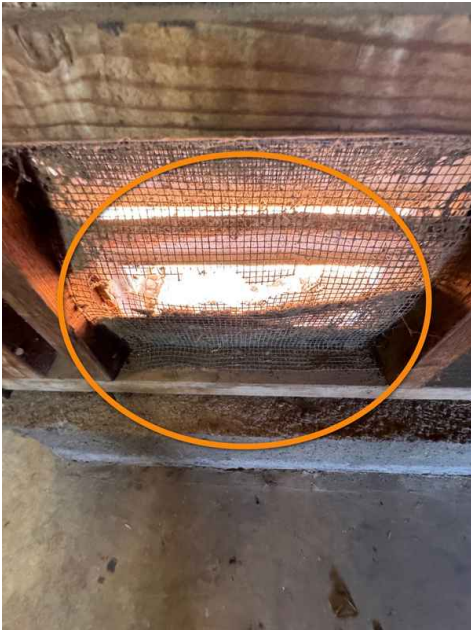
Damaged screen(s) noted at garage vents. This condition can allow pest intrusion. Pests can cause damage to the home. Recommend further evaluation by a licensed pest control contractor and repair as necessary to forestall pest intrusion.

Example noted

Contact a qualified professional.

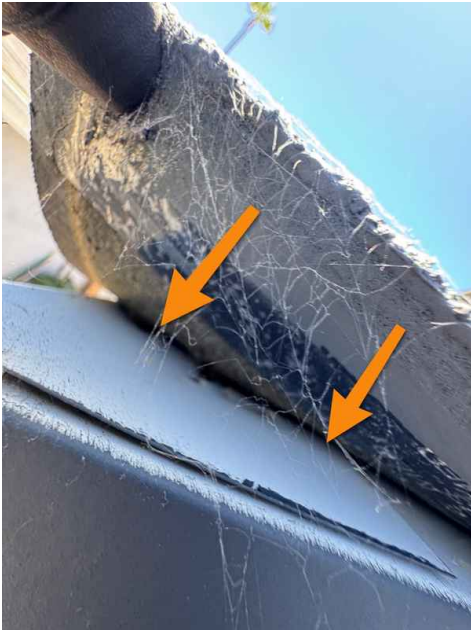
Example noted

Contact a qualified roofing professional.

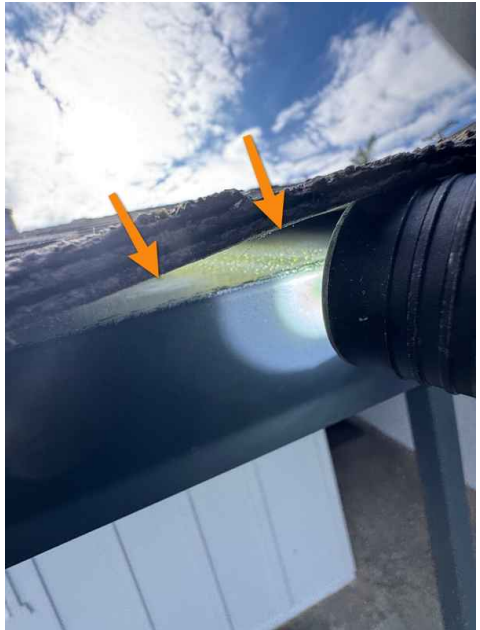
Example noted

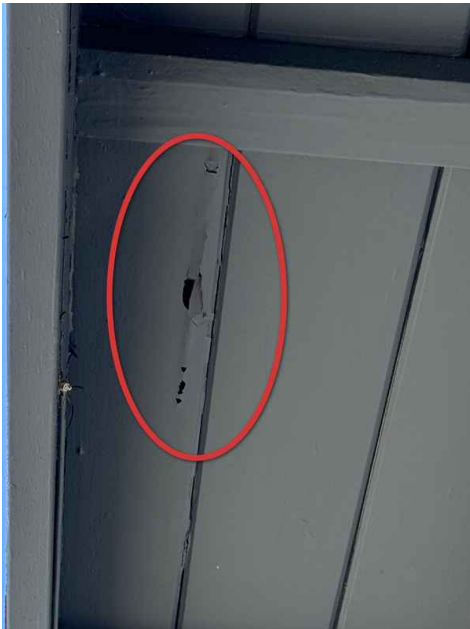
Failing paint noted in several areas at the exterior of the home. This home appears to have been built prior to 1978. Homes built before 1978 may contain lead-based paint. Lead from paint, paint chips, and dust can pose a health and safety hazard, if not managed properly. Recommend a qualified professional be consulted for further evaluation and to ensure proper health and safety measures are taken, particularly if the client chooses to remove or alter existing paint. Note: Sellers in the state of California are required to disclose any information regarding lead paint in a home. I recommend referring to the seller disclosures for any applicable information regarding the paint in this home.

Example noted

Example noted at Left Side of Home

Contact a qualified professional.

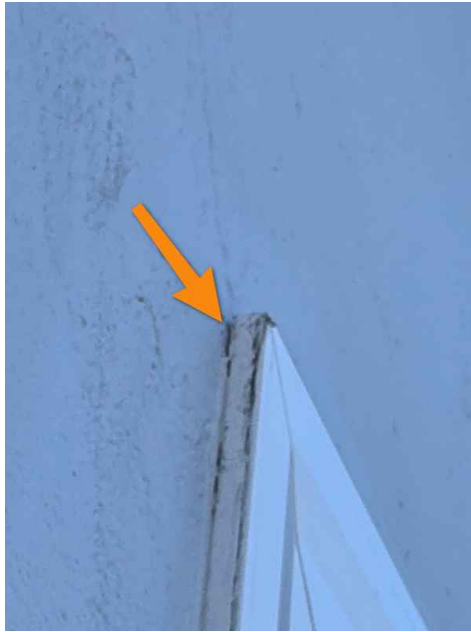
Example noted at Front Left Side of Home

Example noted

Example noted at Right Side of Home

Contact a qualified window repair/installation contractor.

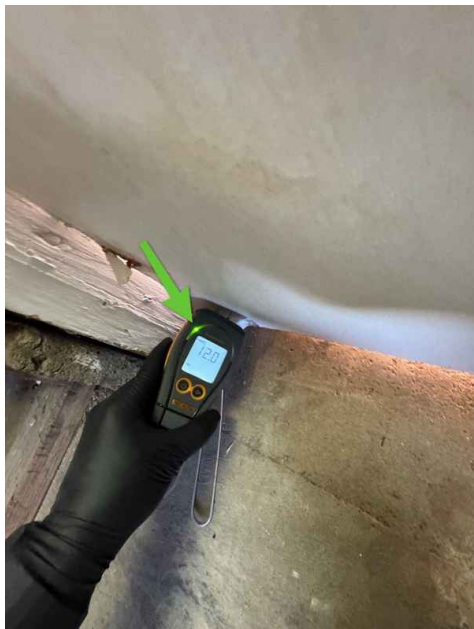
The area appeared to be dry

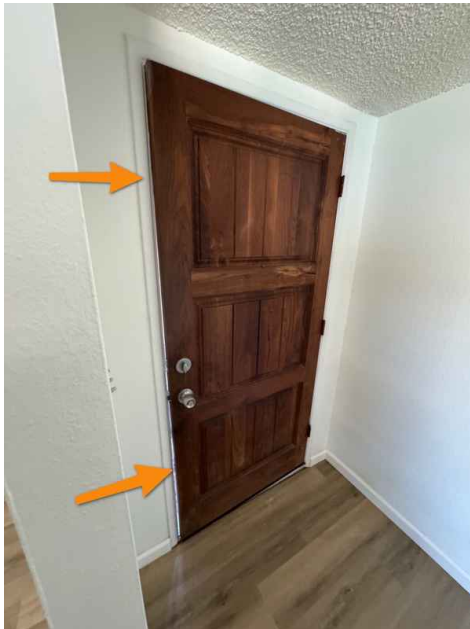
Front Entry

The front entry door did not appear to be square in its opening. The door would not close properly and rubs at frame. This condition may simply be due to misaligned hinges, or it can sometimes indicate possible settlement of the structure. Recommend further evaluation by a licensed door contractor to determine the cause and any repairs necessary at this time to ensure proper function.

Contact a qualified door repair/installation contractor.

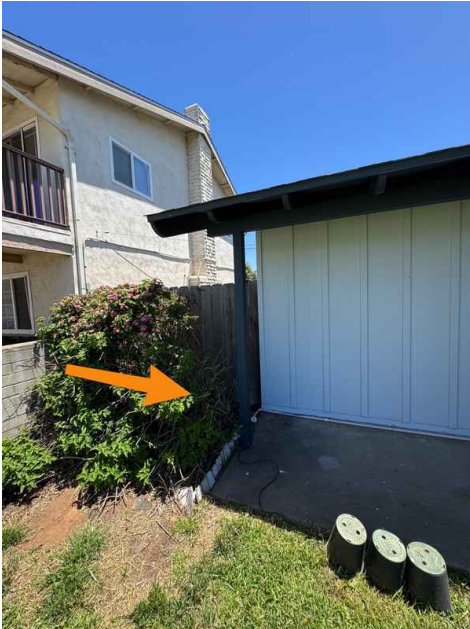
There appeared to be low/neutral areas at the grading next to the home, however, subsurface drainage was visible in just one or more areas at the exterior. Determining if further drains are present, and if drains are functional is beyond the scope of this inspection. Moisture intrusion and deterioration to the home remains a possibility if drainage is inadequate. Recommend further evaluation and monitoring of the grading and any existing drains around the home by a licensed landscaping contractor, and any corrections as necessary.

Example noted at Front Left Side of Home

Recommendation  
Contact a qualified landscaping contractor

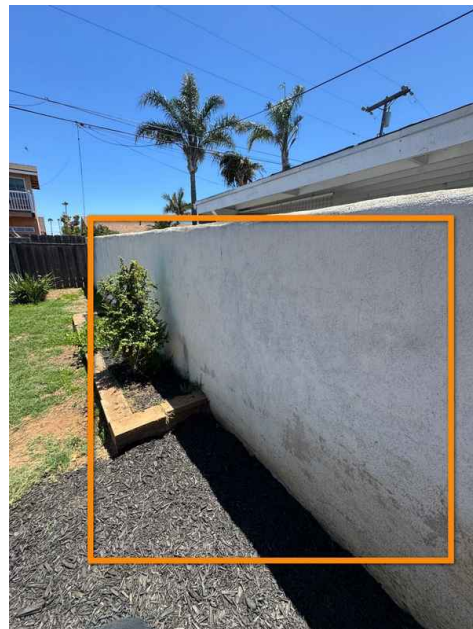
Cracking and separation sections visible at the retaining wall(s) in several areas. Moisture damage also noted. Damage in retaining walls can be caused by many reasons, including ground movement or improper design. The wall(s) did not appear to have weep holes, which allow water to drain from behind the walls. Determining the cause of damage is beyond the scope of this inspection. Recommend further evaluation of the retaining/yard walls by a licensed masonry contractor to determine any repairs necessary. Note: The retaining walls appeared to be shared with the neighboring properties, recommend to inquire with the seller to determine client's responsibility regarding the walls.

Example noted at Right Side wall, cracking noted, no weep holes visible

Contact a qualified masonry professional.
