Cornerstone Home Inspections

Home Inspection Report

21065 Crystal Falls Dr

Inspected on Fri, Jun 26 2026 at 7:52AM

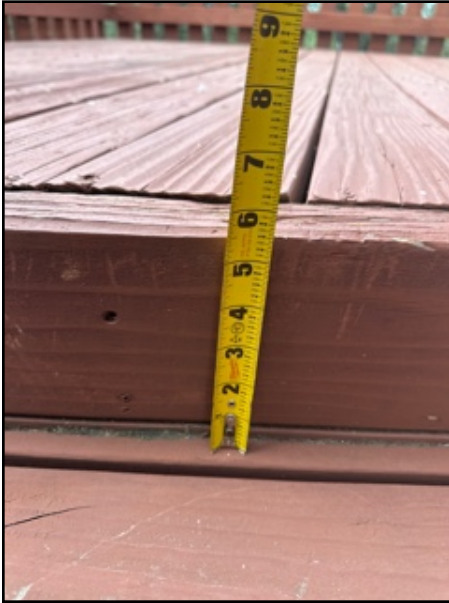
Figure 3-1

Comment 3:
Steps to front porch are inconsistent heights.

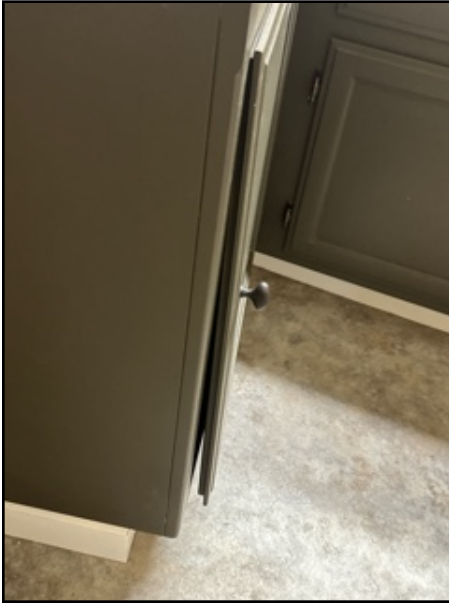
Figure 32-1

Master bathroom cabinet door on left side is warped.

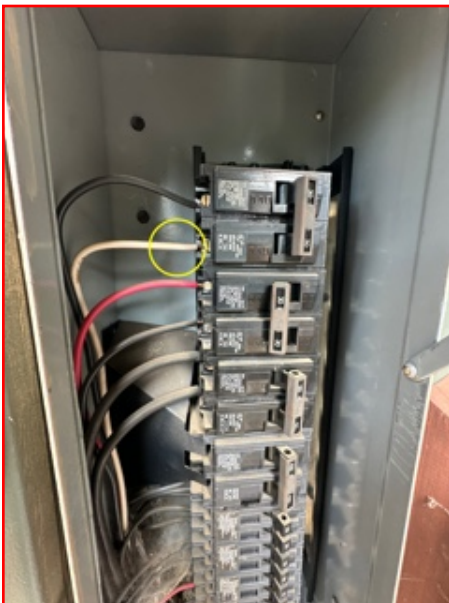
Figure 8-1

4) White wires connected to breakers used to carry load are require to be labeled with black or red tape.

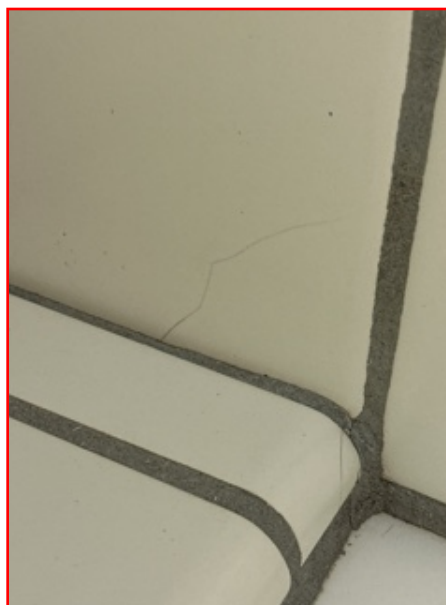
Figure 18-2

Cracked tiles noted on left side of downstairs bathroom tub.

**Comment 19:**
Recommend to reseal any cracked or missing gout surrounding downstairs bathroom tub.

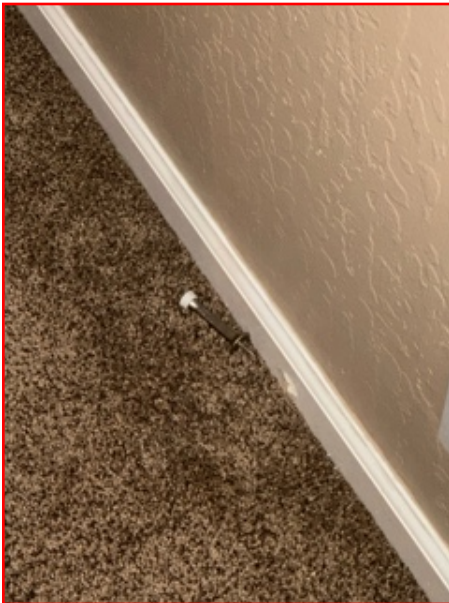
Figure 25-1

14) Downstairs 2nd bedroom door stop is not attached to the wall.

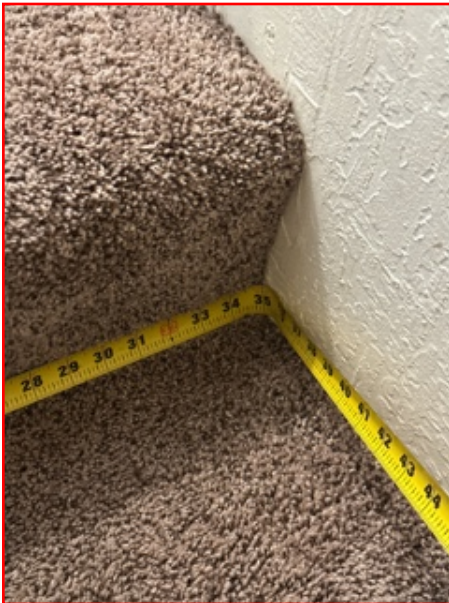
Figure 28-1

16) Current CA building codes require stairways have a minimum width of 36", measured above the handrail.
