INSPECTION REPORT  
5700 Baltimore Dr #39  
La Mesa CA 91942

INSPECTED BY  
Ray Salcido  
HomeSite  
Inspections - A  
Division of DeBerry  
Inspection Services

INSPECTION DATE  
📅 9/23/2024  
🕒 11:00 AM

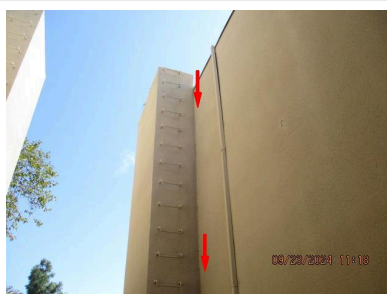
1.3 Item 2 (Picture)

Cracking noted along sides of the chimney junction to the building. The cracks should be sealed. Please Note: The exterior siding may be part of the Home Owners' Association. Items warrant attention and repair.

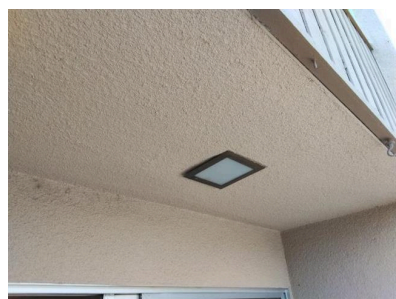
1.8 Item 1 (Picture)

Cover is part of the structure.

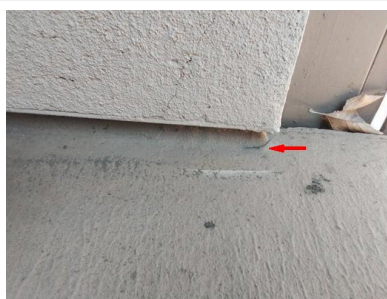
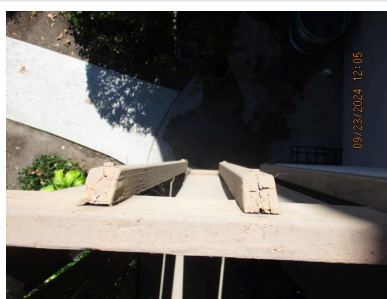
Cracking and staining noted on the balcony surface, railing boards and frame loose, wood weathered and worn. Ensure that the balcony surface is kept well sealed to prevent water intrusion or damage to the inaccessible areas. Drain should be kept clean and clear to allow water to flow off. Recommend review and repairs by a licensed contractor.

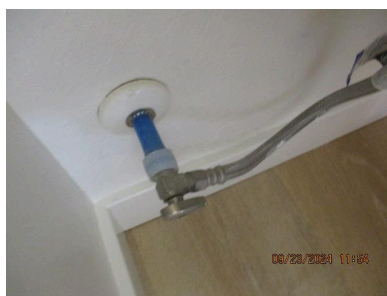
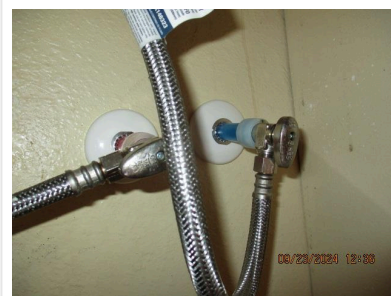
PEX pipes visible beneath the fixtures.

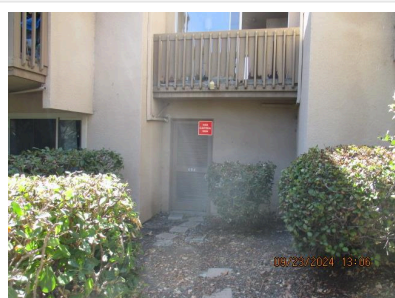
5.0 Item 1 (Picture)

Main electrical closet not accessible.

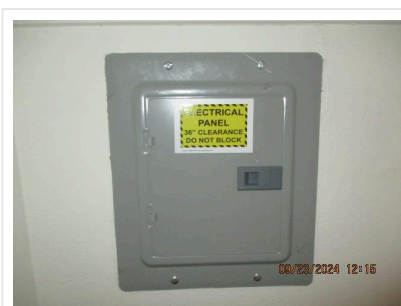
6.0 Item 3 (Picture)

(2) Panel location: In entry hall closet

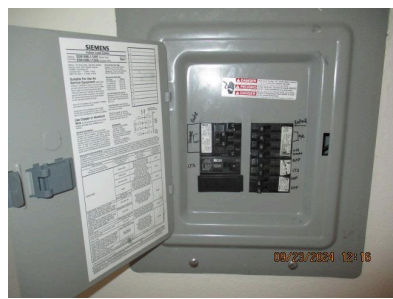
6.1 Item 1 (Picture)

Not tested to determine if labeled correctly.

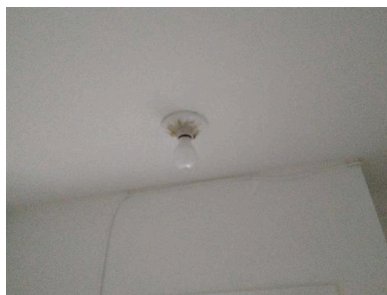
7.9 Item 2 (Picture)

(2) Lights inside closets would be considered improper and potential fire/safety hazards by today's standards. Missing protective cover over light fixtures.

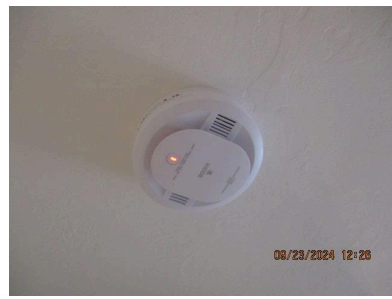
7.12 Item 1 (Picture)

Combination type detectors present at both floors.

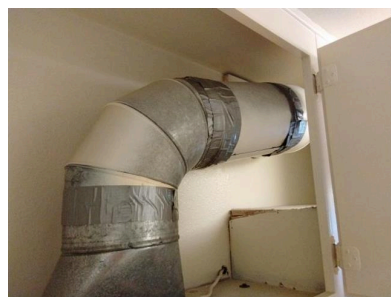
10.13 Item 1 (Picture)

Fan is functional however: The tube needs to be sealed with heat rated tape.

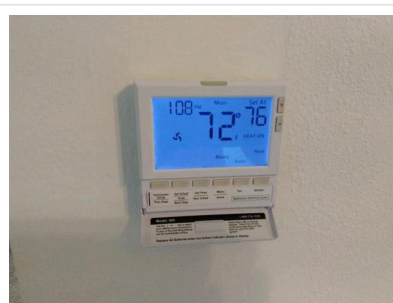
11.2 Item 1 (Picture)

Thermostat located on first floor.

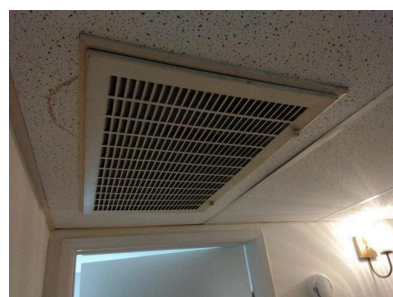
11.3 Item 1 (Picture)

Located in the return.

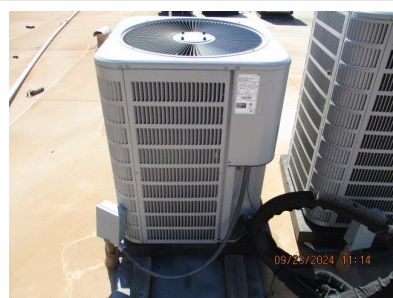
AC is functional. Data plate indicates possibly 2019 manufacture date.

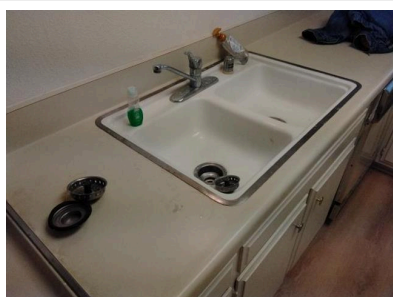
10.0 Item 2 (Picture)

(1) Wear to the counter tops.

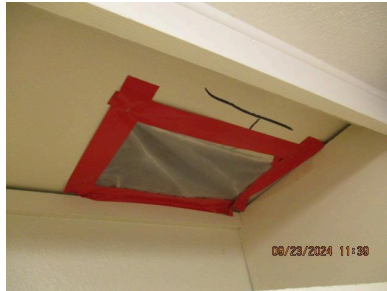
10.1 Item 3 (Picture)

(2) Holes noted on the walls and ceilings in the cabinets, reason for holes not known, plastic covered.

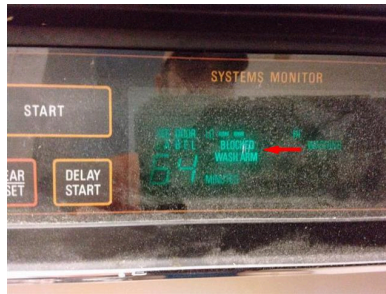
10.10 Item 2 (Picture)

Dishwasher not adequately secured to the cabinetry / countertop. Unit did not function properly, it would start but stop and go into fault mode. Recommend review and repairs by a licensed contractor.

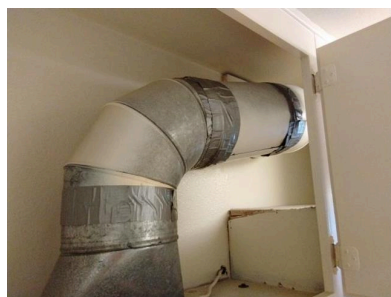
10.13 Item 1 (Picture)

Fan is functional however: The tube needs to be sealed with heat rated tape.

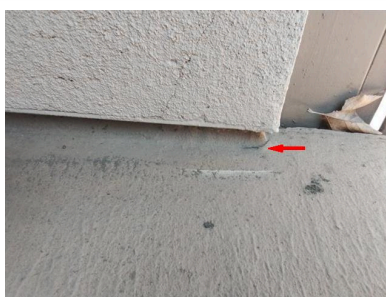
1.9 Item 2 (Picture)

Cracking and staining noted on the balcony surface, railing boards and frame loose, wood weathered and worn. Ensure that the balcony surface is kept well sealed to prevent water intrusion or damage to the inaccessible areas. Drain should be kept clean and clear to allow water to flow off. Recommend review and repairs by a licensed contractor.

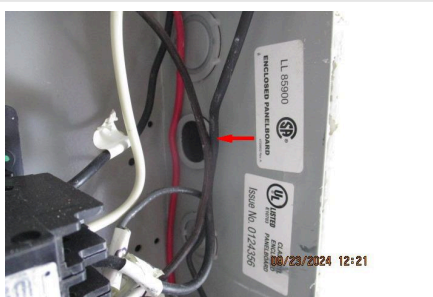
6.0 Item 2 (Picture)

(1) Open "knock-out" holes noted. This is a safety hazard. Insert caps to close off openings. Recommend review and repairs by a licensed electrical contractor.

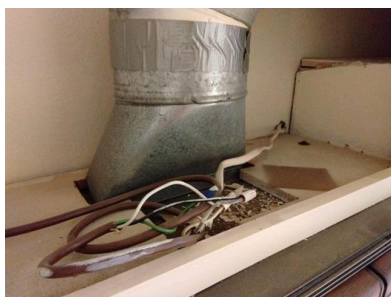
10.12 Item 2 (Picture)

Microwave did not operate properly. Unit failed to heat. This unit would be considered to be at the end of its life. Replacement may be necessary. Exposed wiring in cabinet above microwave, this is improper and potential safety hazard. Recommend evaluation and repair by a licensed electrical contractor.

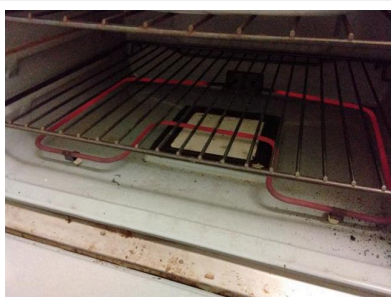
10.14 Item 2 (Picture)

Oven elements are functional however it is missing an anti-tip bracket. This is a safety hazard. Item warrants attention and repair.
